2016 Cleveland Metroparks Hydrilla Report

Cleveland Metroparks Technical Report 2016/NR-01

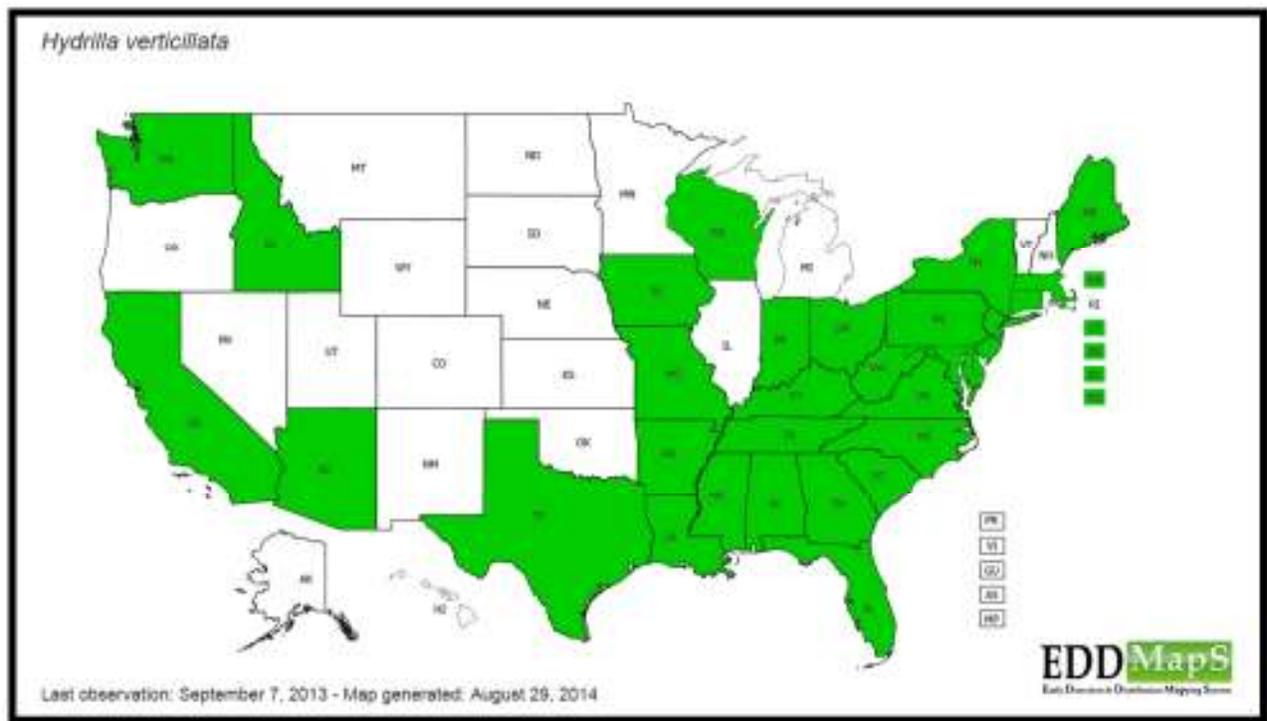
Figure 1. Distribution of Hydrilla in the United States

Hydrilla is abundant in the southeastern United States, where it was first introduced several decades ago by the aquarium and aquaculture trades, and is listed as a federal noxious weed (Batcher, 2000; Langeland, 1996) (Figure 1). Hydrilla rapidly moved up the Atlantic seaboard following its introduction and has been found as isolated occurrences throughout the country (Batcher, 2000; Langeland, 1996) (Figure 1). Recently, Hydrilla has begun to move westward, with established populations in and along the Ohio River and occurrences in New York, Pennsylvania, Ohio, and Indiana (Menninger, 2011) (Figure 1).

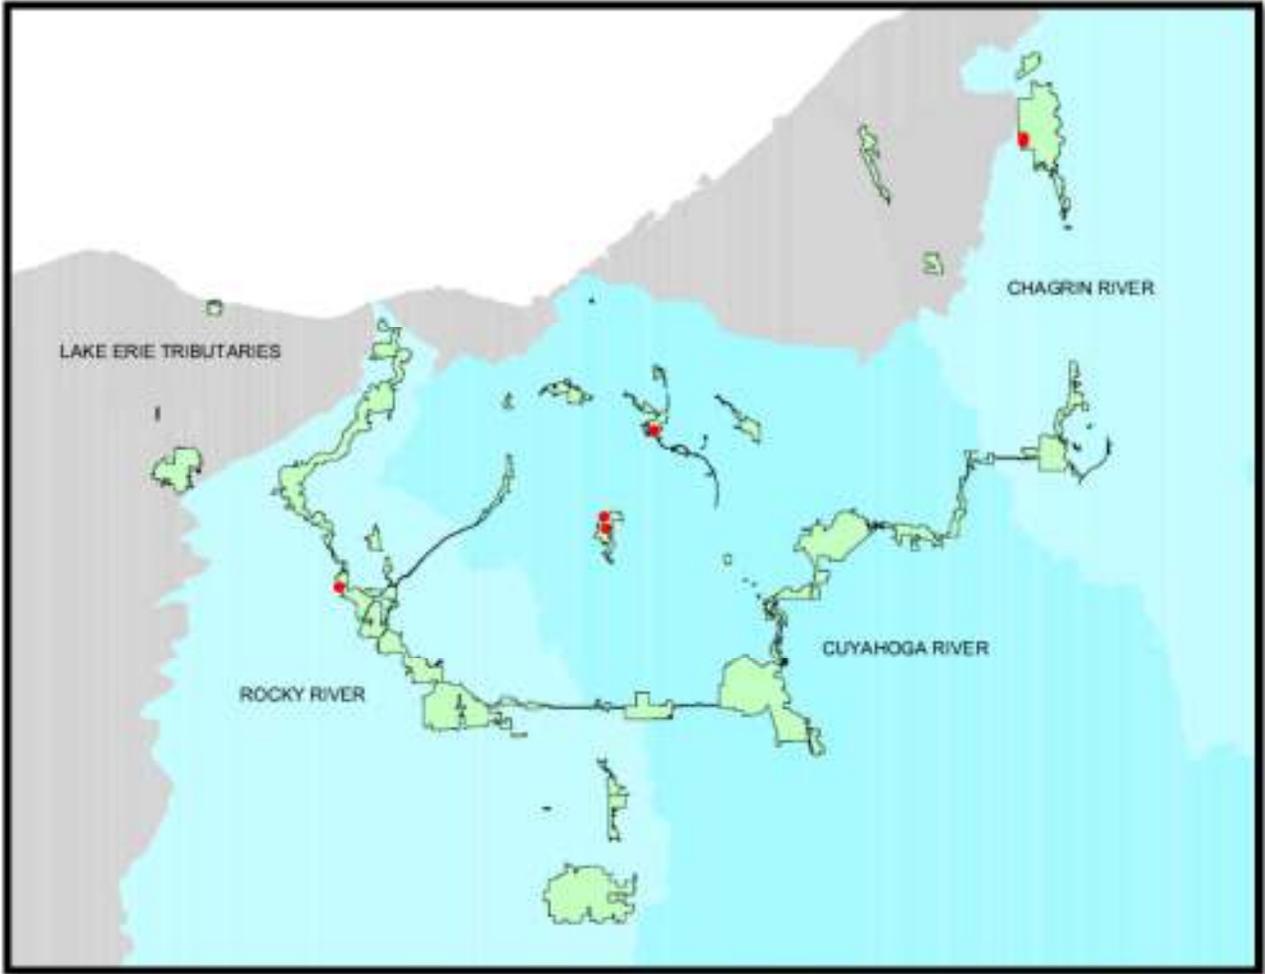
Figure 2. Cleveland Metroparks Hydrilla infestations by watershed

Hydrilla infestations in Cleveland Metroparks are all in highly accessible areas that experience a great deal of human traffic- including boating, fishing, swimming, birding, educational programs, habitat management, fishery management, water-level controls, and the potential for people to easily release aquarium species. This points to human activities as the most likely cause of Hydrilla introduction in and between these waterbodies. Hydrilla is present in all three major watersheds in Cleveland Metroparks (Figure 2). Maps of each infestation can be found in Appendix A.

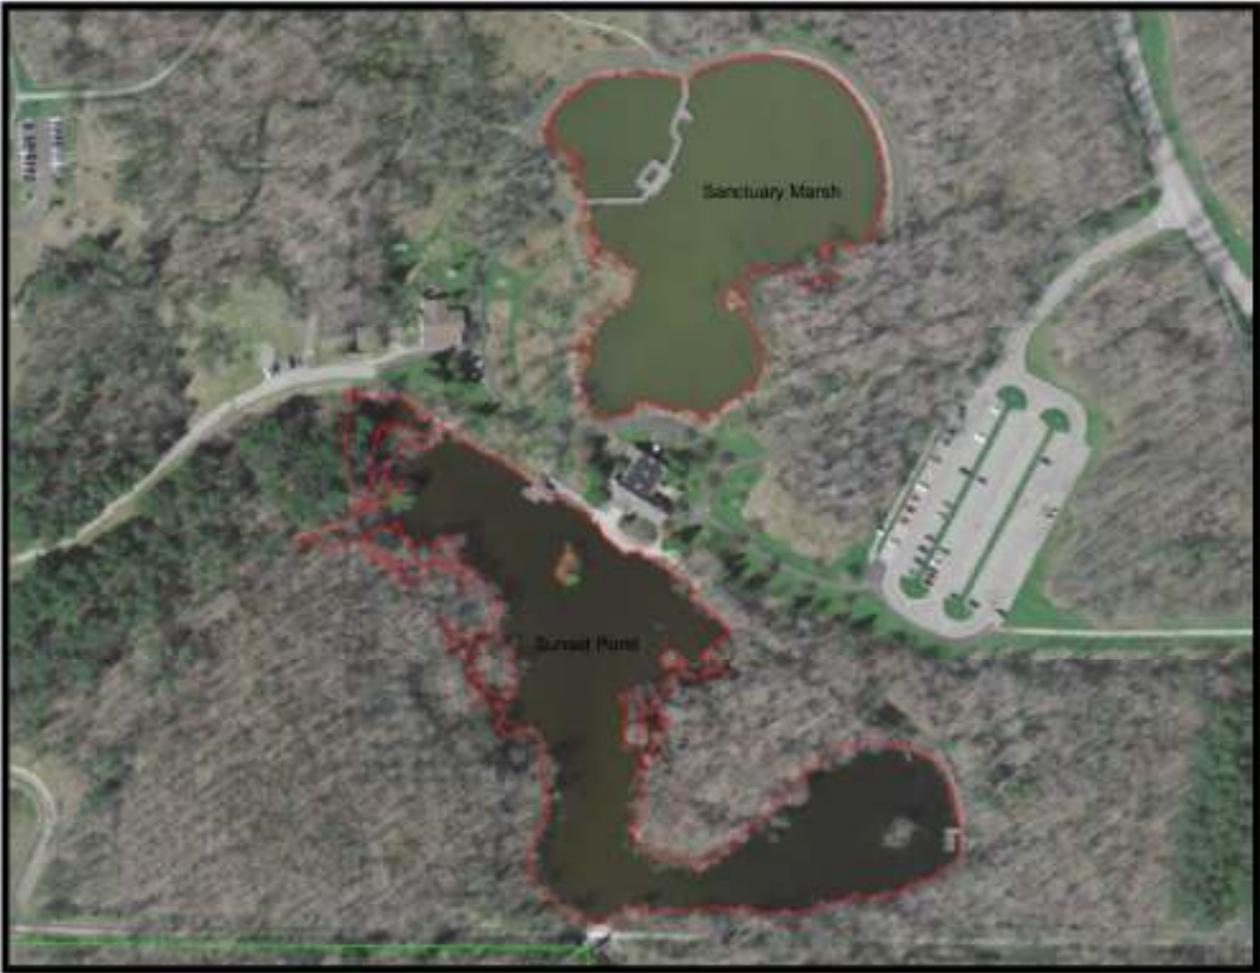
Map 1. Sunset Pond and Sanctuary Marsh in North Chagrin Reservation

Sunset Pond is a 5.2 acre man-made pond located in North Chagrin Reservation. The pond is a popular location for waterfowl, both local and migratory, and has been utilized as a brood-stock source for game fish by Cleveland Metroparks. A water-control structure is located at its outflow to Sanctuary Marsh. Hydrilla was found in Sunset Pond in 2012, consisting of several strands along the deck behind the North Chagrin Nature Center. More extensive surveys to check for additional Hydrilla patches have been hampered by excessive algae growth throughout the pond.

Sanctuary Marsh is a 3.7 acre created wetland located in North Chagrin Reservation. It is a popular location for waterfowl, both local and migratory, as well as other wildlife, and is crossed by a boardwalk. The marsh is used extensively by North Chagrin Nature Center staff for educational programs. It has a water-control structure at its outflow to Buttermilk Creek, a tributary of the Chagrin River. Cleveland Metroparks has regularly conducted boat electrofishing to remove non-native goldfish from the marsh. Hydrilla was found in Sanctuary Marsh in 2012, consisting of substantial mats in shallow areas around the boardwalk and pond dipping dock.

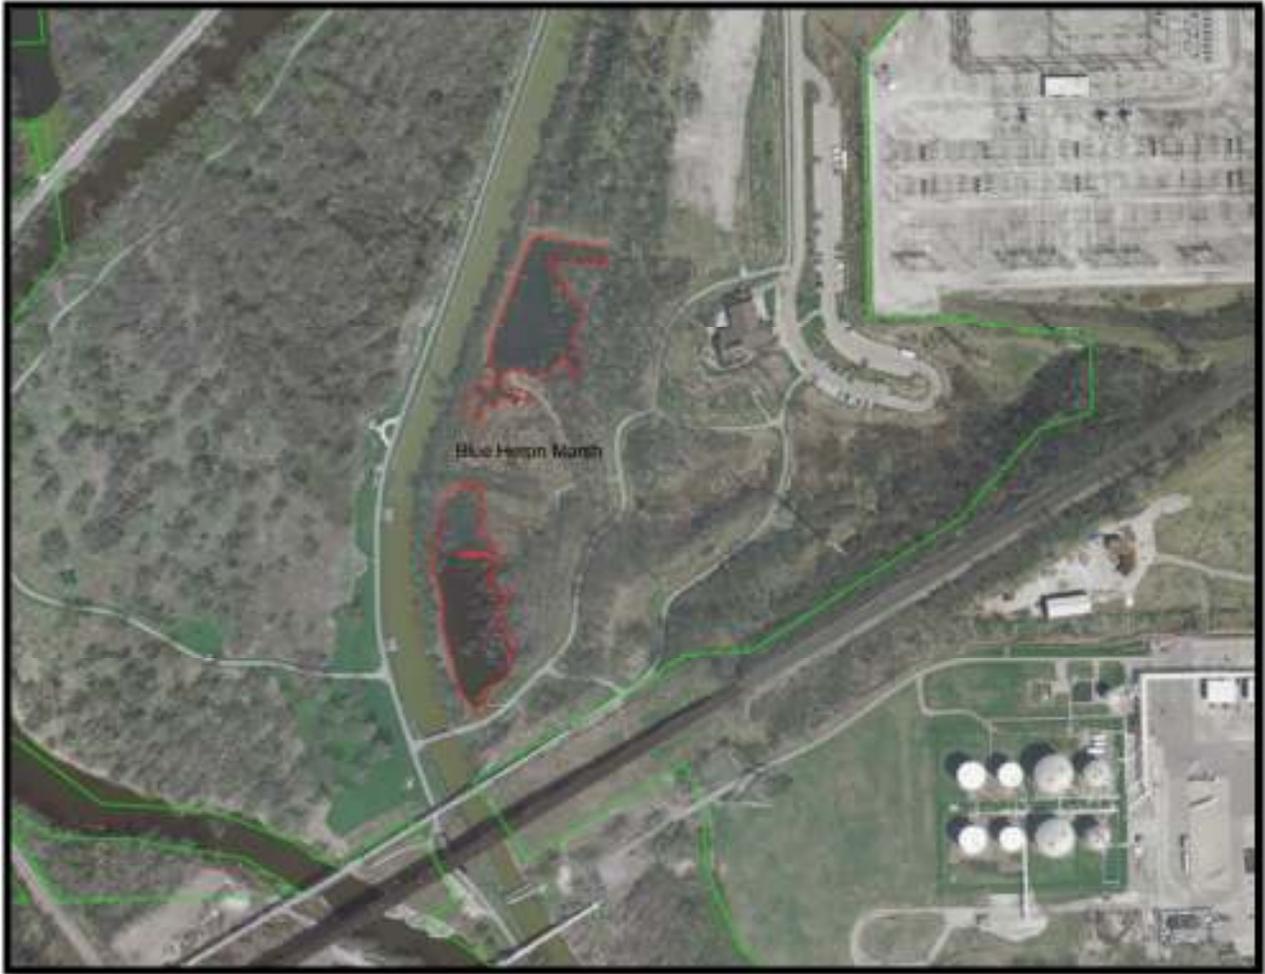
Map 2. Blue Heron Marsh in Ohio & Erie Canal Reservation

Blue Heron Marsh consists of two hydrologically connected wetland cells that discharge into the Ohio & Erie Canal. Their water levels can be modified using a water-control structure at one of the outflows into the Canal. Portions of the marsh have a boardwalk and pond dipping dock, which is utilized by CanalWay Visitor Center staff for educational programs. Additionally, a long-term Blanding's turtle study, including the release of head-started turtles and the tracking and trapping of turtles in the marsh has taken place in the wetlands for several years. A single strand of Hydrilla was found in the marsh in 2011 and subsequent surveys found multiple small, sparse patches of Hydrilla in the southern wetland cell.

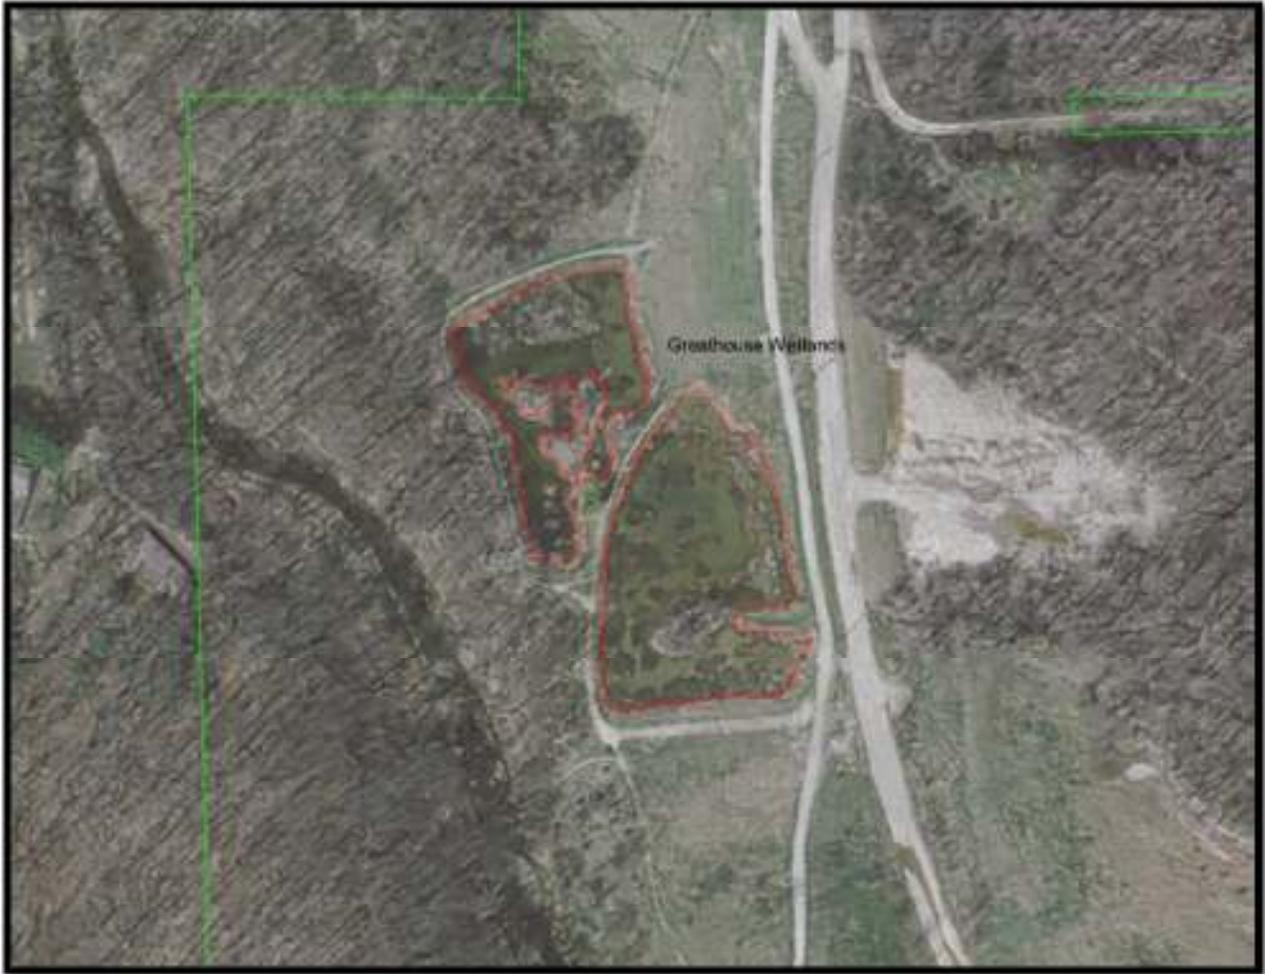
Map 3. Greathouse Wetlands in West Creek Reservation

The Greathouse Wetlands consist of two hydrologically connected cells that total 1.14 acres. These man-made wetlands were constructed in 2002 and a variety of aquatic plants were purchased from nurseries and installed. There are two water-control structures- one between the cells and one at the lower cell's outflow to West Creek, a tributary of the Cuyahoga River. An extensive infestation of Hydrilla was found in the upper cell in 2011, with the lower cell yielding only a few clusters of the plant.

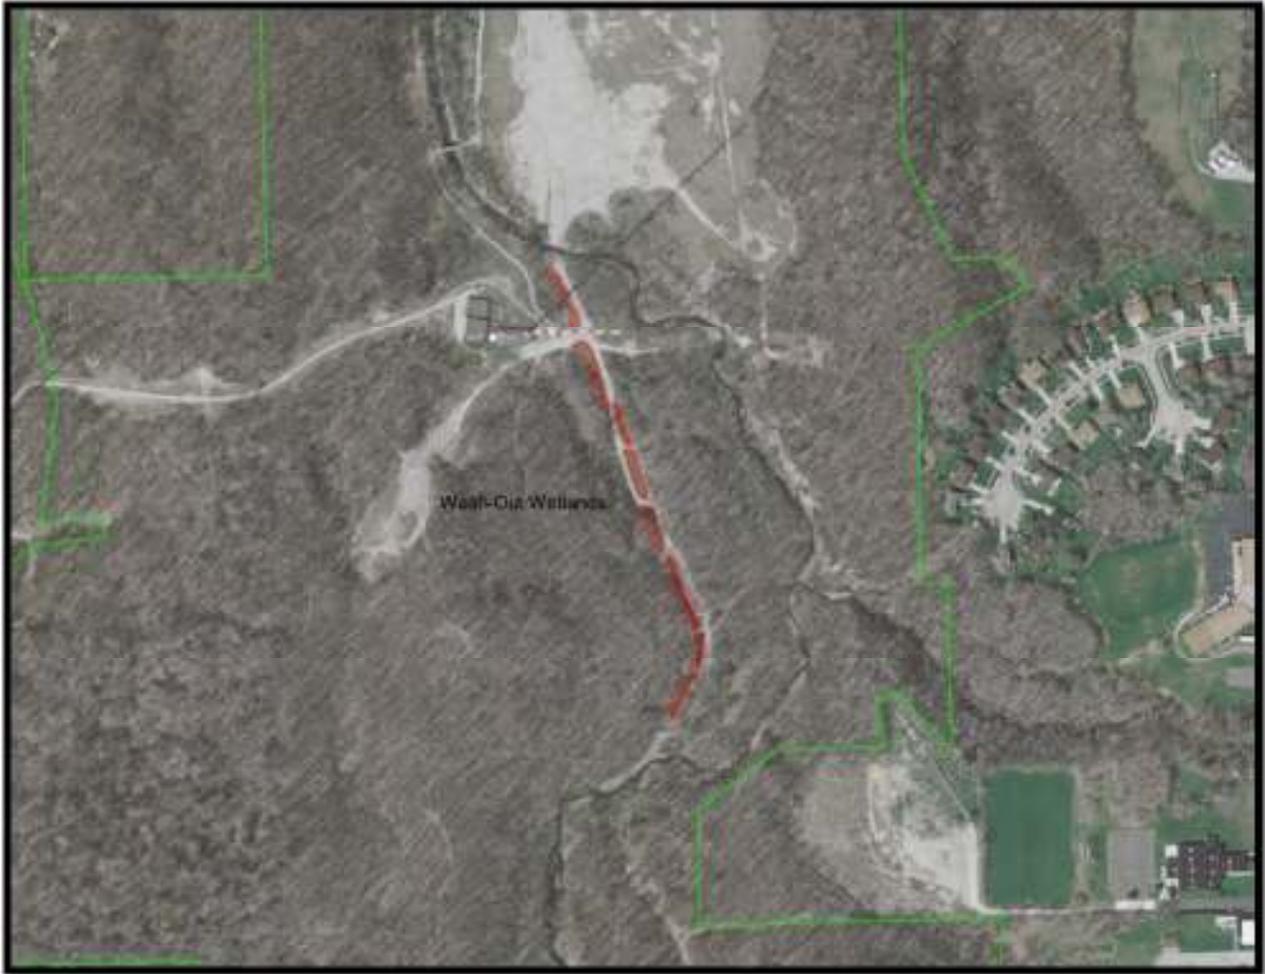
Map 4. Wash-Out Wetlands in West Creek Reservation

The Wash-Out wetlands are composed of 9 hydrologically connected cells that were constructed along a 1,300 foot sewer line wash-out and planted with nursery stock in 2002, totaling 0.44 acres. In 2013 cell 7 (numbered 1 through 9 from south to north) was found home to a dense infestation of Hydrilla.

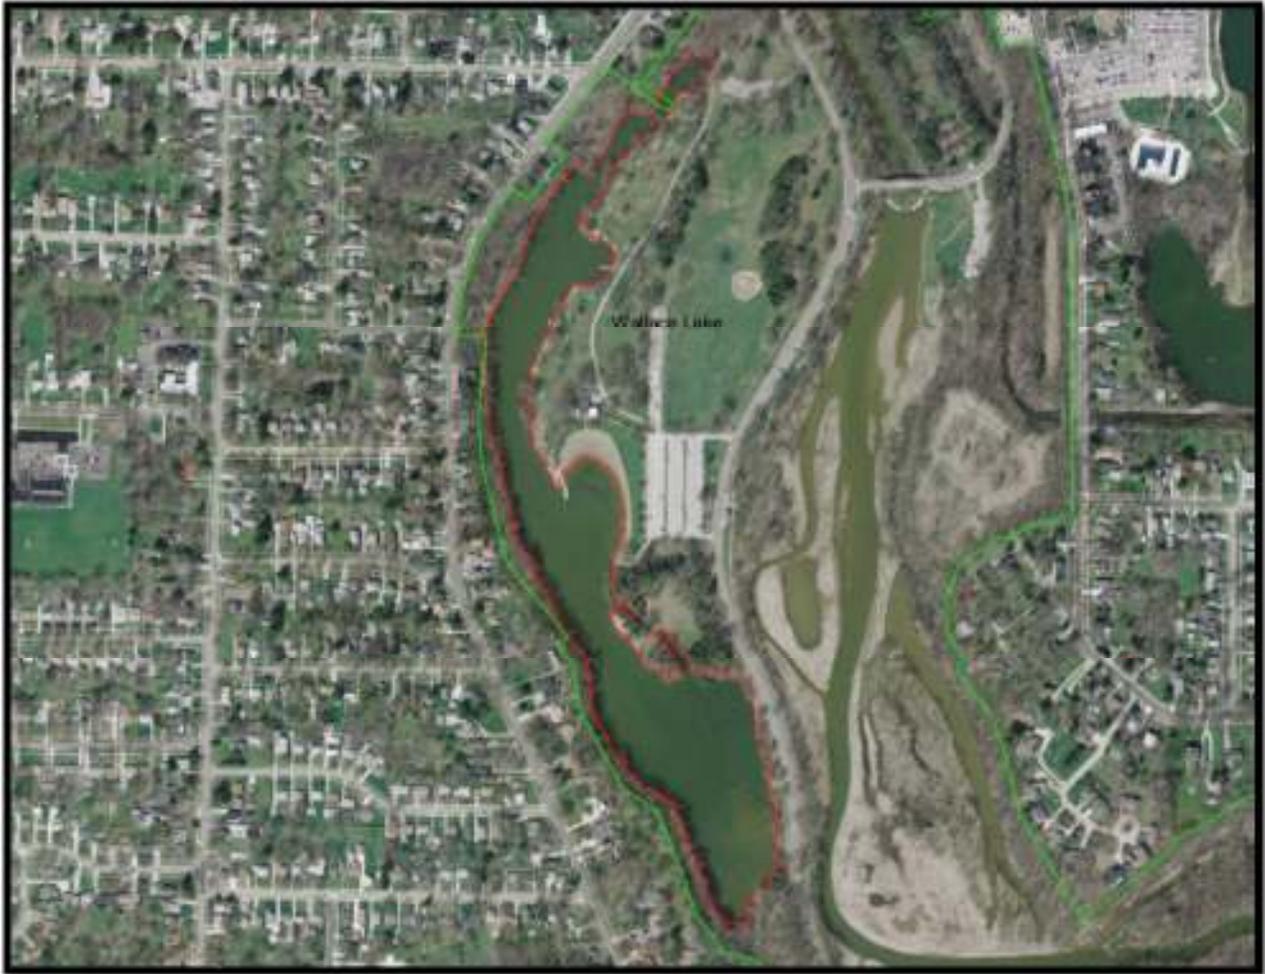
Map 5. Wallace Lake in Mill Stream Run Reservation

Wallace Lake is the location of a former Berea sandstone quarry that was flooded and turned into a lake in the 1930s. It is 17.6 acres in size, and while it was formerly 50-60 feet deep in some areas, its current maximum depth is 26 feet due to decades of sedimentation. The lake consists of two deep basins on its north and south ends with a shallow, narrow neck between them. Wallace Lake has a

water-level control structure and an outflow into the East Branch Rocky River. During high floods there can be unrestricted flow between the lake and river. The lake is a popular area for fishing, swimming, and boating, and is managed during the growing season for nuisance aquatic vegetation. Hydrilla was found in a small number of patches in the southern basin in 2011, near aquatic vegetation that had been transplanted from the Greathouse Wetlands in 2009 and 2010 and spread rapidly throughout the lake during 2012.
