## Response Activities Following the First Verified Discovery of Hydrilla (*Hydrilla verticillata*) in Wisconsin

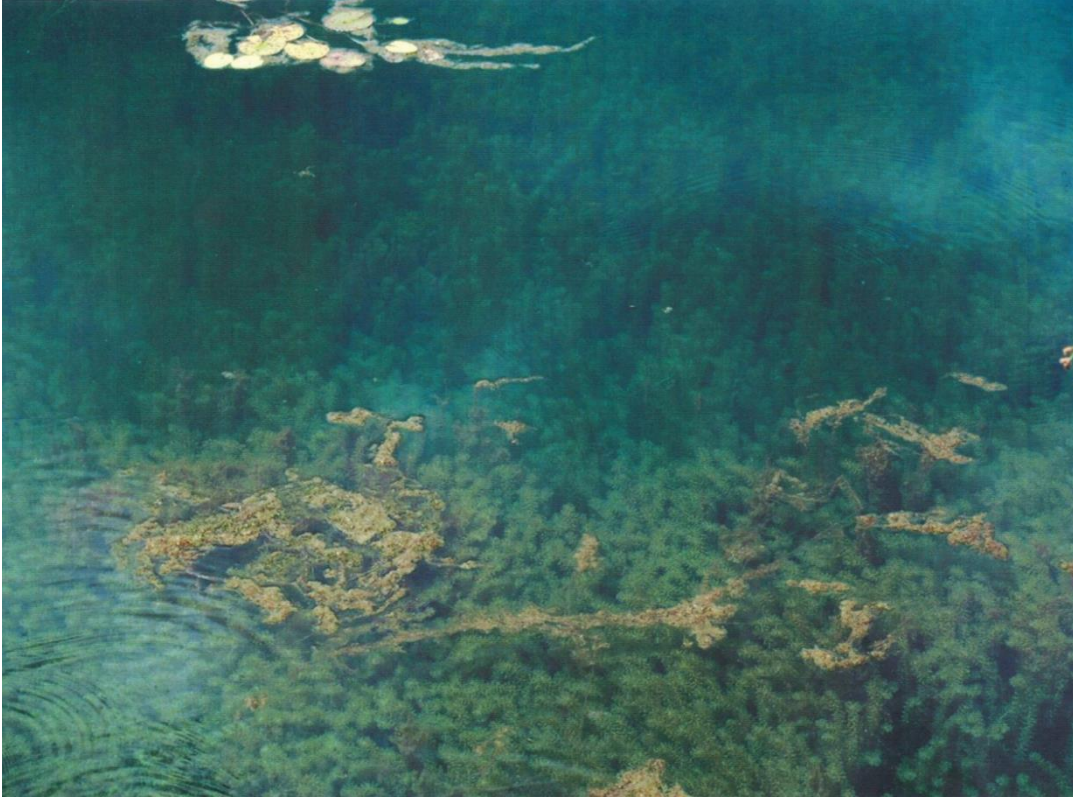
Initial reconnaissance monitoring was conducted, and hydrilla was observed to be well-established throughout the shallow half of the pond, as well as present in scattered shallow areas around the perimeter of the deep half of the pond (Figure 2). The landowner indicated that this current distribution was much wider spread than the initial sighting two years prior. Hydrilla in these areas was observed to be growing just below and up to the surface of the pond. A boat with an underwater camera was utilized to search for hydrilla in the deep half of the pond (max depth = 12 ft), but no hydrilla or other vegetation was observed growing in these deeper areas. The entire pond was outfitted with a plastic liner bottom, but no sediment was placed over the liner bottom in the deeper half of the pond, except around the outer perimeter. In addition, a blue dye was present throughout the pond, which may have limited light penetration to the deeper areas.

**Figure 2: Dense population of hydrilla (*Hydrilla verticillata*) growing in a small private pond in northeastern Wisconsin (Marinette Co.).**

On August 29, 2007 a certified pesticide applicator chemically treated the pond with liquid endothall (Aquathol® K) at 3.0 ppm following the treatment plan developed by the response team. Several members of the response team were present to observe the treatment. The treatment completely killed the vegetative portion of the hydrilla, reducing the possibility of it being carried to another waterbody before, during or after subsequent control activities.

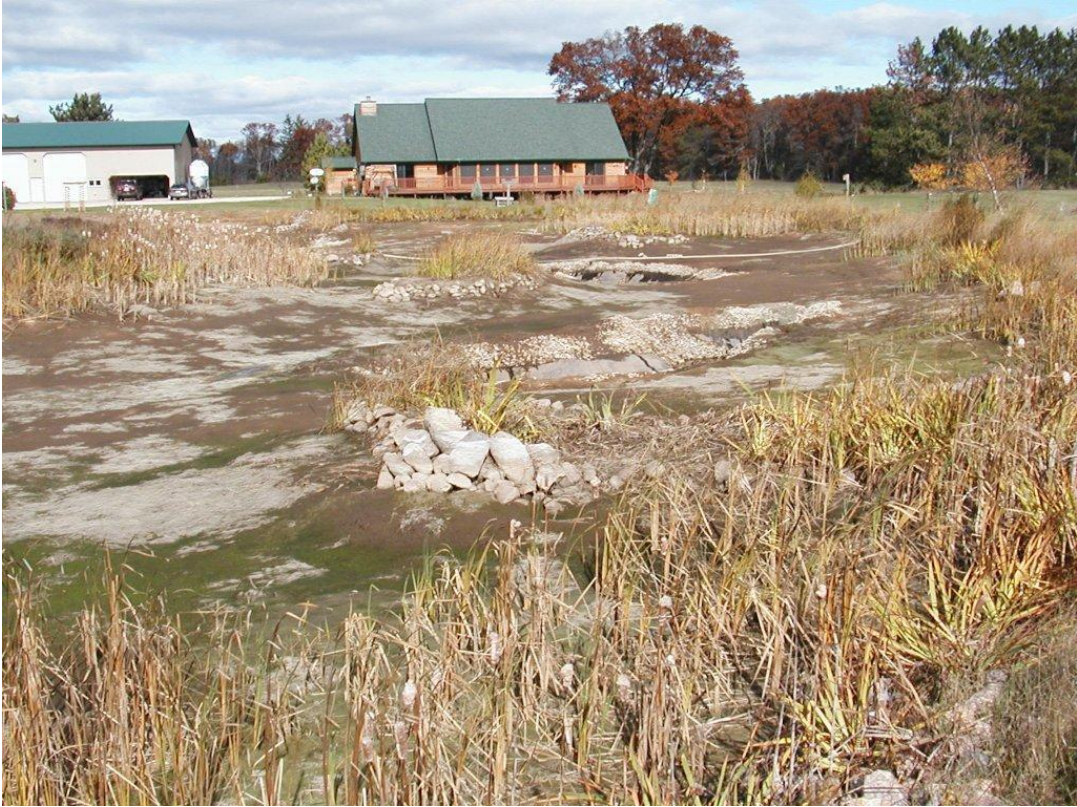
**Figure 3: Shallow half of the private pond following dewatering in fall 2007.**

Following the herbicide application, the response team recommended that the pond be completely dewatered in order to freeze hydrilla tubers and propagules to render them incapable of germinating in spring 2008. On October 19, 2007 a well drilling company began draining the pond. A centrifugal pump with a pumping rate of 60,000 gallons/hour was utilized, and dewatering took three days to complete (Figures 3 & 4). Additional smaller pumps were also needed to pump out water within the small depressions in the shallow area of the pond (Figure 5). Water was pumped onto an upland area owned by the landowner and was observed to quickly soak into the sandy soils. The well drilling company staff were informed about the importance of thoroughly flushing and cleaning all equipment after the pumping was completed to avoid accidental transport of hydrilla propagules. Following this main dewatering event, the landowners continued pumping of the small depressions of the pond as water drained into them in order to facilitate sediment drainage and drying as much as possible prior to freezing.

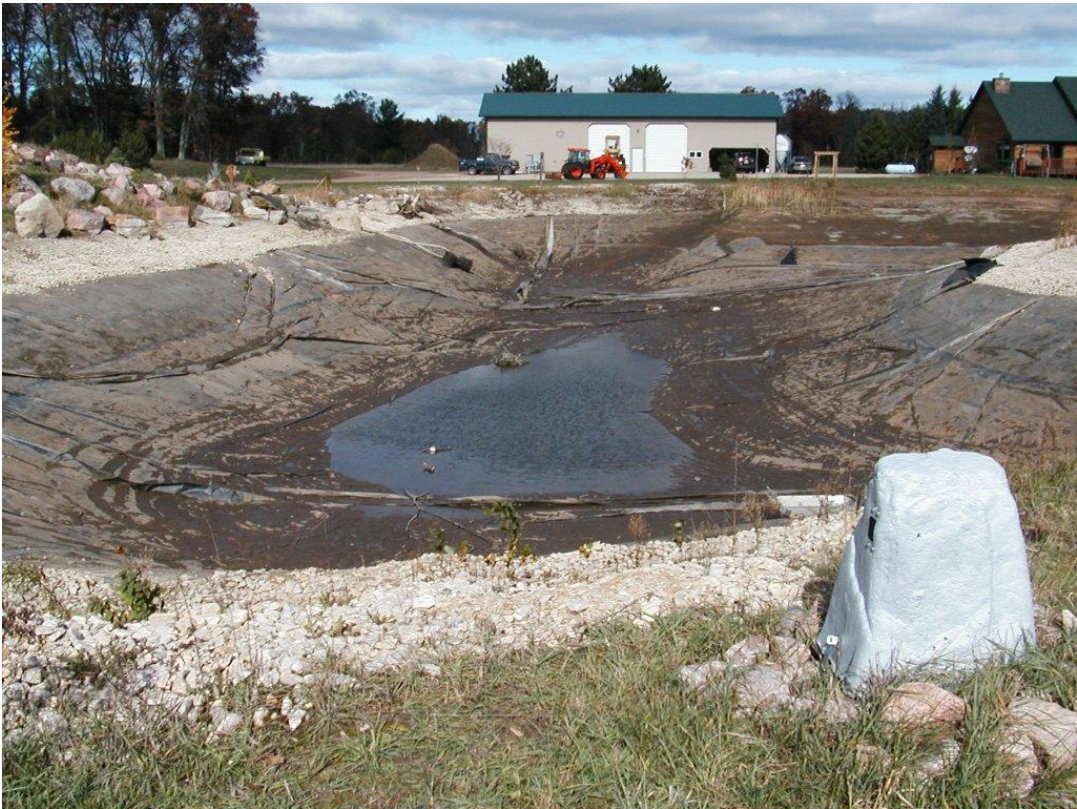
**Figure 4: Deep half of the private pond following dewatering in fall 2007.**

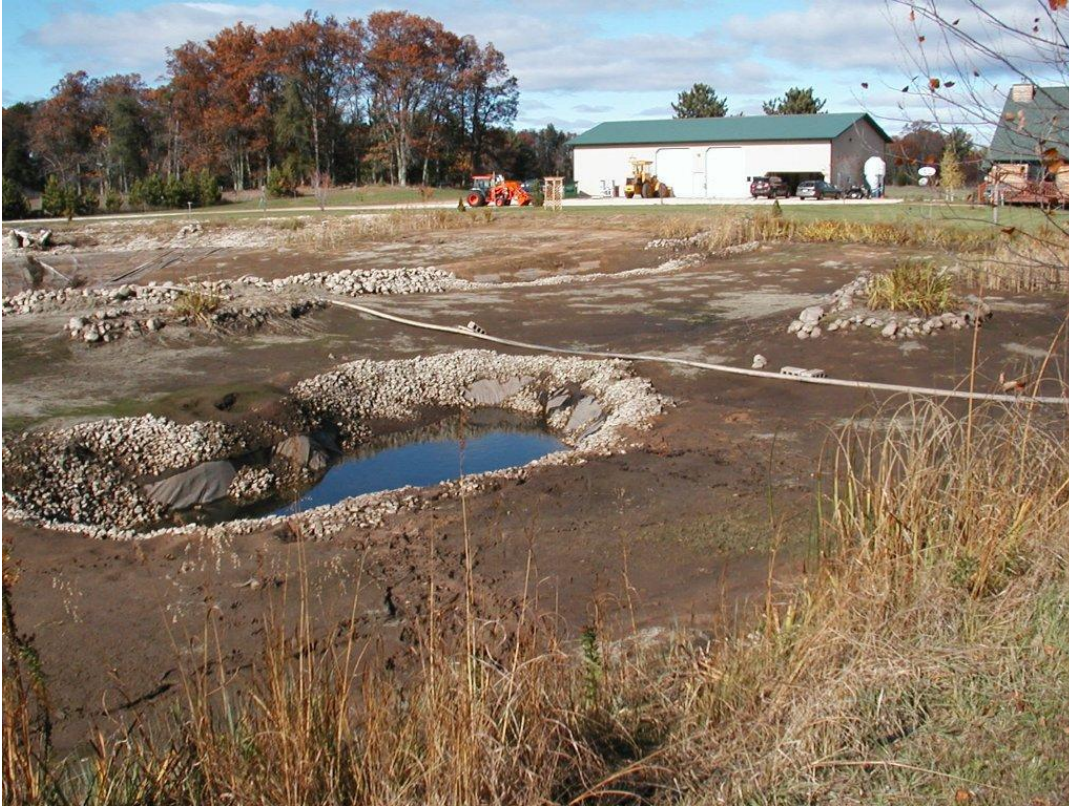
**Figure 5: Small depressions still holding some water in the shallow half of the private pond following dewatering in fall 2007.**
