# 2011 Lake Manitou Aquatic Vegetation Management Plan Update Fulton County, IN January 16, 2012

Prepared for:  
Indiana Department of Natural Resources  
402 W. Washington St. Rm. W273  
Indianapolis, IN 46204

Prepared by:  
SePRO Corporation, Aquatic Control, Aquatic Weed Control, and ReMetrix

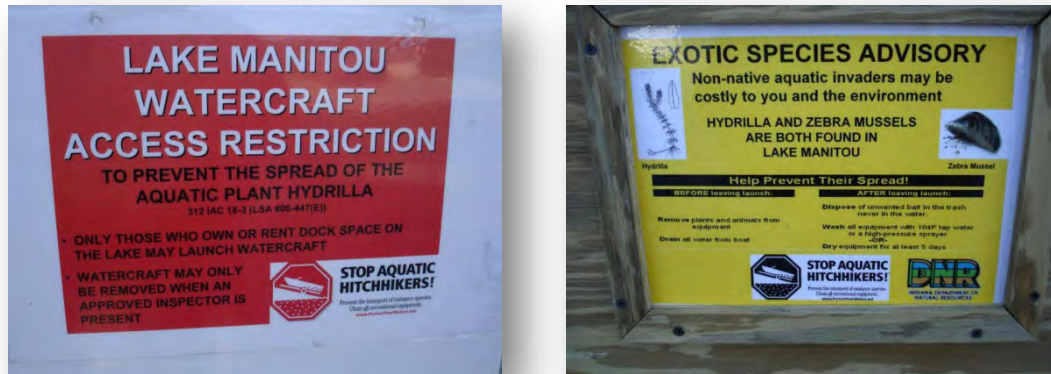
**Figure 1.01. Public notices posted at Lake Manitou public launches.**

Upon confirmation of species, access to the lake was immediately closed to the public to prevent the potential for spread through boats and boat trailers (Figure 1.0.1). Due to a lack of viable hydrilla fragments following treatment, the public ramp was re-opened in June of 2008. In 2009 and 2010 the public ramp was closed, prior to treatment, and then reopened on July 1<sup>st</sup> of each year. The ramps were left open during the 2011 season.

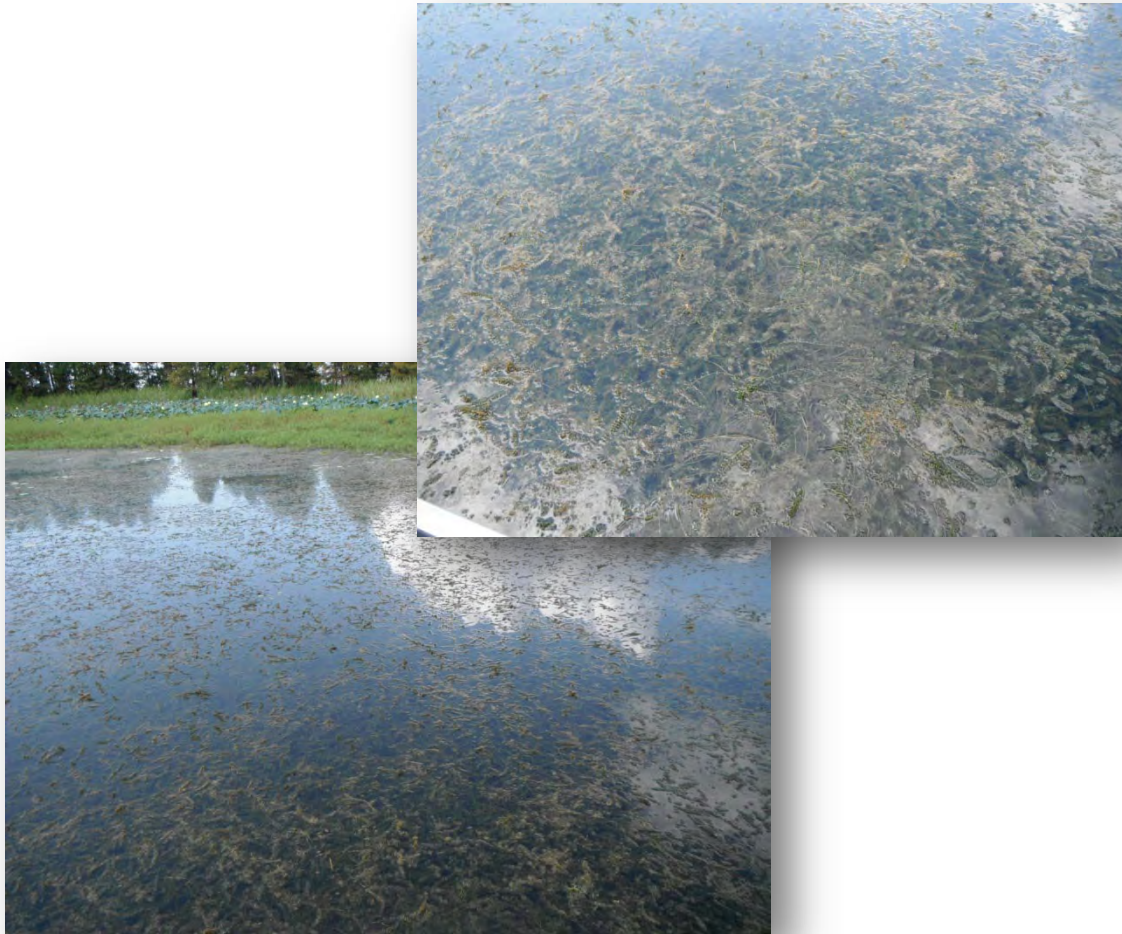
**Figure 1.02. Photograph examples of dense, surface-matted hydrilla.**

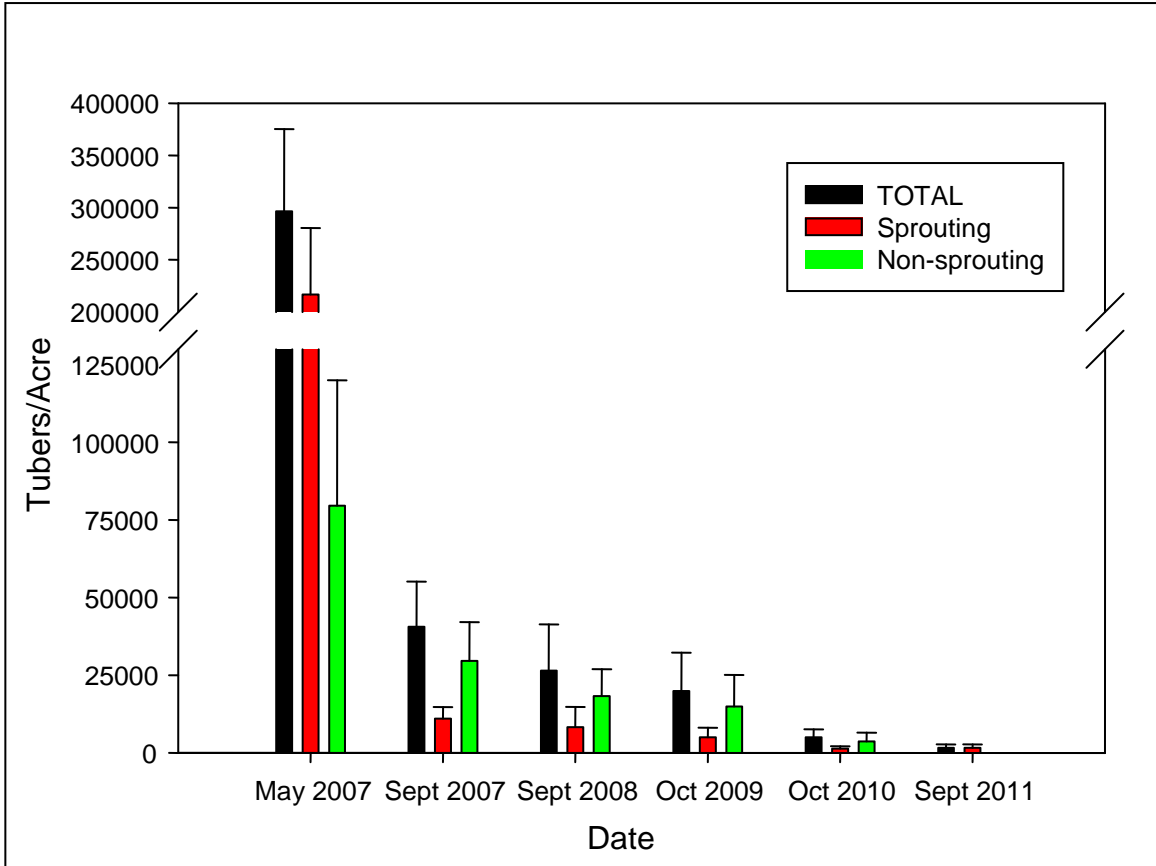
**Chart 2.2.1. Overall changes in monoecious hydrilla tuber abundance in Lake Manitou following five consecutive years of Sonar treatments (spouting + non-sprouting = total).**

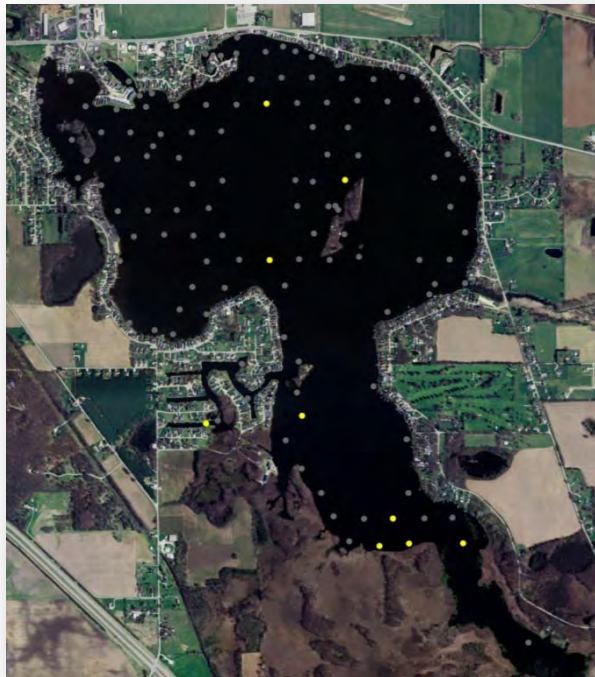
**Figure 2.3.3. Lake Manitou, sago pondweed distribution, June 16, 2011.**

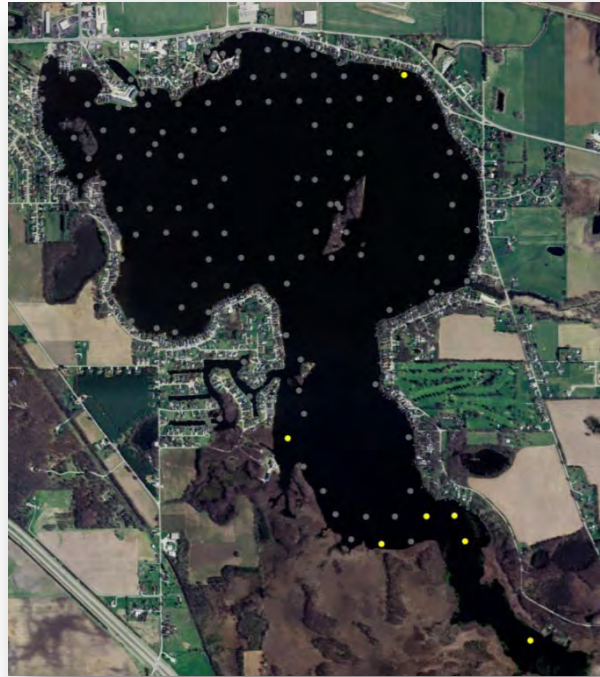
**Figure 2.3.4. Lake Manitou, coontail distribution, June 16, 2011.**

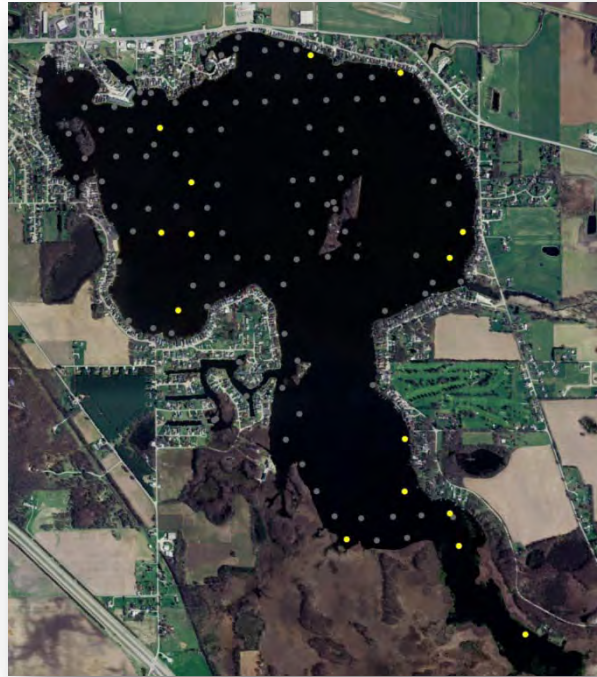
Figure 2.3.5. Lake Manitou, coontail distribution, August 31, 2011.

Coontail was present at the highest percentage of sample sites and also had the highest dominance rating (Figure and Table 2.3.5). Sago pondweed ranked second in percent occurrence (4.1%) (Figure 2.3.6). Bladderwort ranked third in frequency, (1.6%) while Chara was only collected at a single site. Filamentous algae were collected at 75.4% of sites. Spatterdock, hibiscus, white water lily, cattail, and purple loosestrife were observed but not collected in a rake sample.

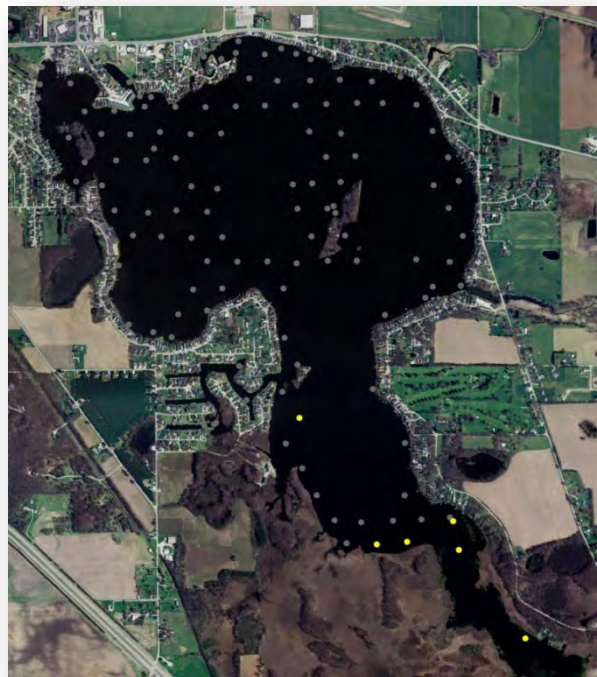
Figure 2.3.6. Lake Manitou, sago pondweed distribution, August 31, 2011.

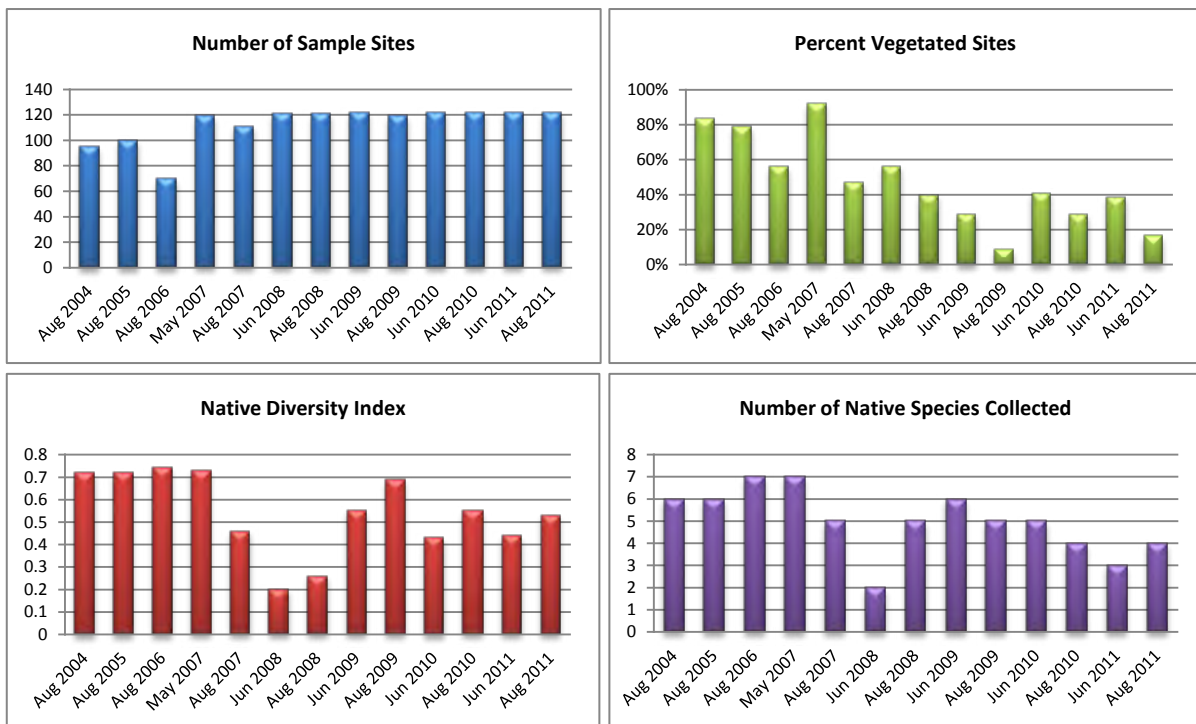
**Chart 2.3.2. Comparison of number of sample sites, % of sites with vegetation, native diversity index, and number of native species collected in the last thirteen Tier 2 surveys. (Data are from Table 2.3.9)**

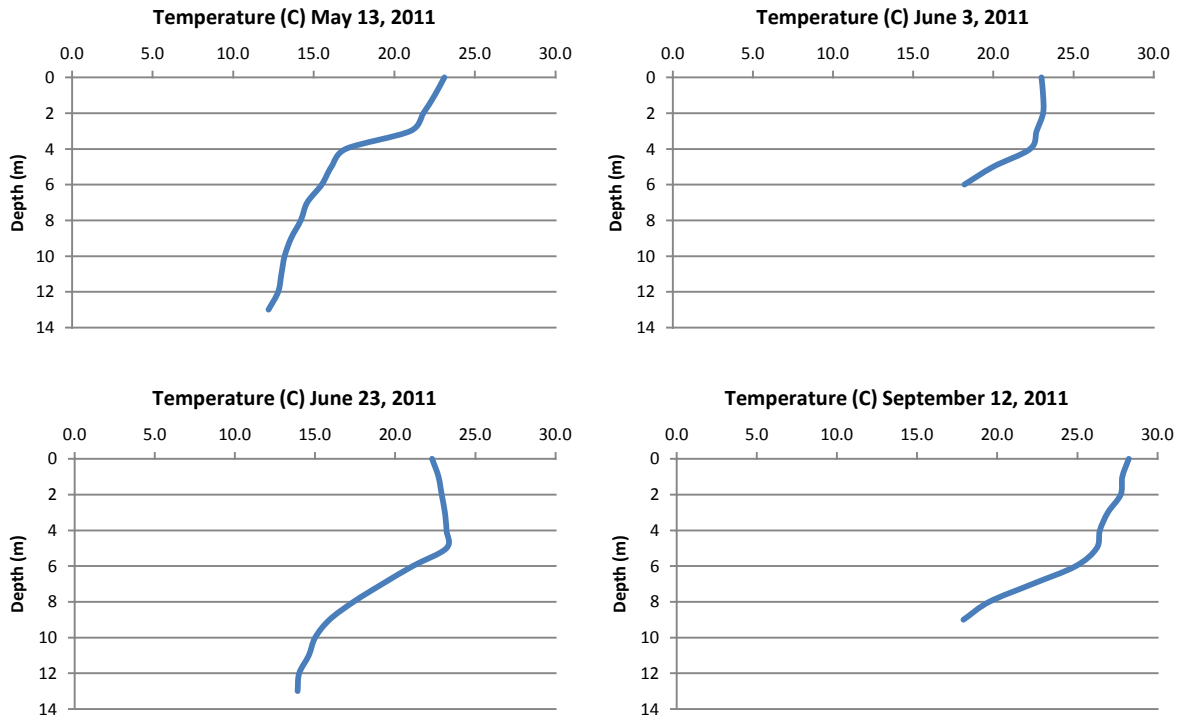
**Chart 4.1.1. Water Temperature profiles associated with Sonar application dates.**
