2014 Cleveland Metroparks Hydrilla Report

Cleveland Metroparks Technical Report 2014/NR-03

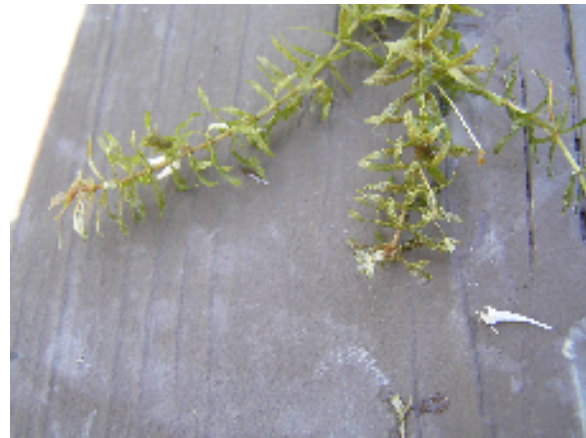
The Greathouse Wetlands consist of two hydrologically connected cells that total 1.14 acres (Figure 3). These man-made wetlands were built in 2002 and planted with nursery stock. There is a water control structure between the upper and lower cells and between the lower cell and West Creek. An extensive infestation of Hydrilla was found in the upper wetland cell in 2011, while the lower cell yielded a few clusters of the plant.

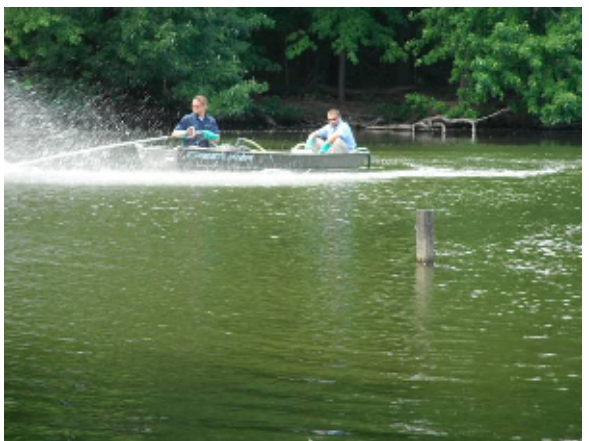
Wallace Lake is the location of a former Berea sandstone quarry that was flooded and turned into a lake in the 1930's (Figure 4). It is 17.6 acres in size and, while it formerly was 50-60 feet deep, its current maximum depth is 26 feet due to decades of sedimentation. The lake consists of two deep basins to the north and south with a shallow, narrow connection between them. The lake has water level control structures that allow it to be drawn down. The lake empties into the East Branch Rocky River and, during high flood conditions, there can be unrestricted flow between the two waterbodies. The lake is used extensively for fishing, swimming, and kayaking and is managed during

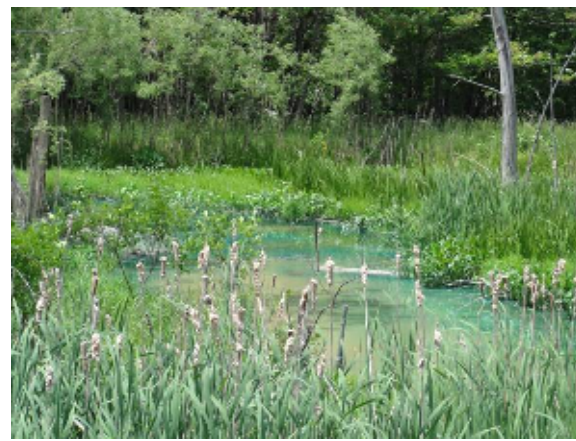
Sunset Pond is a 5.2 acre man-made pond located in North Chagrin Reservation (Figure 5). The pond is a popular location for waterfowl, both local and migratory, and has been utilized as a broodstock source for game fish by Cleveland Metroparks. A water control structure is present between it and Sanctuary Marsh, which is located downstream. Hydrilla was found in the pond in 2012, consisting of several strands along the deck behind North Chagrin Nature Center. Subsequent surveys in 2013 failed to locate any Hydrilla; however, surveys were hampered by excessive algal growth present throughout the pond.

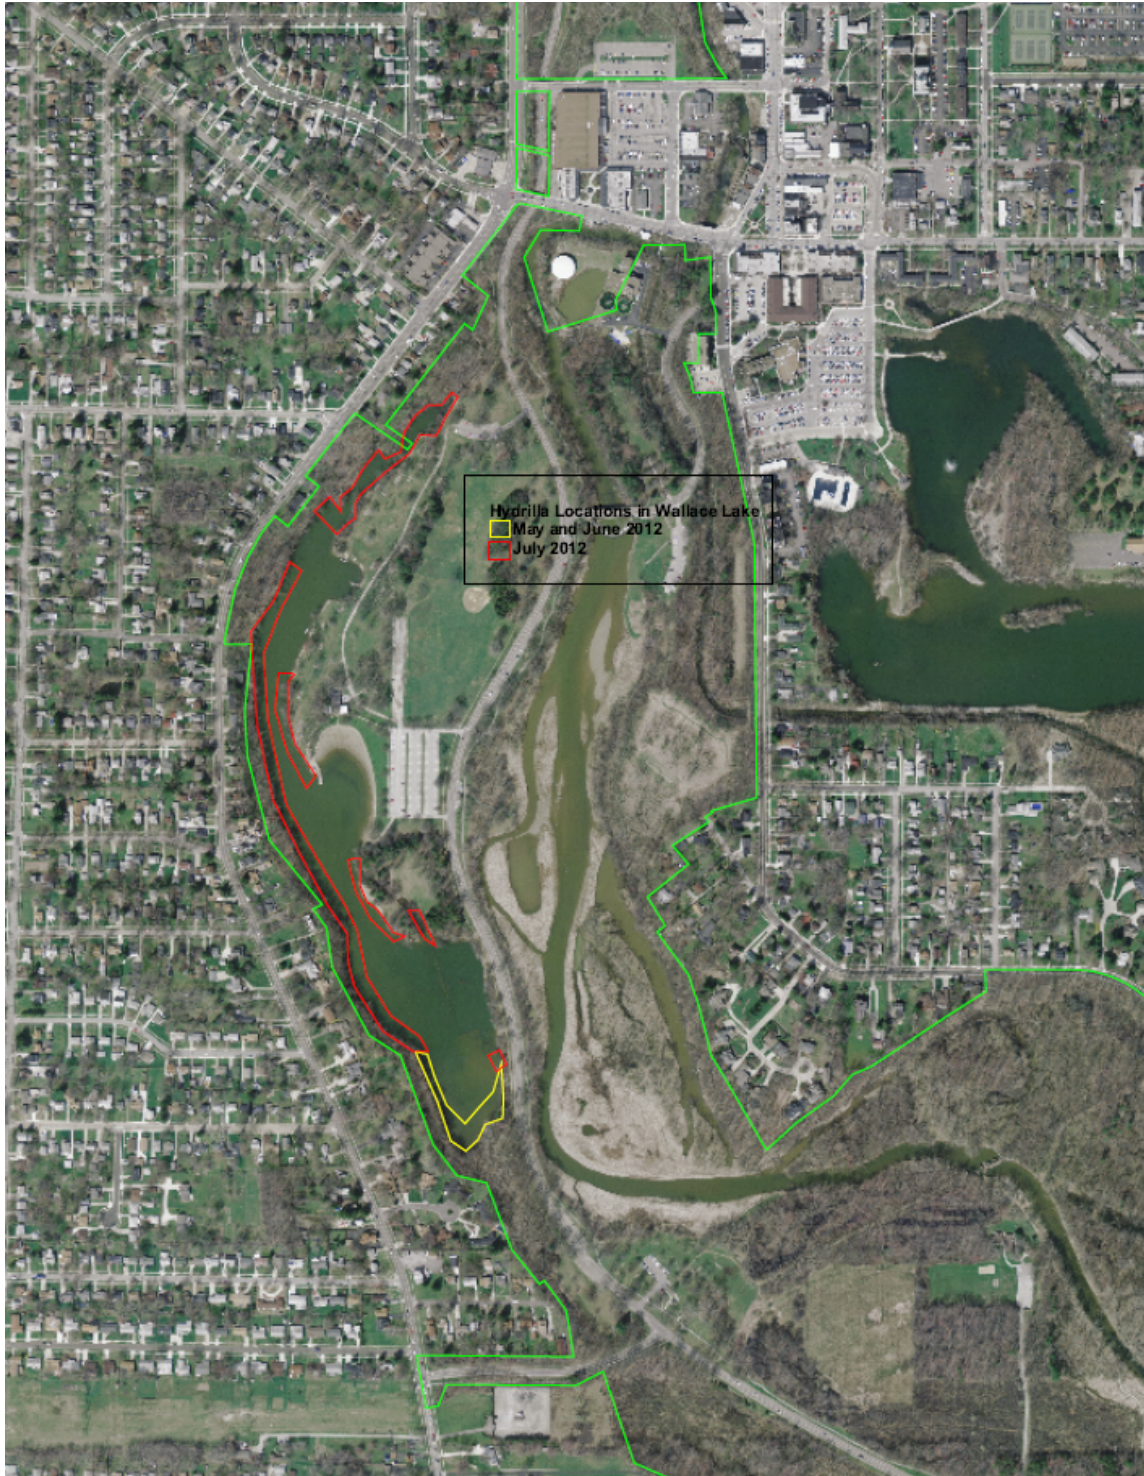
Figure 8. The spread of Hydrilla in Wallace Lake in 2012.

the growing season for nuisance aquatic vegetation. Hydrilla was found in a few spots in the southern basin in 2011, but during 2012 it rapidly spread throughout the lake (Figure 8).
