**2014 Lake Manitou Aquatic Vegetation  
Management Plan Update  
Fulton County, IN  
February 17, 2015**

Prepared by:  
SePRO Corporation, Aquatic Control, Aquatic Weed Control, and ReMetrix

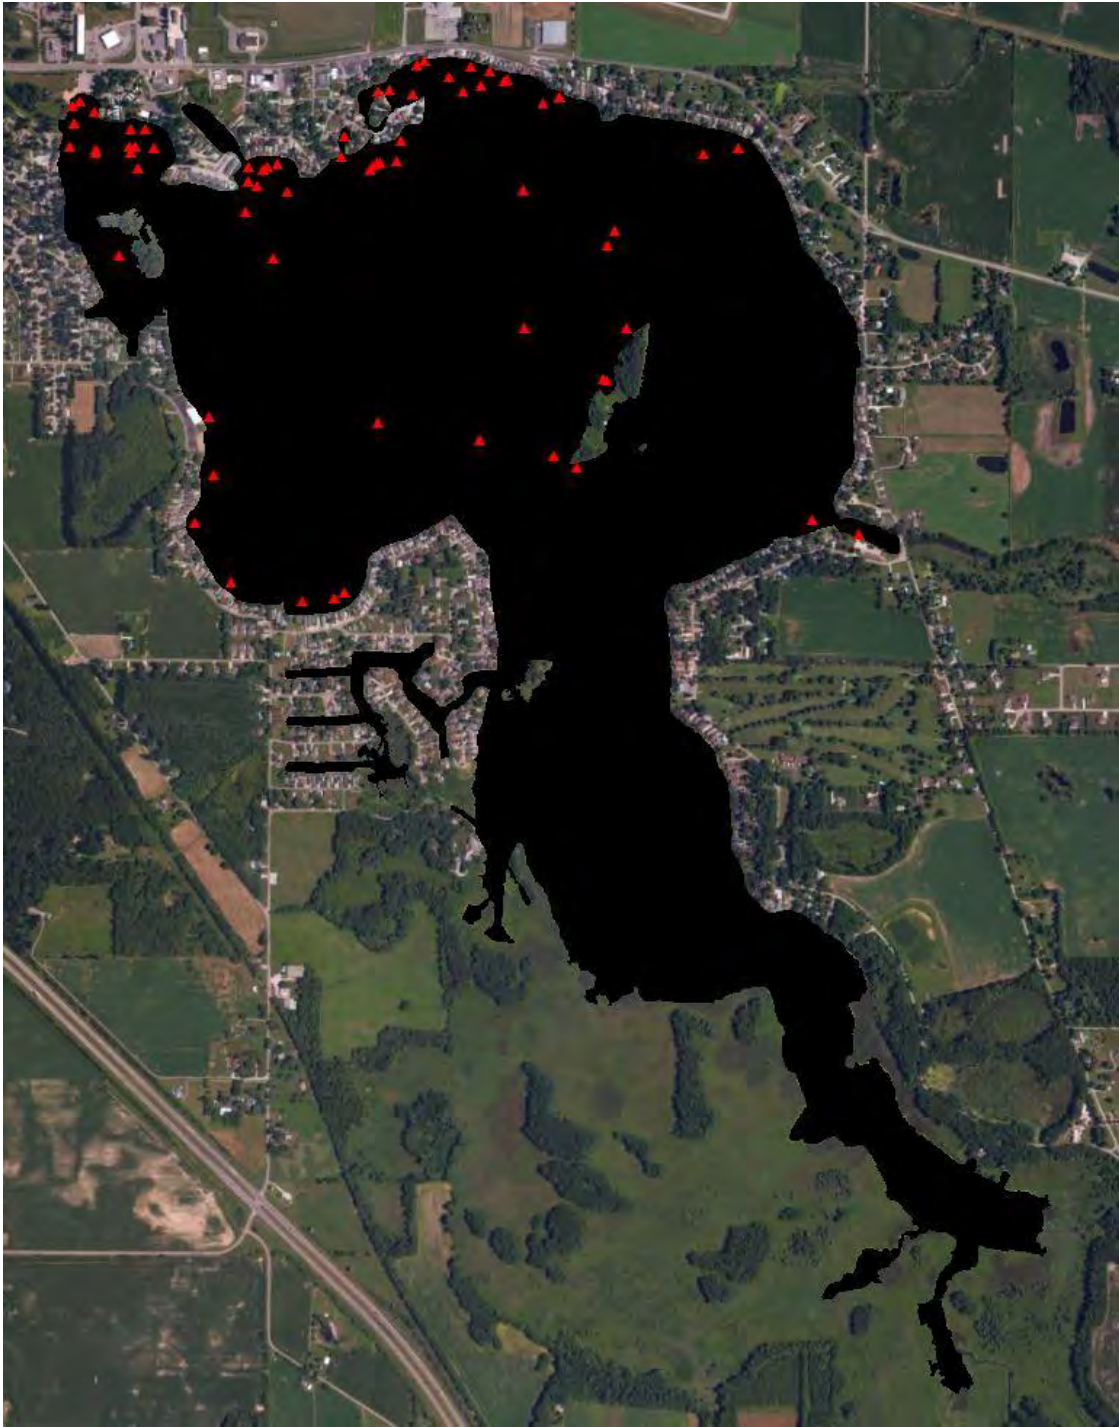
**Figure 1.0.3. Lake Manitou hydrilla sightings 2006-2014. (Includes all sightings recorded by the project team and IDNR.)**

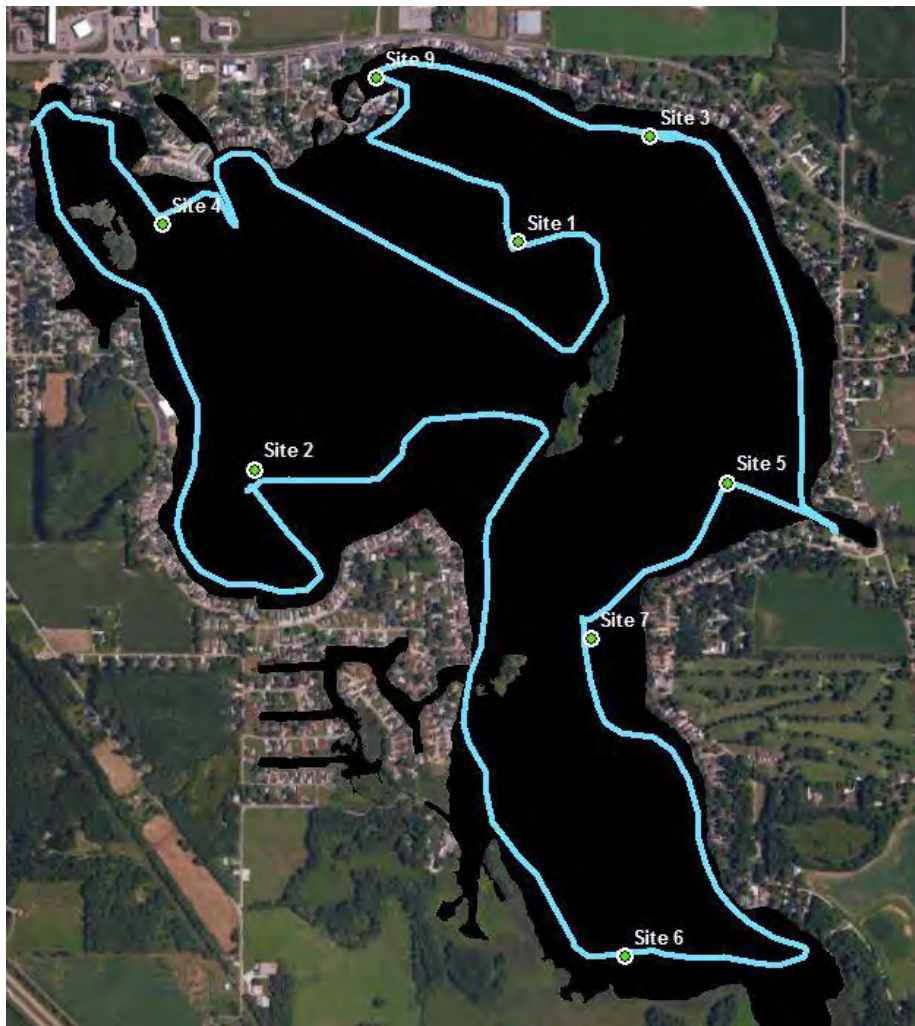
**Figure 2.1.1. FasTEST monitoring/vegetation reconnaissance survey route. Route shown is representative track from May 27, 2014 survey. Tracks of all recon surveys are available upon request.**

Reconnaissance surveys were completed during FasTEST collections, and were the most frequent type of survey completed (Table 2.0.1). Surveyors followed a pre-established route designed to maneuver over formerly known areas of hydrilla (Figure 2.1.1) Along with collecting FasTEST samples, personnel recorded information at each of the eight sample sites on plant species presence, injury, cover, and growth ratings, Secchi depth, and surface temperature. Dissolved oxygen/temperature profiles were also taken at the predetermined FasTEST site 2. Individual monitoring data sheets are included in the Appendix.

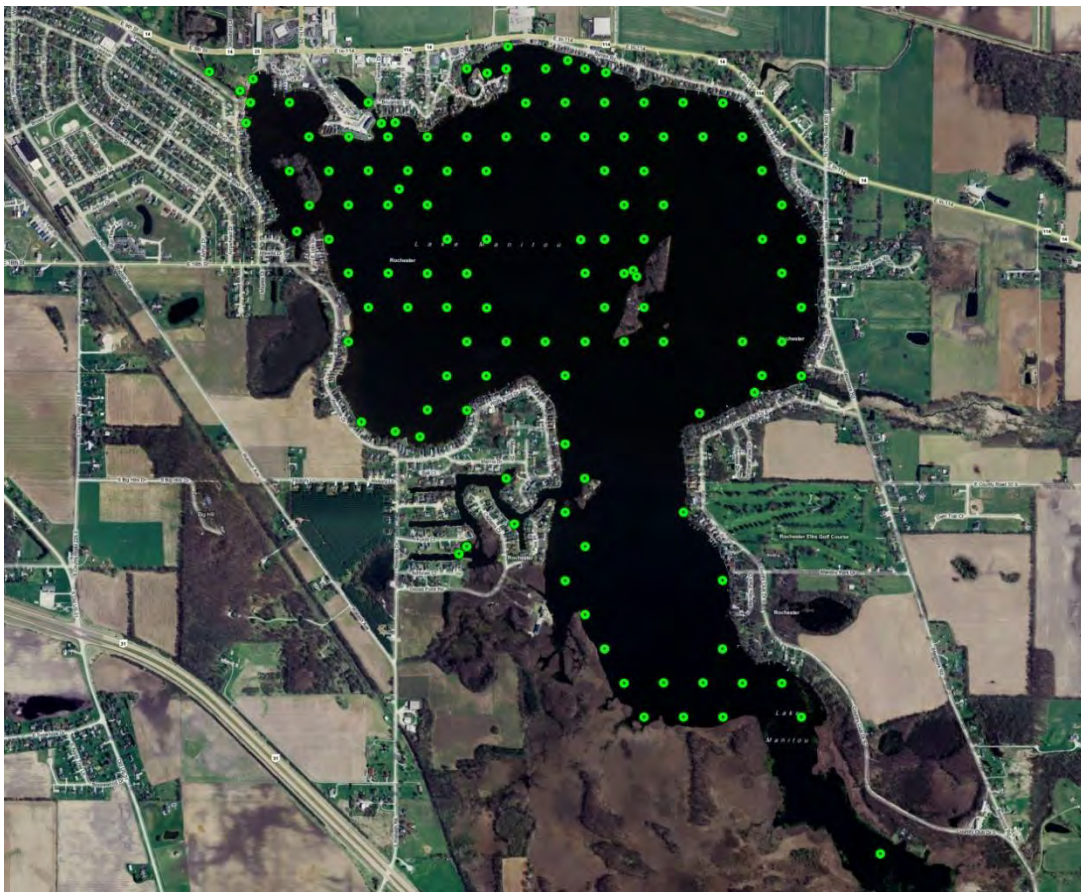
**Figure 2.3.1. Tier 2 vegetation sample sites visited in 2014.**

Tier 2 surveys were completed on June 26<sup>th</sup> and August 27<sup>th</sup>. Tier 2 surveys were included in the vegetation monitoring program to quantify species diversity and abundance, allow for pre- and post-treatment comparisons of the plant community, and potentially locate additional areas of hydrilla. The design of the Lake Manitou point-intercept survey was based on the LARE protocol (IDNR 2014). A total of 122 sites were sampled in the spring and late summer (Figure 2.3.1).

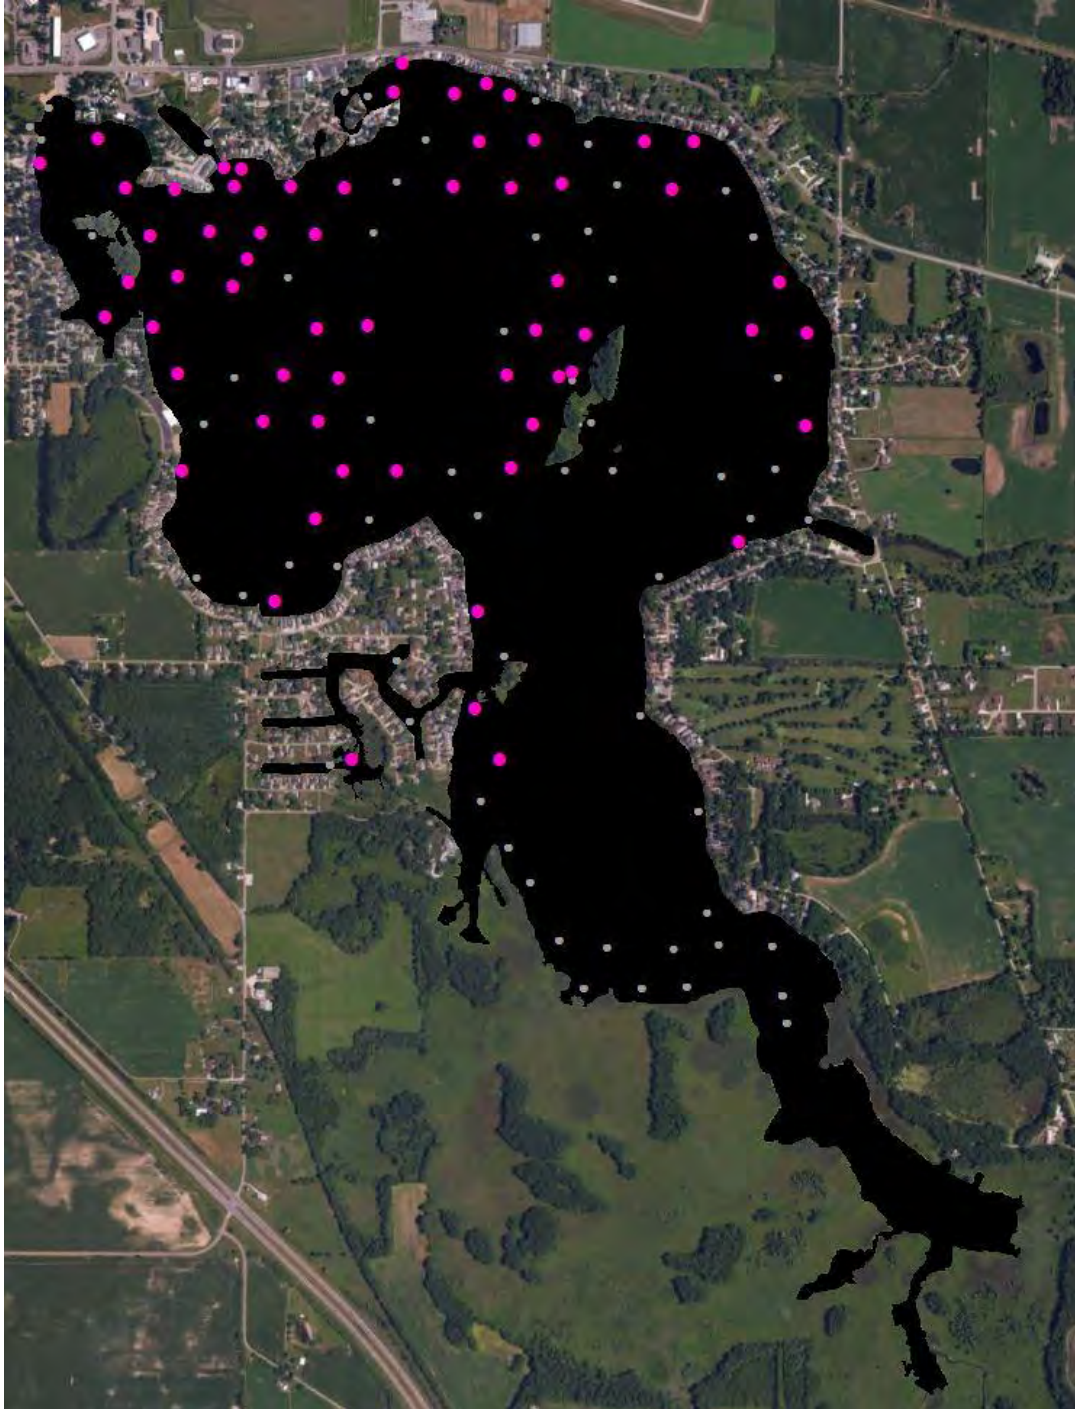
Figure 2.3.2. Lake Manitou, *Chara* distribution, June 26, 2014.

*Chara* (*Chara sp.*) and common coontail (*Ceratophyllum demersum*) were present at the highest percentage of sample sites (54.9% & 16.5% respectively) (Figure 2.3.2 & 2.3.3). Largeleaf pondweed (*Potamogeton amplifolius*) was collected at two sites, while bladderwort (*Utricularia sp.*), sago pondweed (*Potamogeton pectinatus*), leafy pondweed (*Potamogeton foliosus*), horned pondweed (*Zannichellia palustris*), and water stargrass (*Heteranthera dubia*) were only collected at single sites. Filamentous algae was present at 69.7% of sites.

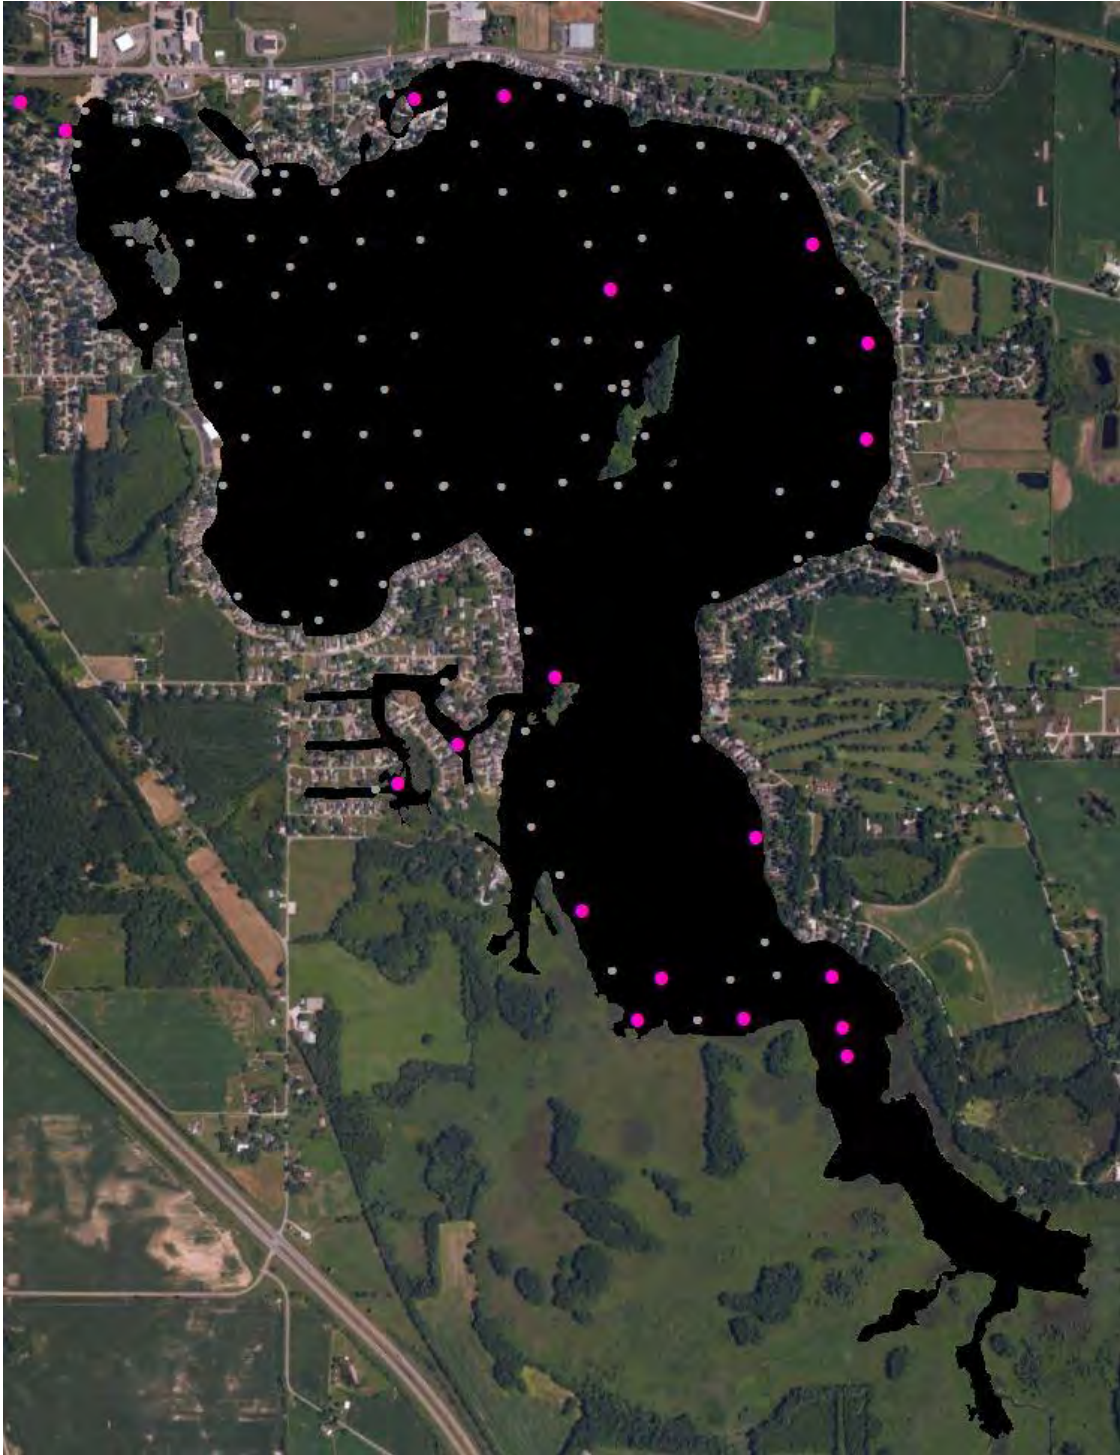
Figure 2.3.3. Lake Manitou, common coontail distribution, June 26, 2014.

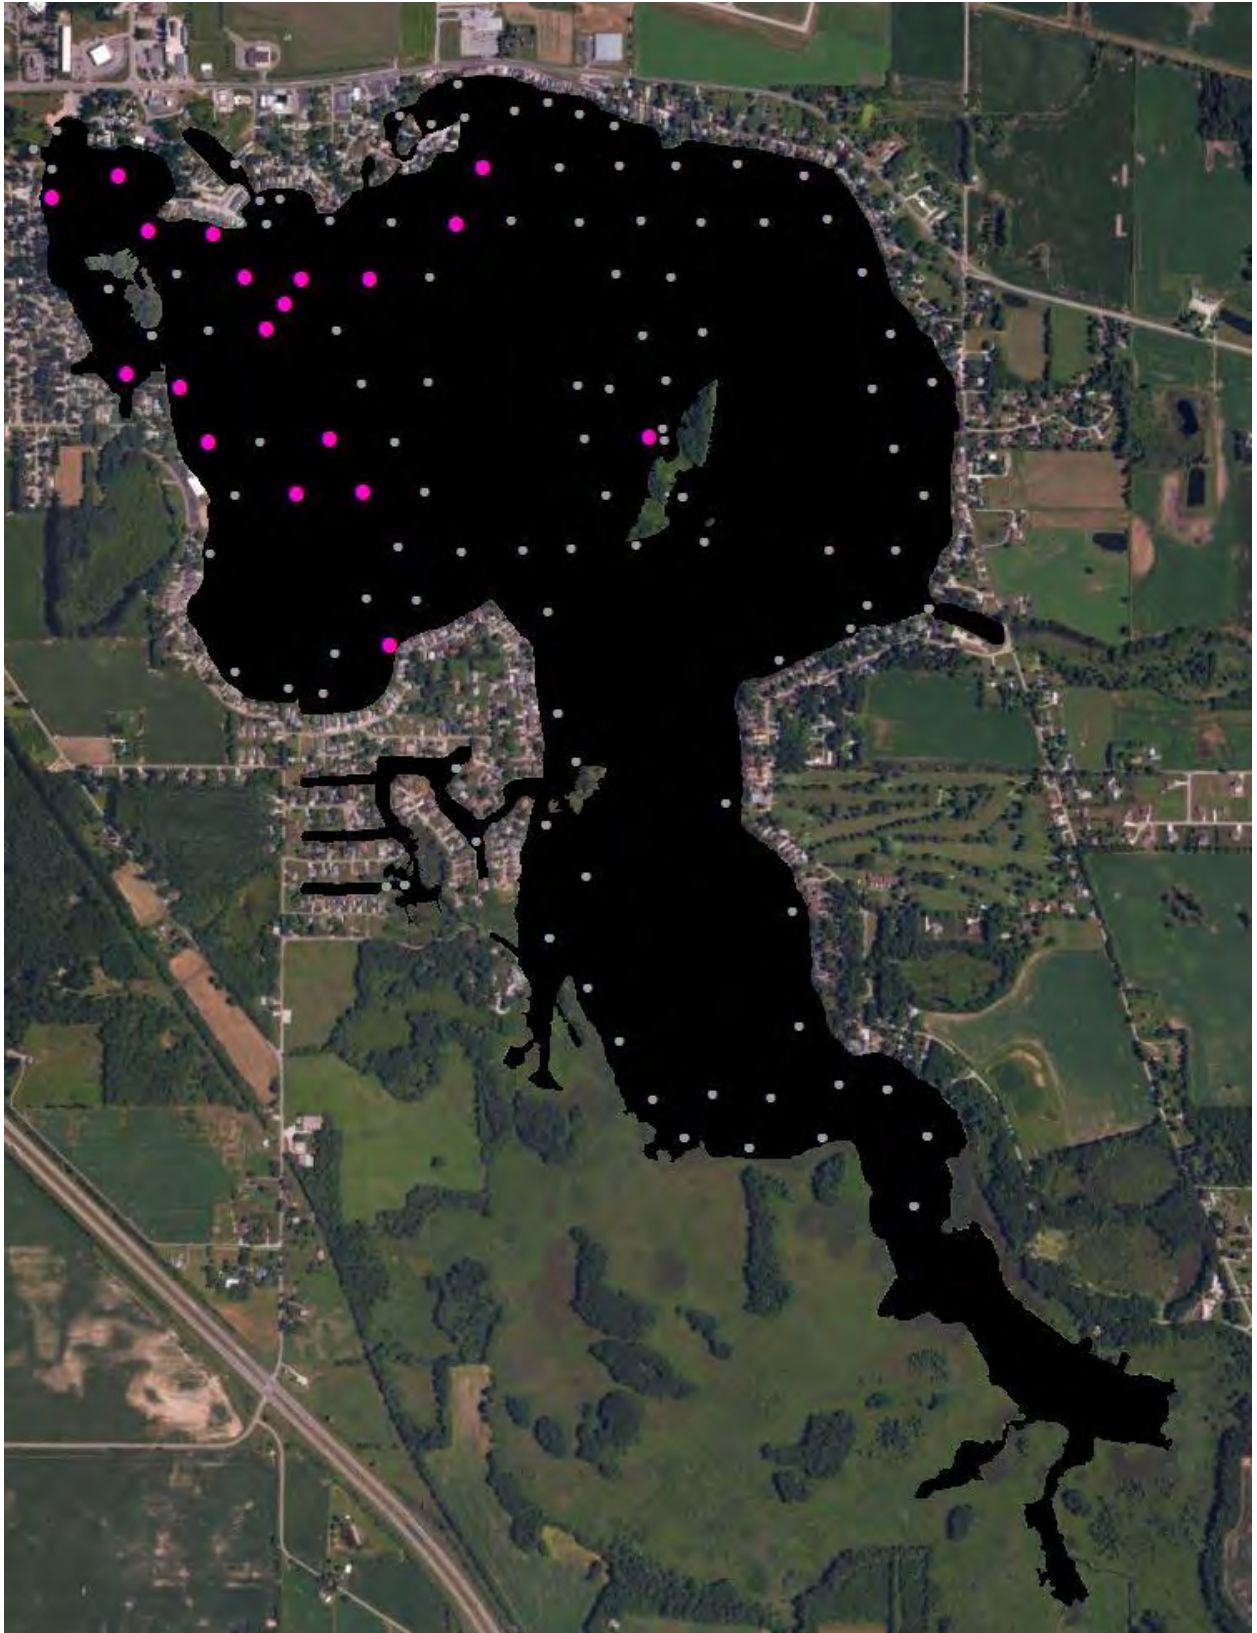
Figure 2.3.4. Lake Manitou, Chara distribution, August 27, 2014.

Chara was still present at the highest percentage of sample sites (Figure 2.3.4). Coontail ranked second in percent occurrence (4.1%) (Figure 2.3.5). Bladderwort, largeleaf pondweed, water stargrass, flatstem pondweed (*Potamogeton zosteriformis*), and sago pondweed were also collected. Filamentous algae was present at 47.5% of sites.

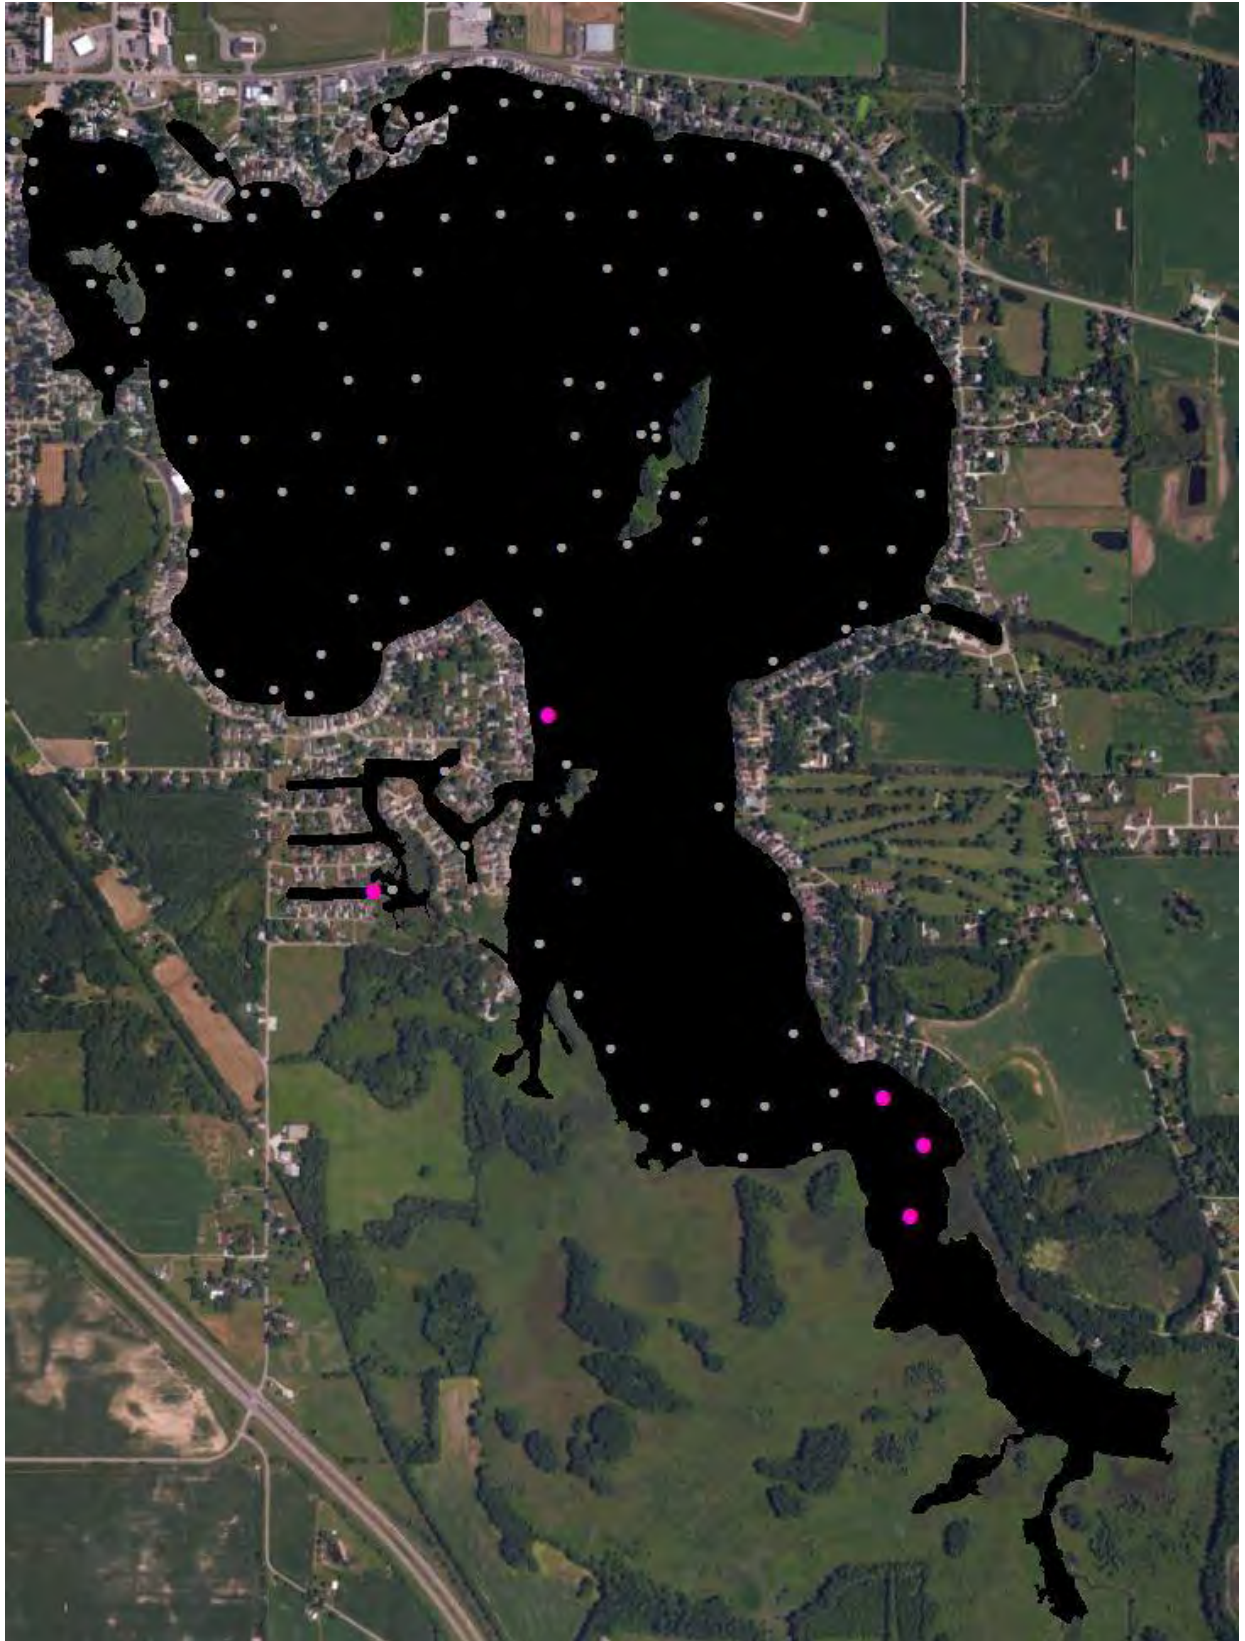
Figure 2.3.5. Lake Manitou, common coontail distribution, August 27, 2014.

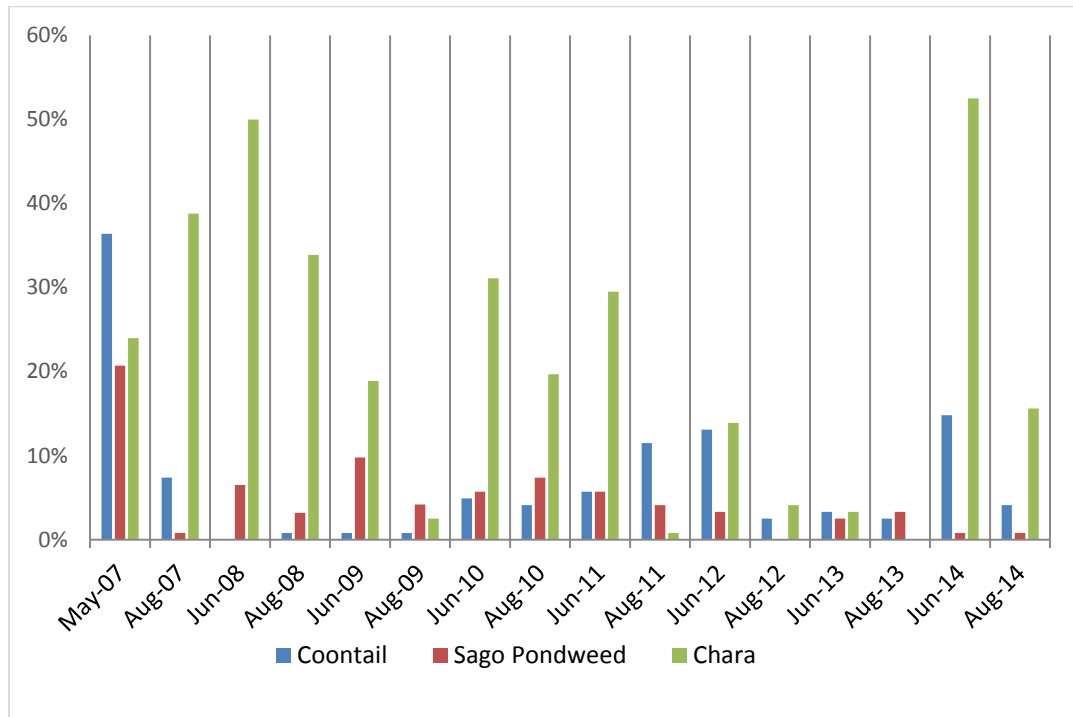
**Chart 2.3.1. Percent occurrence of common coontail, sago pondweed, and Chara in Lake Manitou since 2007 (data from Table 2.3.4).**

The hydrilla eradication treatment with Sonar was expected to temporarily alter the makeup of the submersed native plant community. Prior to the whole lake treatments, eelgrass occurred at the highest percentage of sample sites, but was either not collected or collected at low levels since treatment began. Chara, common coontail, and sago pondweed are now the most frequently occurring species since initiation of the eradication program. After posting declines during the last two years, occurrence of these species appears to have slightly increased in 2014. In addition, water stargrass, which was only collected once in the past two seasons, was collected in both 2014 surveys and horned pondweed was collected for the first time. The changes in percent occurrence in the last nineteen Tier 2 surveys are illustrated in Table 2.3.4 and Chart 2.3.1.

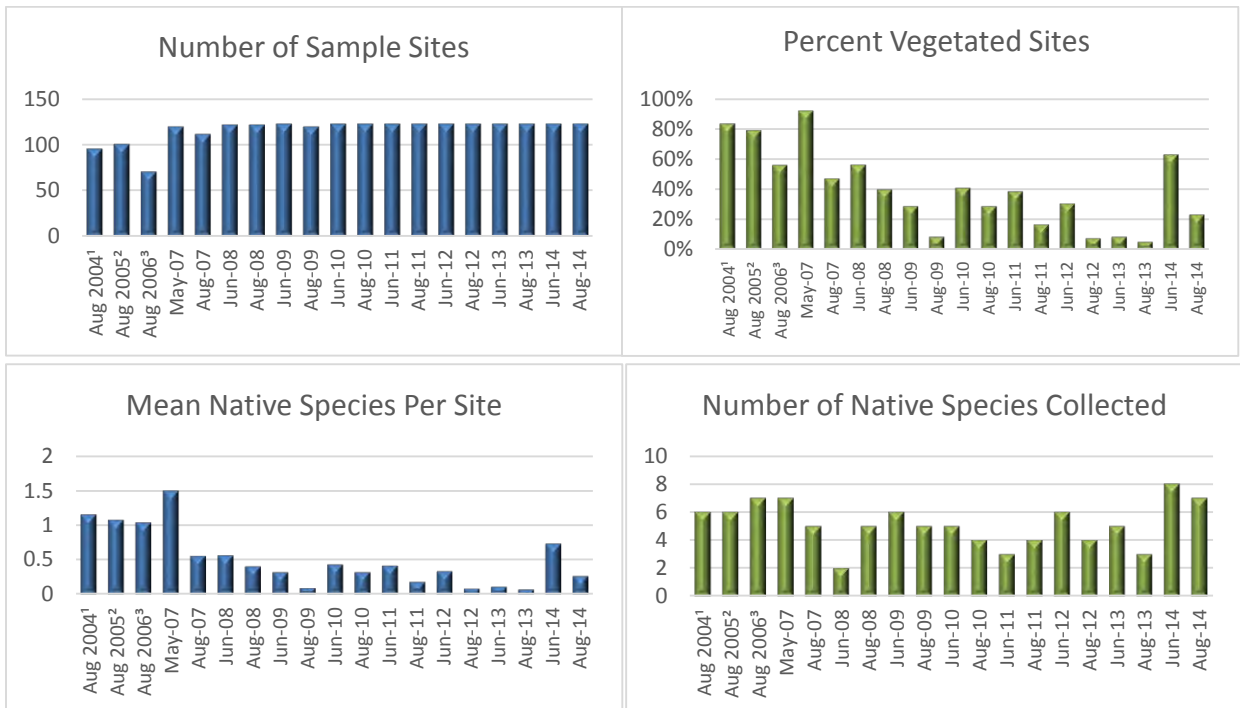
**Chart 2.3.2. Comparison of number of sample sites, percentage of sites with vegetation, mean native species per site, and number of native species collected since 2004. (Data are from Table 2.3.5)**

Tier 2 surveys also provide insight into changes of submersed aquatic plant diversity and abundance. Table 2.3.5 and Chart 2.3.2 compare the percentage of sample sites with vegetation, native species per site, and the number of native species collected in the last decade. Figure 2.3.6 shows the change in total species abundance between the spring and summer surveys. The 2014 spring survey posted the highest diversity and number of sites with vegetation since 2007. A trend of increased water clarity, the decrease in the size of the active treatment area, the greater use of Sonar pellets versus liquid formulation, and a later start to treatments may have contributed to the uptick in observed native plants. Submersed vegetation metrics are expected to further increase once the hydrilla eradication project is completed. There are well-established populations of coontail and pondweeds in the upper end of the lake that will likely repopulate Lake Manitou once the eradication of hydrilla is complete.

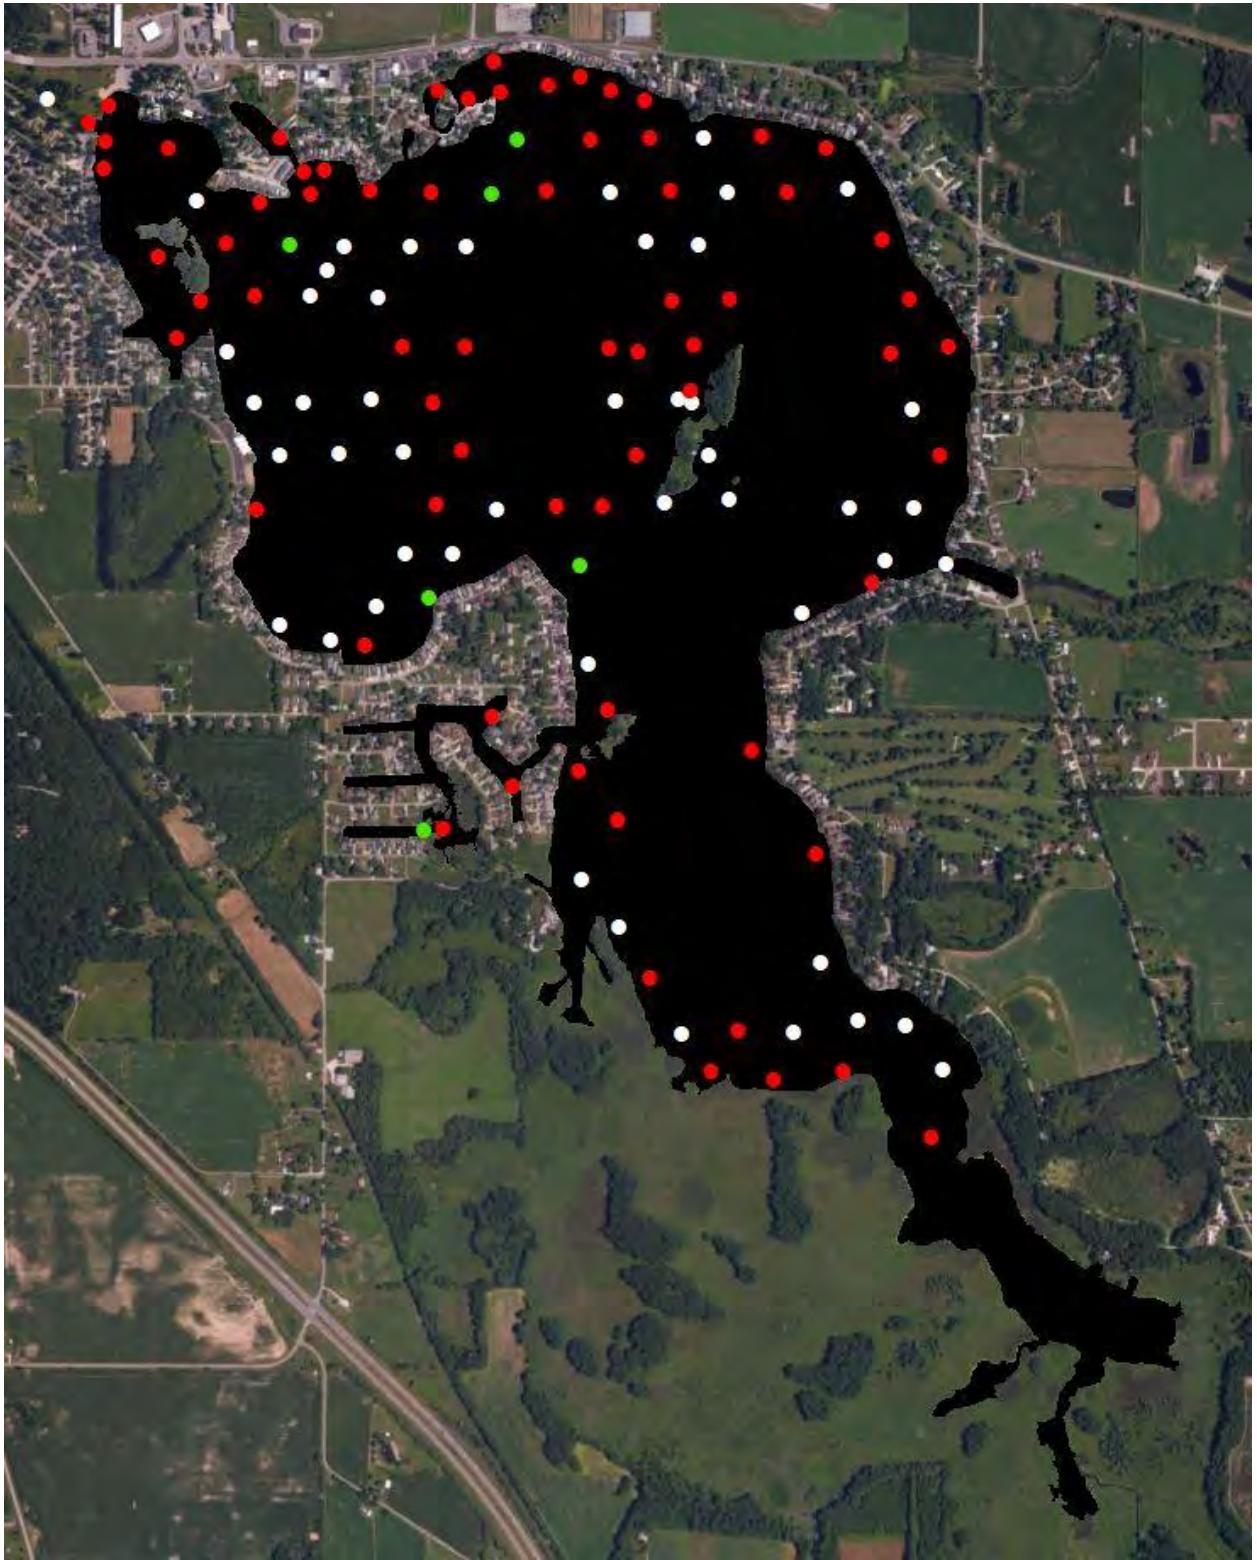
Figure 2.3.6. Lake-wide change in total species abundance, June 26, 2014 to August 27, 2014. Green markers indicate an increase in species present, white markers indicate no change, and red markers indicate a decrease in species present from June to August.

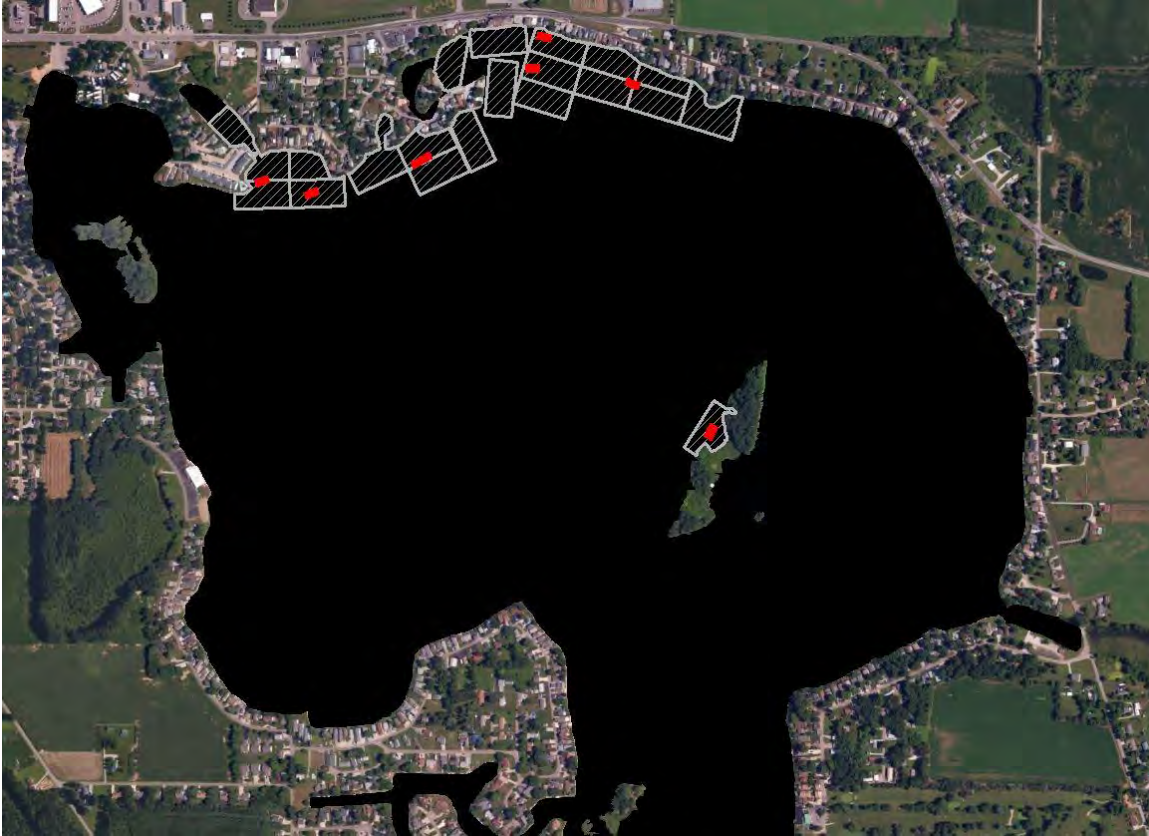
Figure 2.4.1 Dive survey design.

In 2013, the 1.5-day dive survey design was further refined with goal to have a long-term approach for diver assessment to support the remainder of the hydrilla eradication efforts on Manitou. Seven new 'high-intensity' survey areas were established in blocks surrounding discrete locations of diver hydrilla finds in 2011 and 2012. Each high-intensity zone was 6600 square feet in size (60 by 100 feet). Divers traversed these zones with objective of visual coverage of the entire bottom for maximum ability to detect vegetative hydrilla growth. 21 additional 'low intensity' blocks were surveyed that were a select number of the 35 zones surveyed in 2012 that immediately surrounded the new high-intensity blocks of past hydrilla finds. This design (shown in Figures 2.4.1, 2.4.2, and 2.4.3) balanced the objectives of 1) developing data on discrete number of vegetative hydrilla plants within the high intensity areas to track hydrilla decline through time as a metric for late-stage eradication success while also 2) surveying the broader area of past infestation to provide a wider look in case 'hot spots' of remaining hydrilla might still be detected for closer assessment in the future. This same design was used again in 2014. The 2014 dive survey was conducted on June 18 and 19. To focus efforts on hydrilla detection, other submersed plant species were not individually tracked but were qualitatively noted for the diver survey overall.

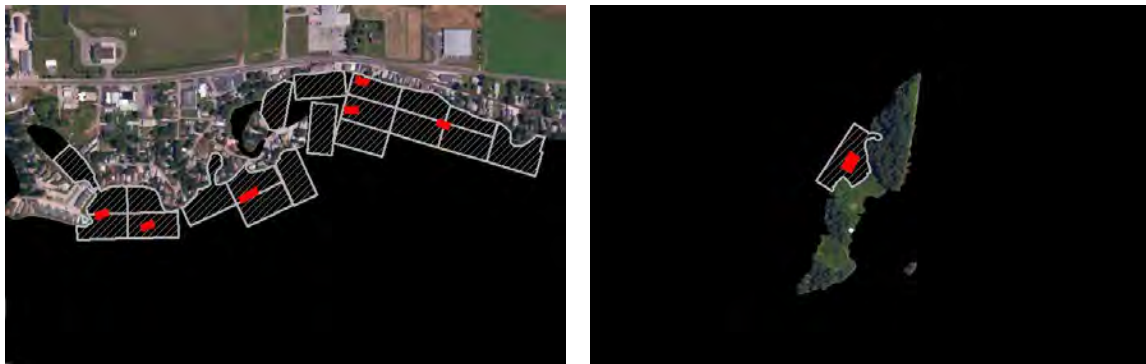
Figure 2.4.2 and 2.4.3 Dive survey design close ups.

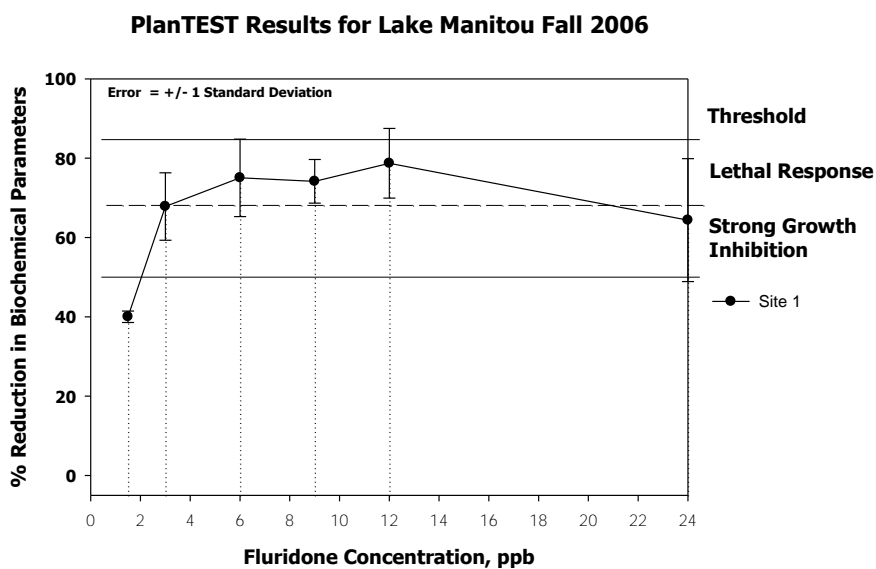
Chart 4.0.1 PlanTEST Results for Lake Manitou.

SePRO collected hydrilla samples from Lake Manitou in 2006 and conducted a PlanTEST at the SePRO Research and Technology Campus (SRTC) in Whitakers N.C. The PlanTEST is a proprietary test developed by SePRO Corporation that uses key biochemical parameters (Sprecher et al. 1998) to determine the plants inherent susceptibility to Sonar. The test was used to direct Sonar treatment recommendations by providing an indication of concentrations necessary for control. The hydrilla in Lake Manitou responded favorably to Sonar under laboratory conditions (Chart 4.0.1 and Figure 4.0.1). SePRO’s recommended treatment protocol was based on results of the PlanTEST, extensive experience in hydrilla control throughout the U.S., and proprietary modeling of Sonar dissipation from various formulations.

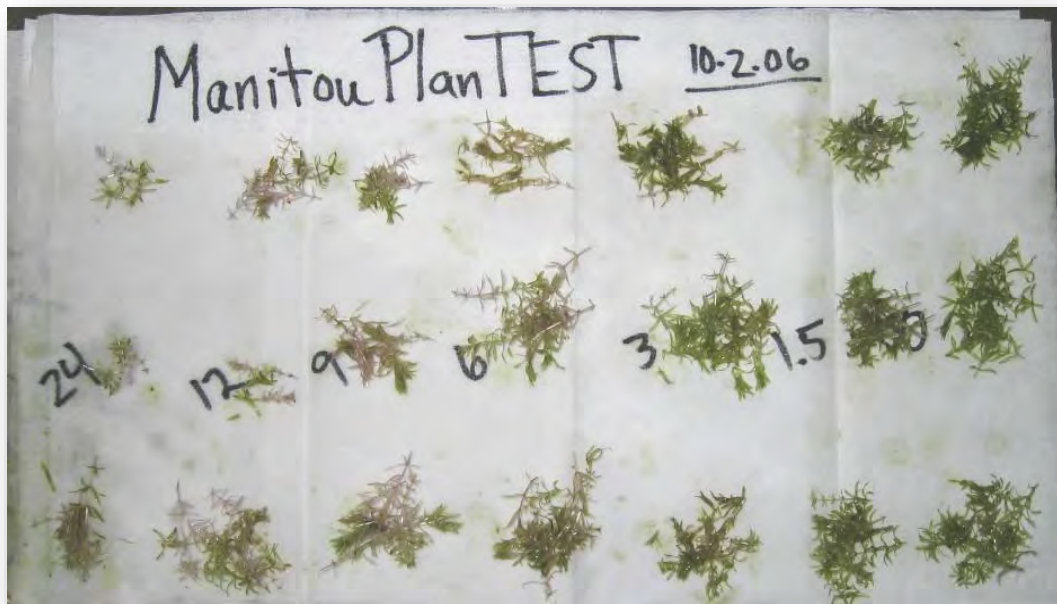
**Figure 4.0.1. Lake Manitou hydrilla susceptibility to Sonar (PlanTEST).**

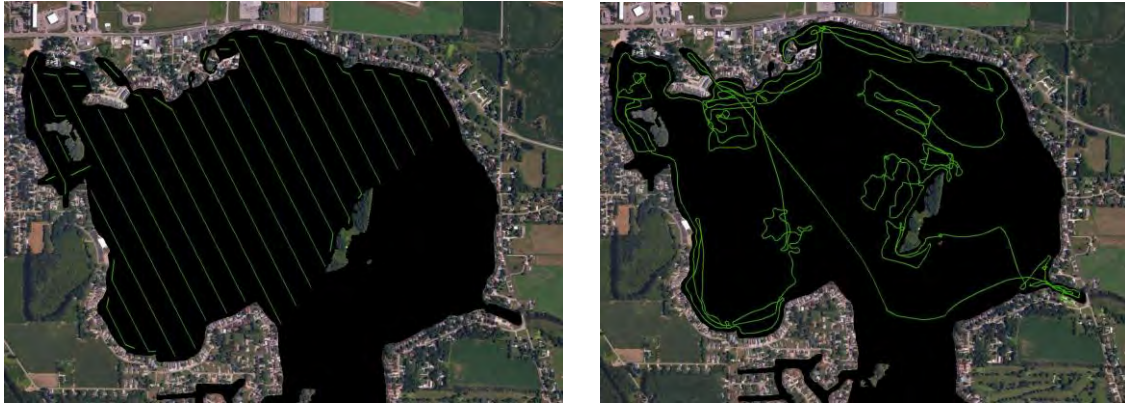
Figure 4.1.1. Initial application tracks for Sonar AS (left map) and Sonar PR (right map), May 21, 2014.

Sonar AS was applied with a custom built Carolina Skiff, 19-foot fiberglass boat equipped with a 90hp engine. The boat was equipped with a custom built herbicide application unit designed for accurate application of low dose Sonar AS. Travel routes and rates were pre-determined using information generated by the one-foot bathymetric contour survey and water volume table provided by ReMetrix. The actual Sonar AS and Sonar PR application travel routes are illustrated in Figure 4.1.1. Sonar PR was applied to 18 different locations, all sites of historic hydrilla finds (Figure 4.1.2). A custom built herbicide blower on a 19-foot Carolina Skiff was used for application of the granular Sonar PR product.

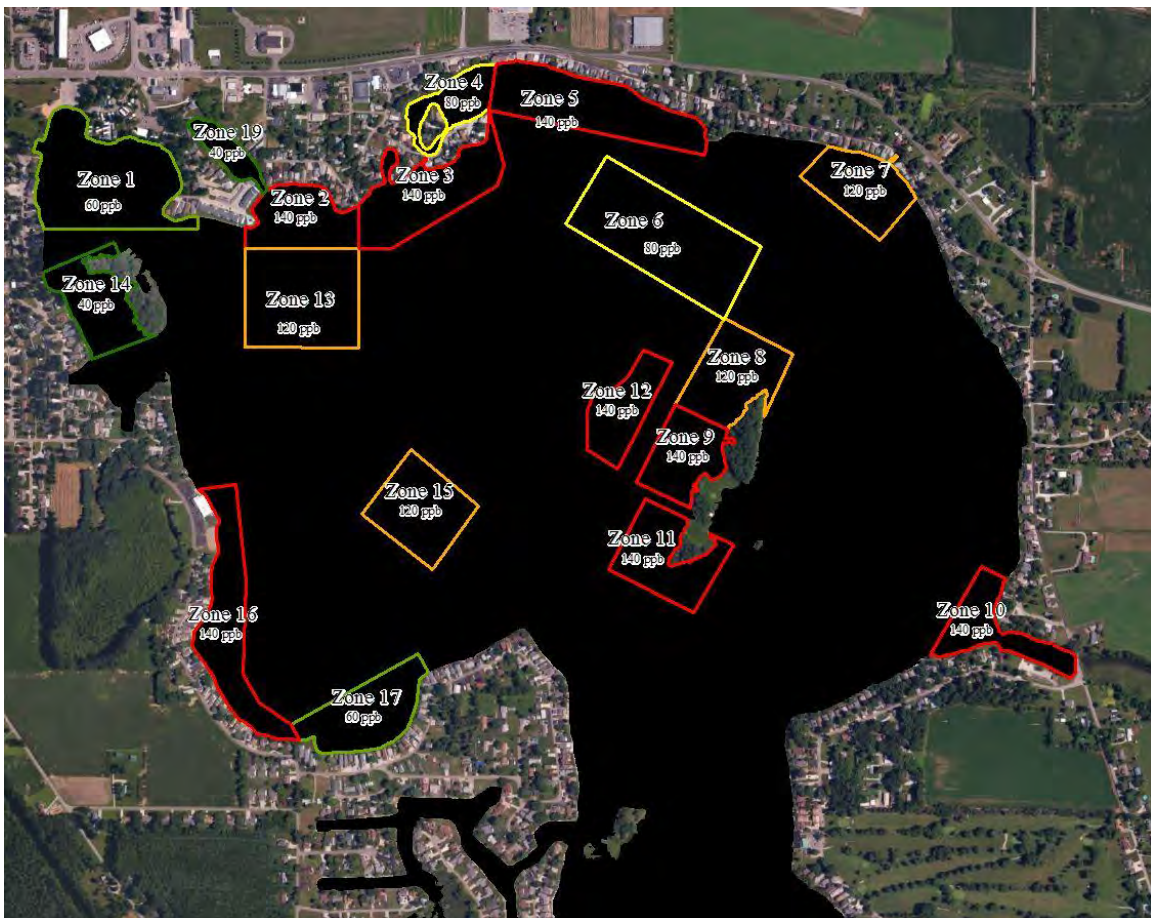
Figure 4.1.2. Sonar PR application prescription map for May 21, July 14, and August 21, 2014 applications. Use rates represent total seasonal application split across the three events.

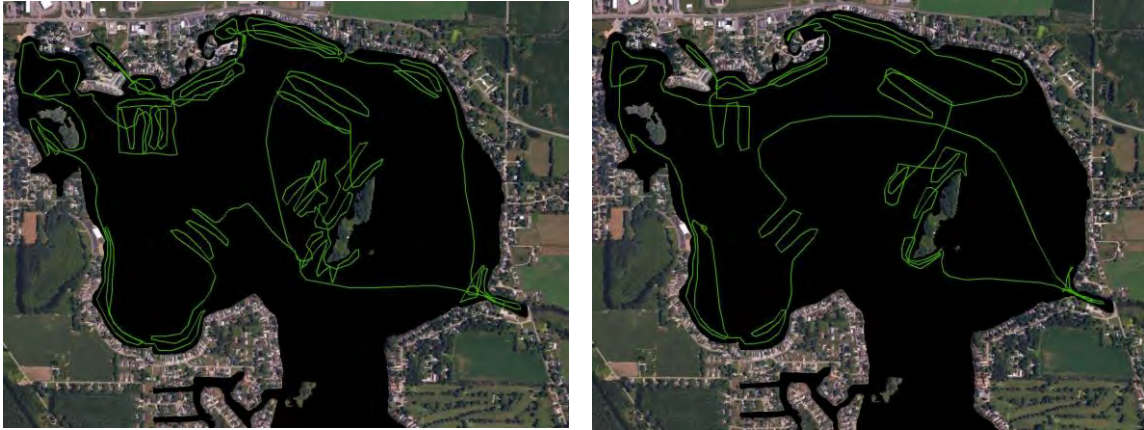
Figure 4.1.3. July 14<sup>th</sup> (*left map*) and August 21<sup>st</sup> (*right map*) Sonar PR applications.

No Sonar AS bump treatments were required in 2014. Two pre-planned Sonar PR applications were completed on July 14<sup>th</sup> and August 21<sup>st</sup>. Sonar PR was applied to the same locations as the initial Sonar PR treatment but at half the initial rate. Figure 4.1.3 displays the actual application routes from these applications.

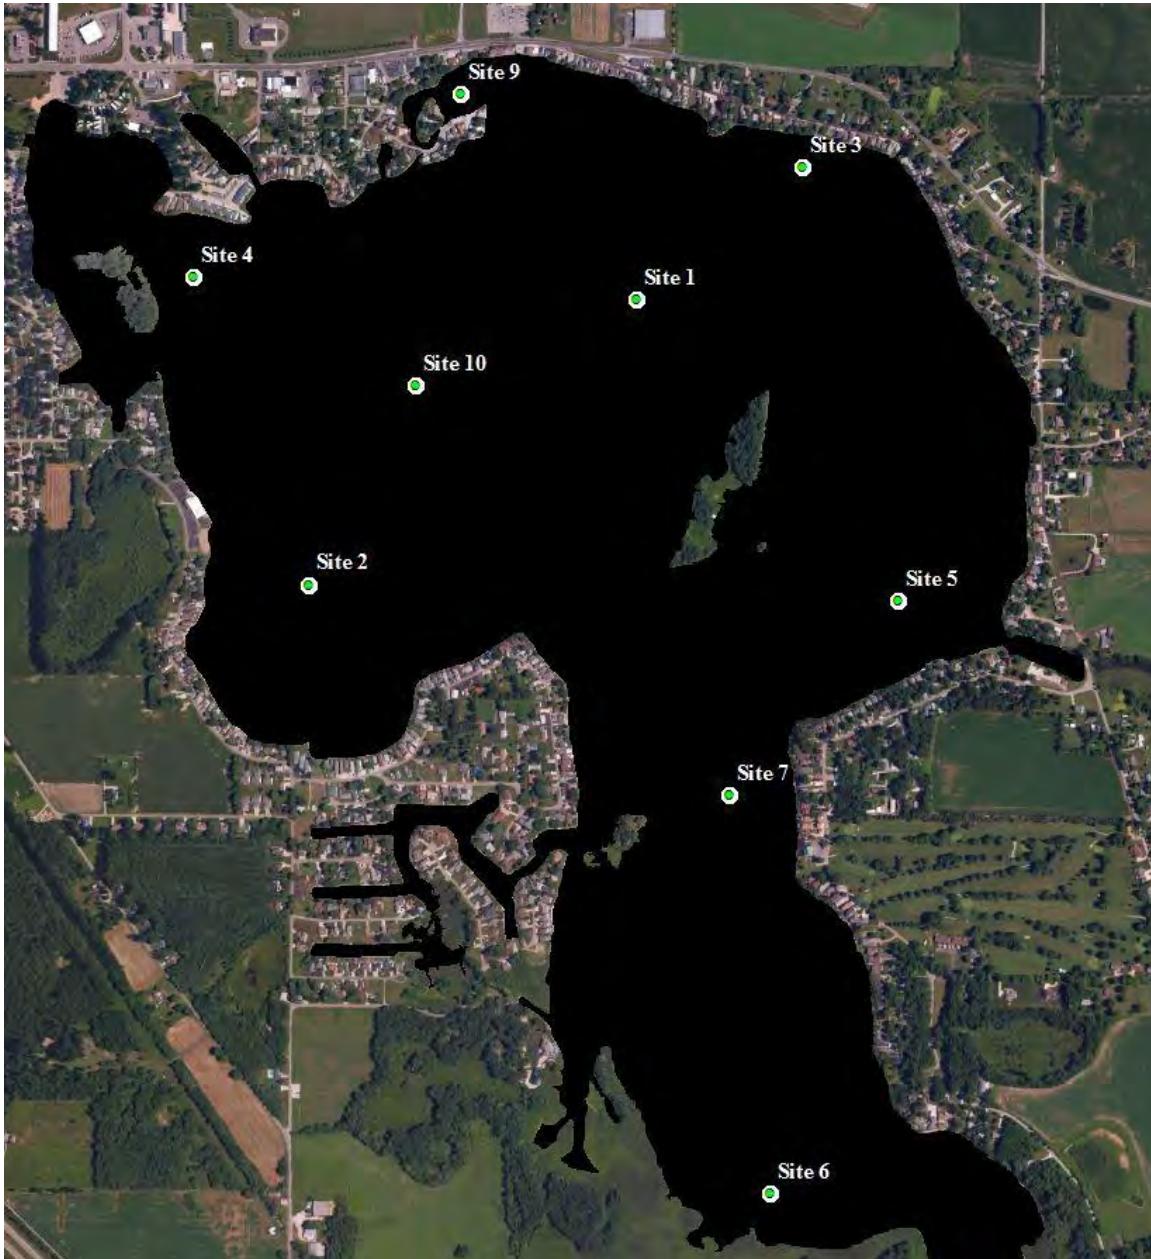
Figure 4.2.1. Permanent FastTEST sample locations during 2014.

The FasTEST was used to monitor fluridone concentration on 11 dates between May 27, 2014 and October 13, 2014, a span of 145 days following initial treatment. The FasTEST ensured the target concentrations were achieved and maintained through mid-October 2014. FasTEST samples were collected from eight permanent stations located throughout Lake Manitou (Figure 4.2.1 & Table 4.2.1). Twelve sets of surface samples were collected and results are summarized in Table 4.2.2, and Chart 4.2.1. Results indicate the concentration was maintained above 2.5 ppb for essentially the entire 2014 growing season. The objective was to maintain >2.5 ppb until October 15<sup>th</sup> based on previous projection that hydrilla would unlikely be able to sprout from a tuber and form a new tuber after that period.
