**2014 Lake Manitou Aquatic Vegetation  
Management Plan Update  
Fulton County, IN  
February 17, 2015**

Prepared by:  
SePRO Corporation, Aquatic Control, Aquatic Weed Control, and ReMetrix

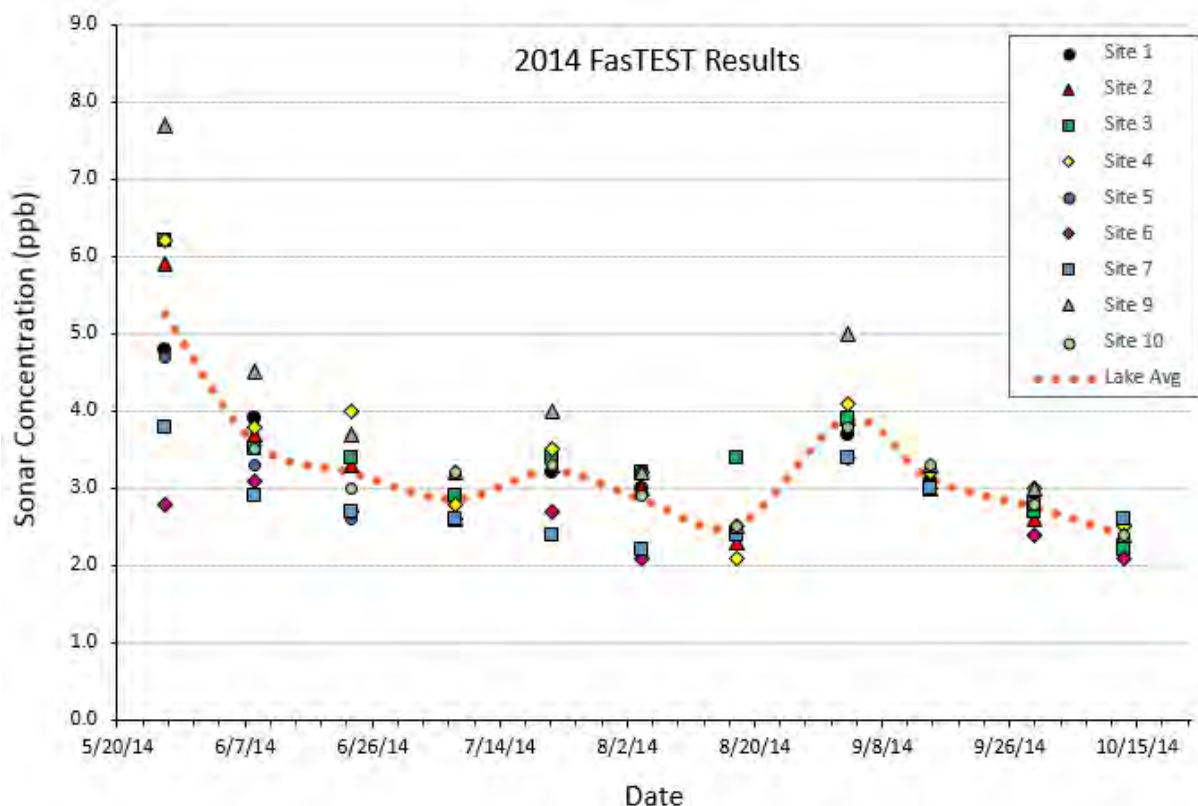
**Chart 4.2.1. Sonar concentration (ppb fluridone on vertical axis) by FasTEST site (nine locations) and lakewide average during 2014.**

The FasTEST was used to monitor fluridone concentration on 11 dates between May 27, 2014 and October 13, 2014, a span of 145 days following initial treatment. The FasTEST ensured the target concentrations were achieved and maintained through mid-October 2014. FasTEST samples were collected from eight permanent stations located throughout Lake Manitou (Figure 4.2.1 & Table 4.2.1). Twelve sets of surface samples were collected and results are summarized in Table 4.2.2, and Chart 4.2.1. Results indicate the concentration was maintained above 2.5 ppb for essentially the entire 2014 growing season. The objective was to maintain >2.5 ppb until October 15<sup>th</sup> based on previous projection that hydrilla would unlikely be able to sprout from a tuber and form a new tuber after that period.

The objective of modifications to the Sonar treatment program for Lake Manitou over the last two seasons has been to decrease herbicide pressure on the lake's native aquatic plant community in the upper (south) end of the lake. In 2013, lakewide seasonal average Sonar concentrations were 3.3 ppb versus 3.9 ppb in 2012, and samples from untreated site 6 in the south end averaged 2.8 ppb in 2013 versus 3.3 ppb in 2012. In 2014, the lakewide seasonal average concentration was effectively the same or slightly lower at 3.2 ppb and the site 6 average tracked in similar fashion at 2.7 ppb. However, spikes of concentration associated with Sonar AS bumps were minimized with the highest lakewide average of 5.3 ppb observed at the start of the program versus 7.2 ppb in 2013. The highest reading observed at site 6 in 2014 was just 3.4 ppb versus 5.8 ppb in 2013 (a 4.6 ppb reading was also measured in 2013). The Sonar program in 2014 with increased emphasis on use of Sonar PR was extremely efficient in maintaining Sonar levels in the target treatment zone in a range of 2.5 – 4 ppb from June to mid-October. No 'reactive' bumps of Sonar AS were needed following the initial planned liquid application at the start of the 2014 treatment. Only the two scheduled Sonar PR pellet re-applications were utilized. This minimized both field labor expenses associated with re-applications as well as avoided spikes of elevated concentrations that can increase impact to non-target native plants.
