**Post-Treatment Assessment
for Aquatic Plant Control
ERDC Demonstration Project
Tonawanda Creek/Erie Canal
2015**

Contract No. W912P4-10-D-0002

December 2015

UNITED STATES ARMY CORPS OF ENGINEERS
Buffalo District

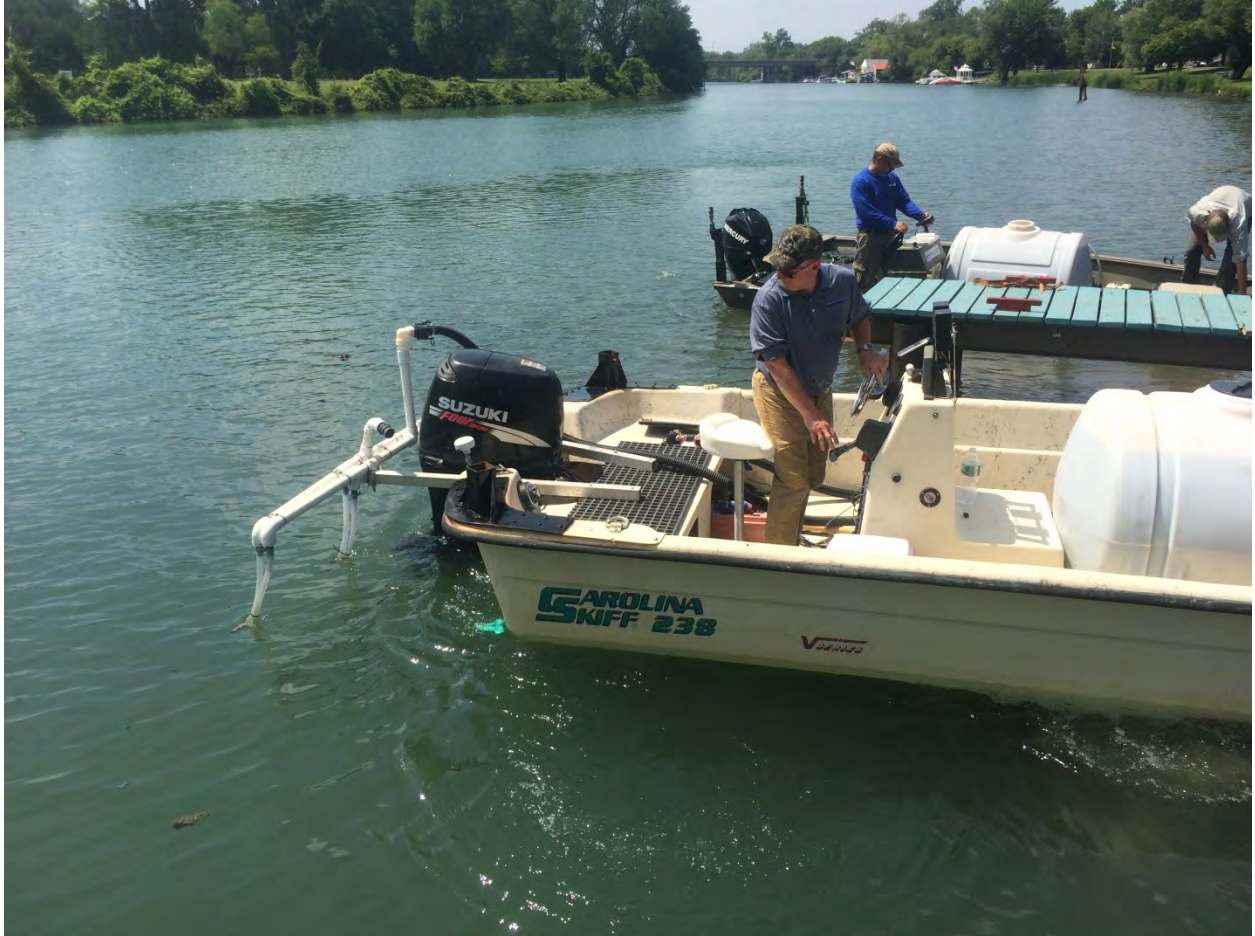
Photo A-3 Application skiff set-up.

An in-line herbicide injection system was used on the three conventional work skiffs. Each skiff was outfitted with a 225-gallon polyethylene tank. The liquid herbicide was pumped from 250-gallon totes in the chemical delivery box truck located onshore into the polyethylene tanks via 1-inch-diameter tubing by gasoline-powered transfer pumps. Personal protective equipment (PPE) was worn by ACT staff and by the driver from the company that delivered the herbicide and assisted with the herbicide transfer to the skiffs.

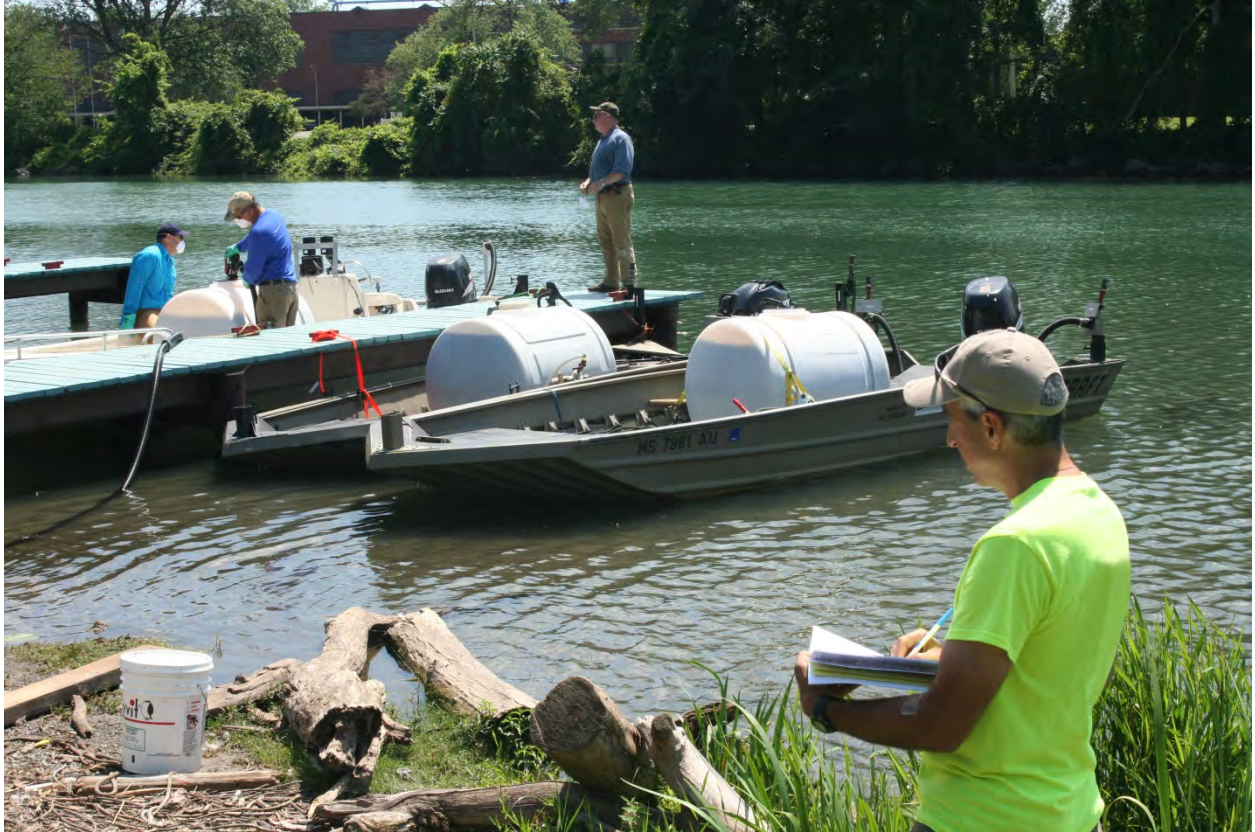
Photo A-4 Application skiffs.

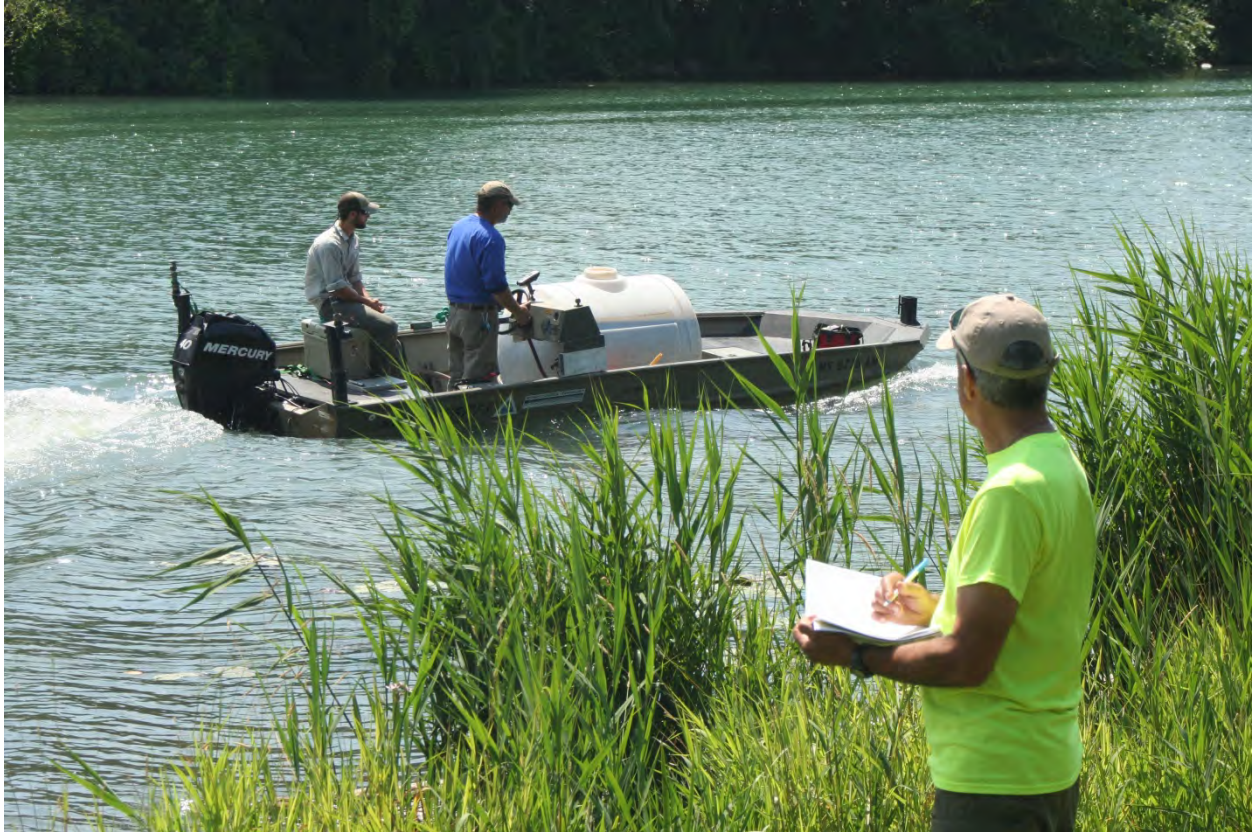
Photo A-5 Application skiff.

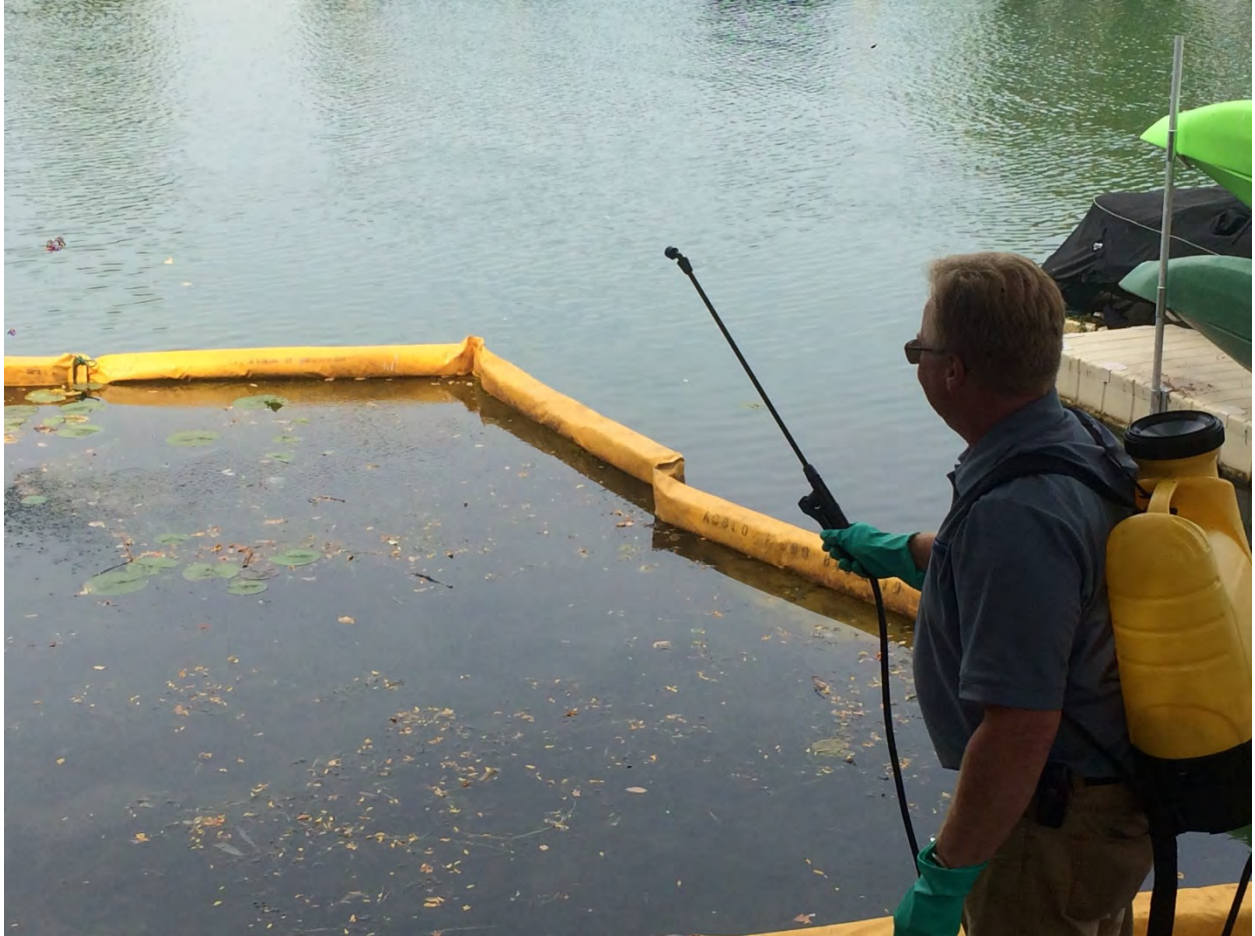
Photo A-7 Application in Spot Treatment Area

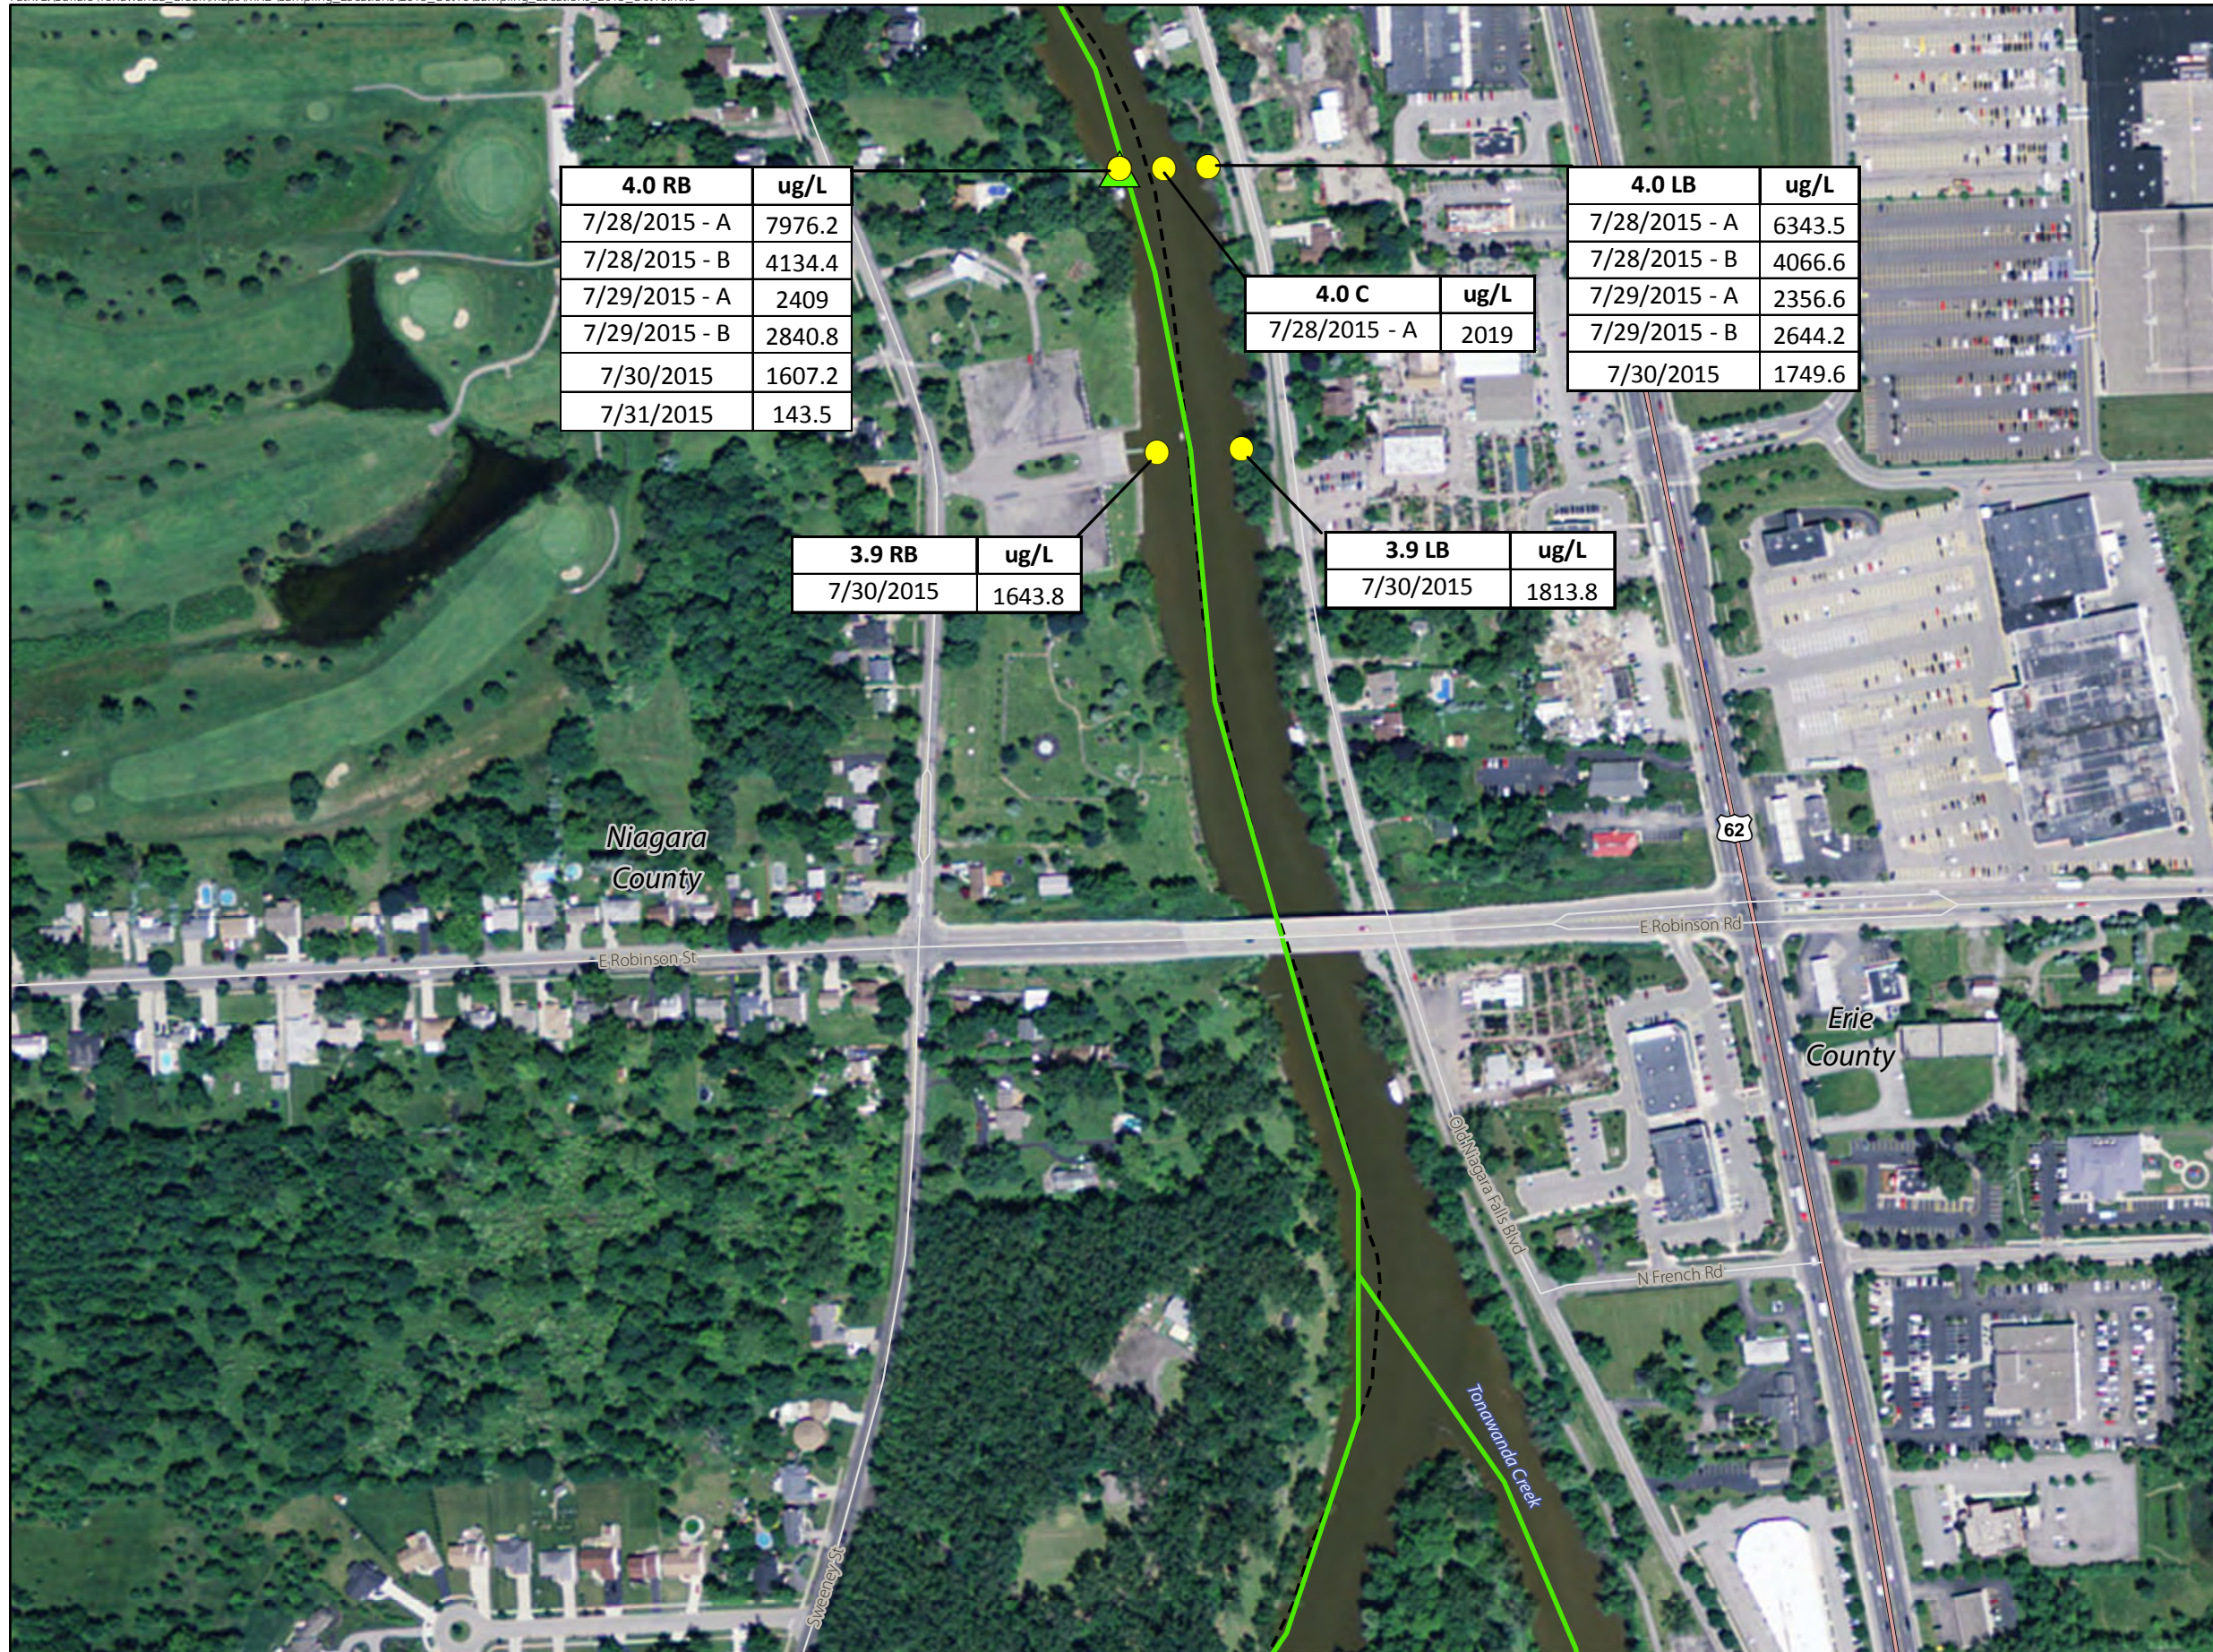
4.0 RB	ug/L
7/28/2015 - A	7976.2
7/28/2015 - B	4134.4
7/29/2015 - A	2409
7/29/2015 - B	2840.8
7/30/2015	1607.2
7/31/2015	143.5

3.9 RB	ug/L
7/30/2015	1643.8
