# 2016 Lake Manitou Aquatic Vegetation Management Plan Update Fulton County, IN December 19, 2016

Prepared for:  
Indiana Department of Natural Resources  
402 W. Washington St. Rm. W273  
Indianapolis, IN 46204

Prepared by:  
SePRO Corporation, Aquatic Control, Aquatic Weed Control, and ReMetrix

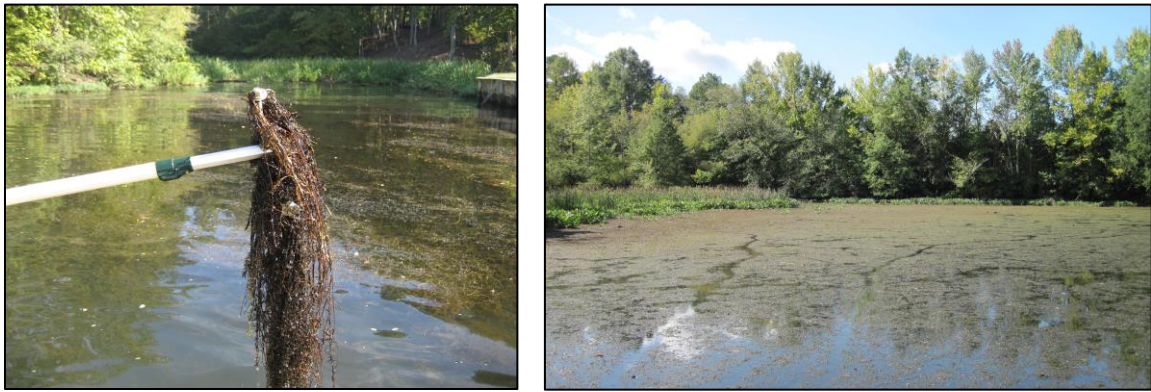
**Figure 1.0.2. Photograph examples of dense, surface-matted hydrilla.**

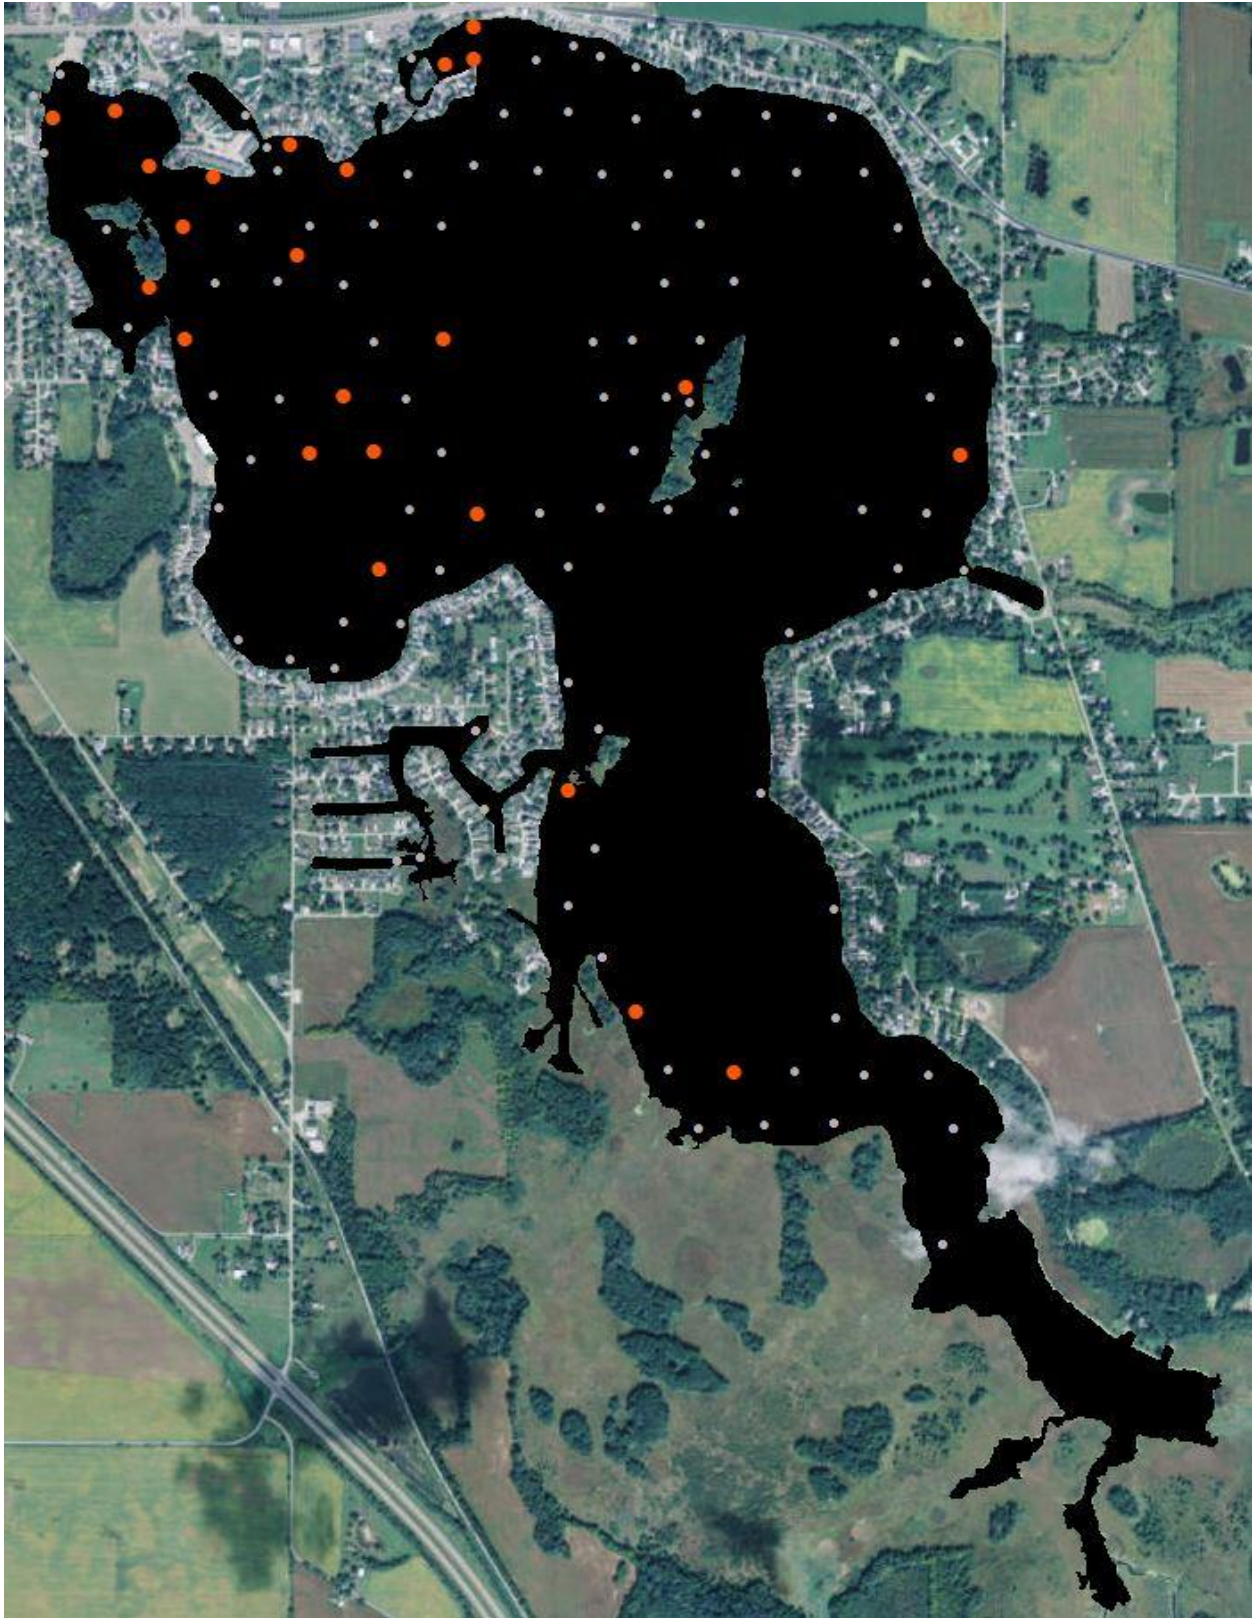
Figure 2.3.2. Lake Manitou, chara distribution, June 29, 2016.

Chara was present at the highest percentage of sample sites (19.7%) followed by common coontail (*Ceratophyllum demersum*) (15.6%) (Figure 2.3.2 & 2.3.3). Leafy pondweed (*Potamogeton foliosus*) ranked third in frequency (7.4%), followed by sago pondweed (*Potamogeton pectinatus*) (4.1%). Curly-leaf pondweed was the only invasive collected and it was found at 3 sites (Figure 2.3.4). Filamentous algae was present at 60.7% of sites.

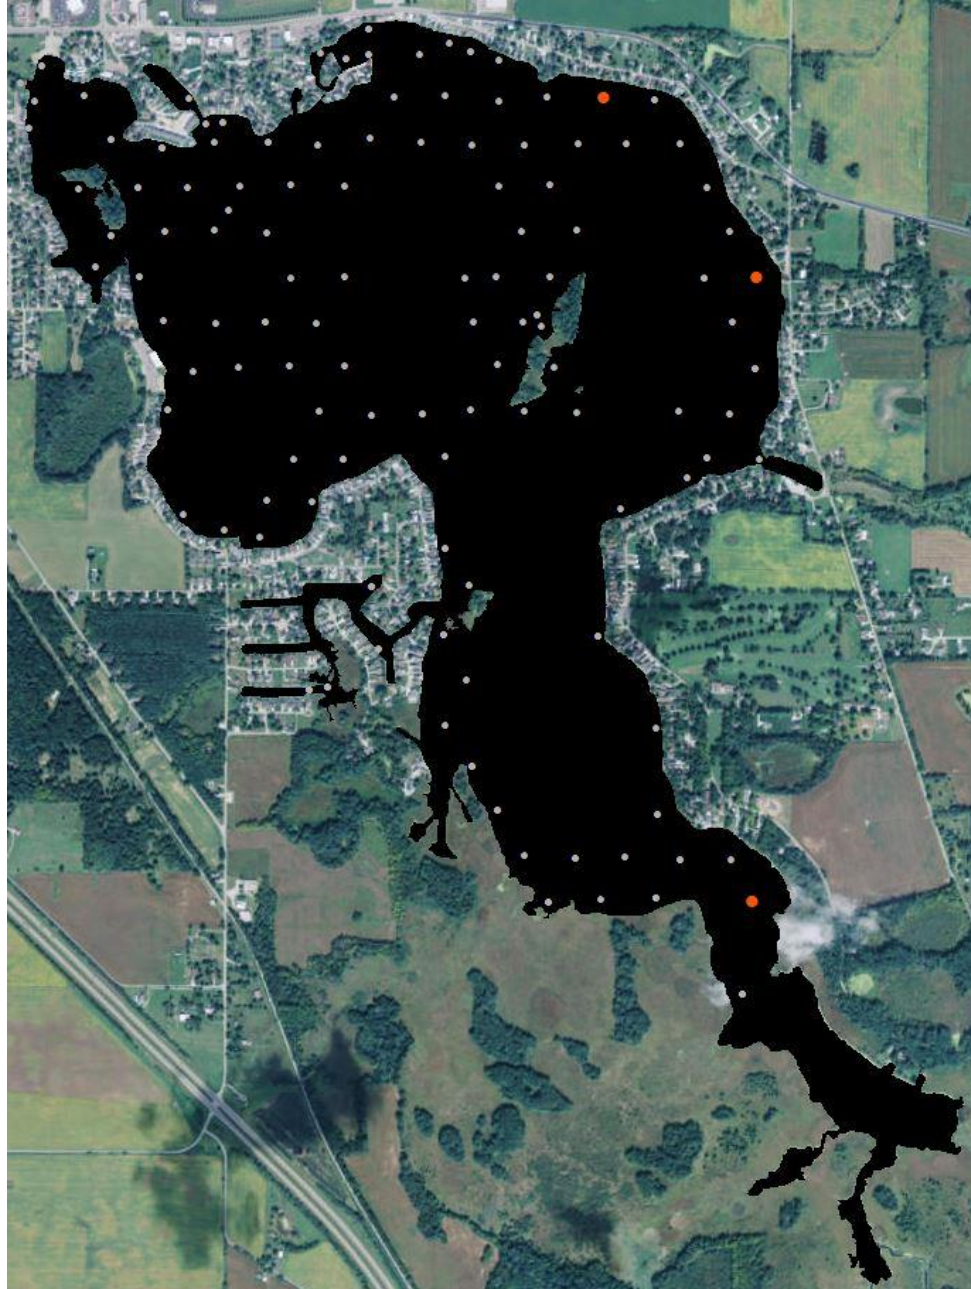
Figure 2.3.4. Lake Manitou, curly-leaf pondweed distribution, June 29, 2016.

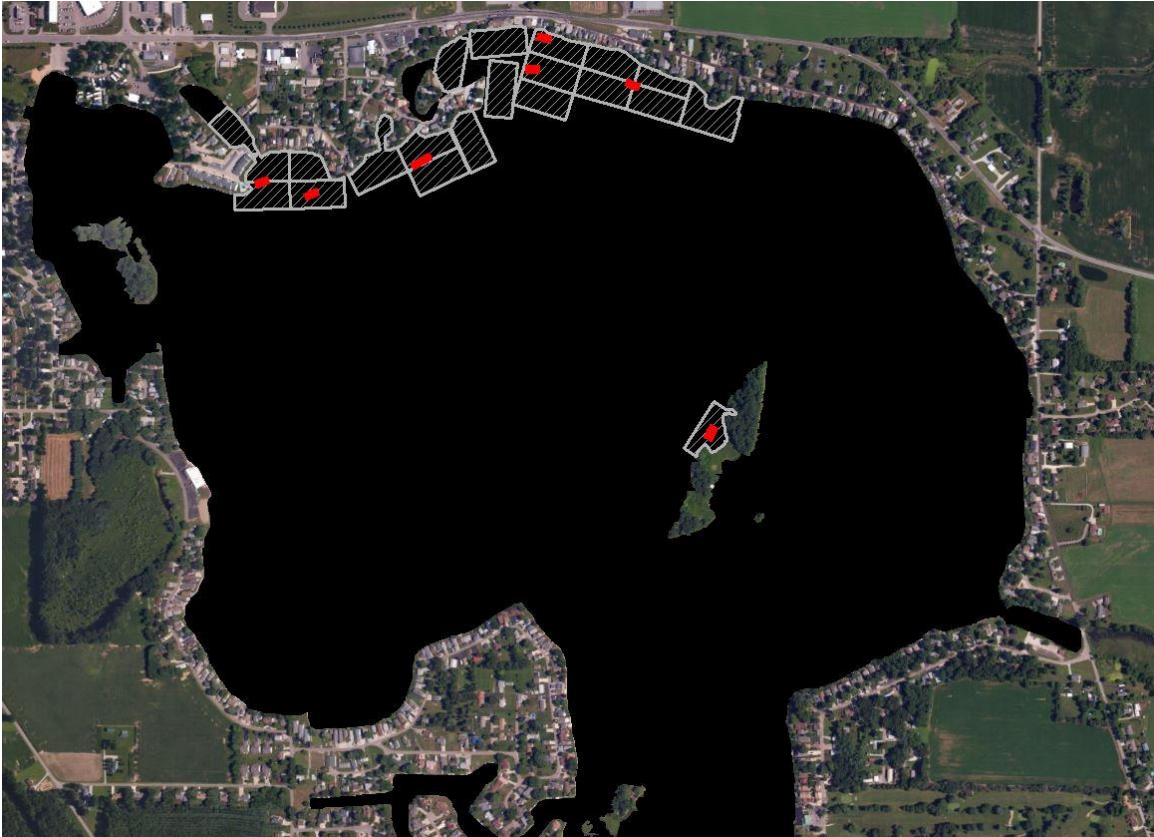
Figure 2.4.1 Dive survey design.

In 2013, the 1.5-day dive survey design was further refined with goal to have a long-term approach for diver assessment to support the remainder of the hydrilla eradication efforts on Manitou. Seven new 'high-intensity' survey areas were established in blocks surrounding discrete locations of diver hydrilla finds in 2011 and 2012. Each high-intensity zone was 6600 square feet in size (60 by 100 feet). Divers traversed these zones with objective of visual coverage of the entire bottom for maximum ability to detect vegetative hydrilla growth. 21 additional 'low intensity' blocks were surveyed that were a select number of the 35 zones surveyed in 2012 that immediately surrounded the new high-intensity blocks of past hydrilla finds. This design (shown in Figures 2.4.1, 2.4.2, and 2.4.3) balanced the objectives of 1) developing data on discrete number of vegetative hydrilla plants within the high intensity areas to track hydrilla decline through time as a metric for late-stage eradication success while also 2) surveying the broader area of past infestation to provide a wider look in case 'hot spots' of remaining hydrilla might still be detected for closer assessment in the future. Four single hydrilla plants were detected in the 2013 dive survey. This same design was used again in 2014, and no hydrilla was detected. The same design was used again in 2015. The 2015 dive survey was conducted on June 29 and 30. To focus efforts on hydrilla detection, other submersed plant species were not individually tracked but were qualitatively noted for the diver survey overall.

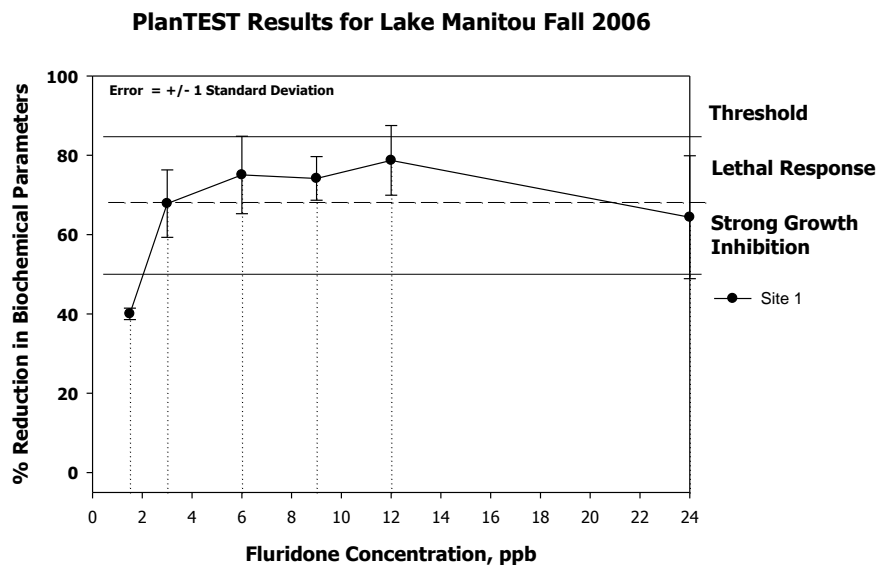
Chart 4.0.1 PlanTEST Results for Lake Manitou.

SePRO collected hydrilla samples from Lake Manitou in 2006 and conducted a PlanTEST at the SePRO Research and Technology Campus (SRTC) in Whitakers N.C. The PlanTEST is a proprietary test developed by SePRO Corporation that uses key biochemical parameters (Sprecher et al. 1998) to determine the plants inherent susceptibility to Sonar. The test was used to direct Sonar treatment recommendations by providing an indication of concentrations necessary for control. The hydrilla in Lake Manitou responded favorably to Sonar under laboratory conditions (Chart 4.0.1 and Figure 4.0.1). SePRO’s recommended treatment protocol was based on results of the PlanTEST, extensive experience in hydrilla control throughout the U.S., and proprietary modeling of Sonar dissipation from various formulations.

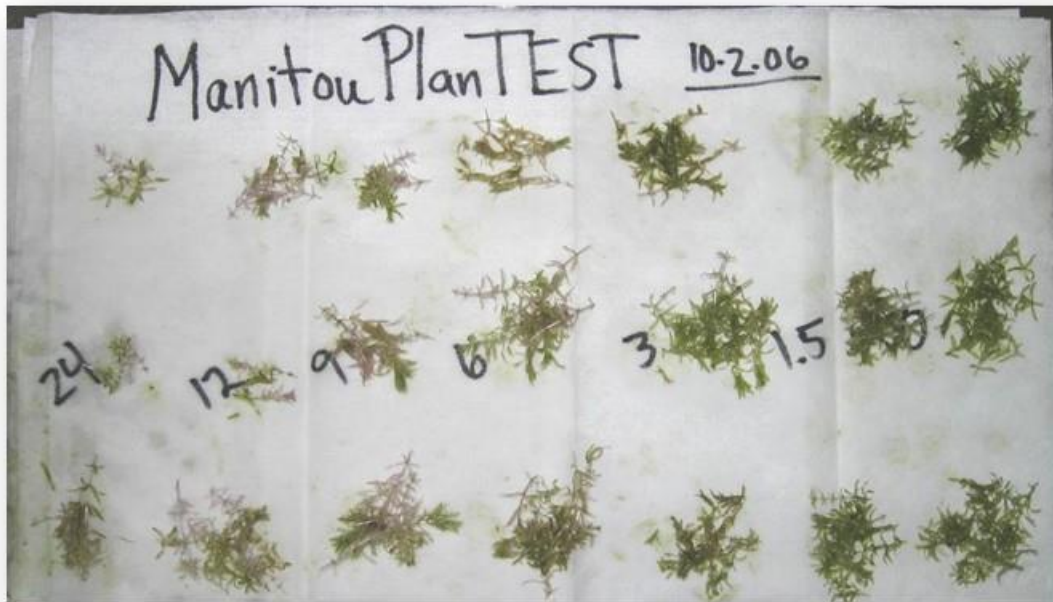
**Figure 4.0.1. Lake Manitou hydrilla susceptibility to Sonar (PlanTEST).**

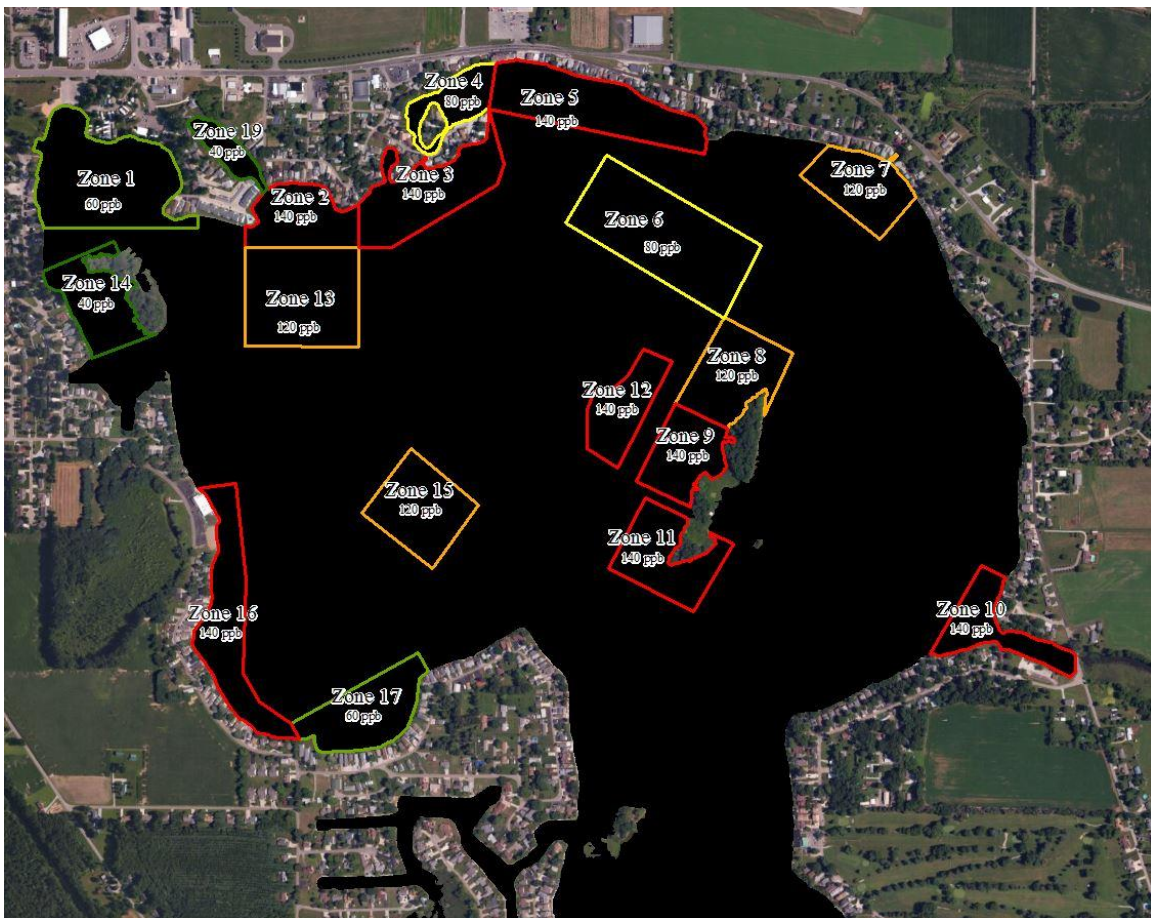
Figure 4.1.1. Treatment areas for Sonar PR application on May 9, June 29, and August 15, 2016. Total ppb of Sonar PR applied for the season is noted for each zone. The total Sonar utilized in 2016 was spread across three different split applications.

On May 9, 2016, the first application was made by Aquatic Control, Inc., with SePRO Corporation and ReMetrix personnel on site for technical assistance. Pelletized Sonar PR was applied to 18 zones (Figure 4.1.1) at concentrations ranging from 20-70 ppb (total of 4.1 ppb based on lake volume). A custom built herbicide blower on a 19-foot Carolina Skiff was used for application of the granular Sonar PR product. Pre-planned Sonar PR bump applications were completed on June 29<sup>th</sup> and August 15<sup>th</sup> (Figure 4.1.2). For these two re-applications, Sonar PR was applied to the same locations as the initial Sonar PR treatment but at half the initial rate.

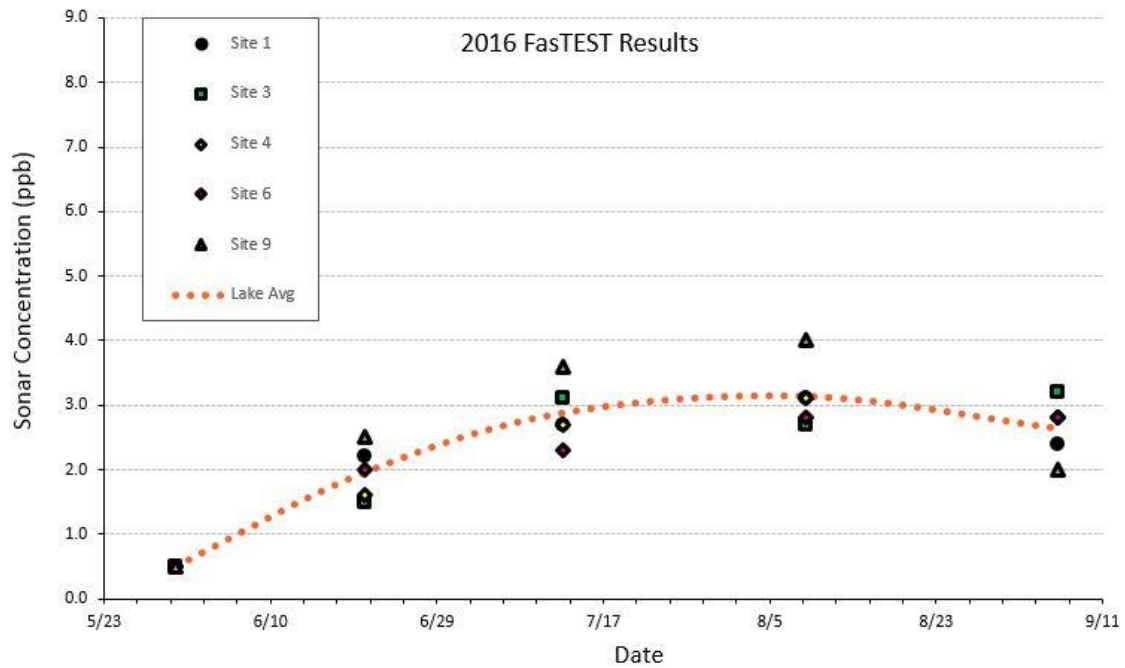
**Chart 4.2.1. Sonar concentration (ppb fluridone on vertical axis) by FasTEST site (five locations) and lakewide average during 2016.**

Due to the reduced treatment regime in 2016, FasTEST monitoring was also reduced from 8 permanent stations to 5 (Figure 4.2.1 & Table 4.2.1). The FasTEST was used to monitor fluridone concentration on 5 dates between May 31<sup>st</sup> and September 6<sup>th</sup>, 2016—a span of 121 days following initial treatment. The FasTEST measurements confirmed that effective Sonar concentrations for monoecious hydrilla control were achieved and maintained through the summer with projected effective levels into the early fall. Results indicate the concentration was maintained above 2.0 ppb for the vast majority of the 2016 growing season (Table 4.2.2, and Chart 4.2.1).
