**Post-Treatment Assessment  
of ERDC Hydrilla Control  
Demonstration Project  
Tonawanda Creek/Erie Canal  
2016**

**Contract No. W912P4-10-D-0002**

**March 2017**

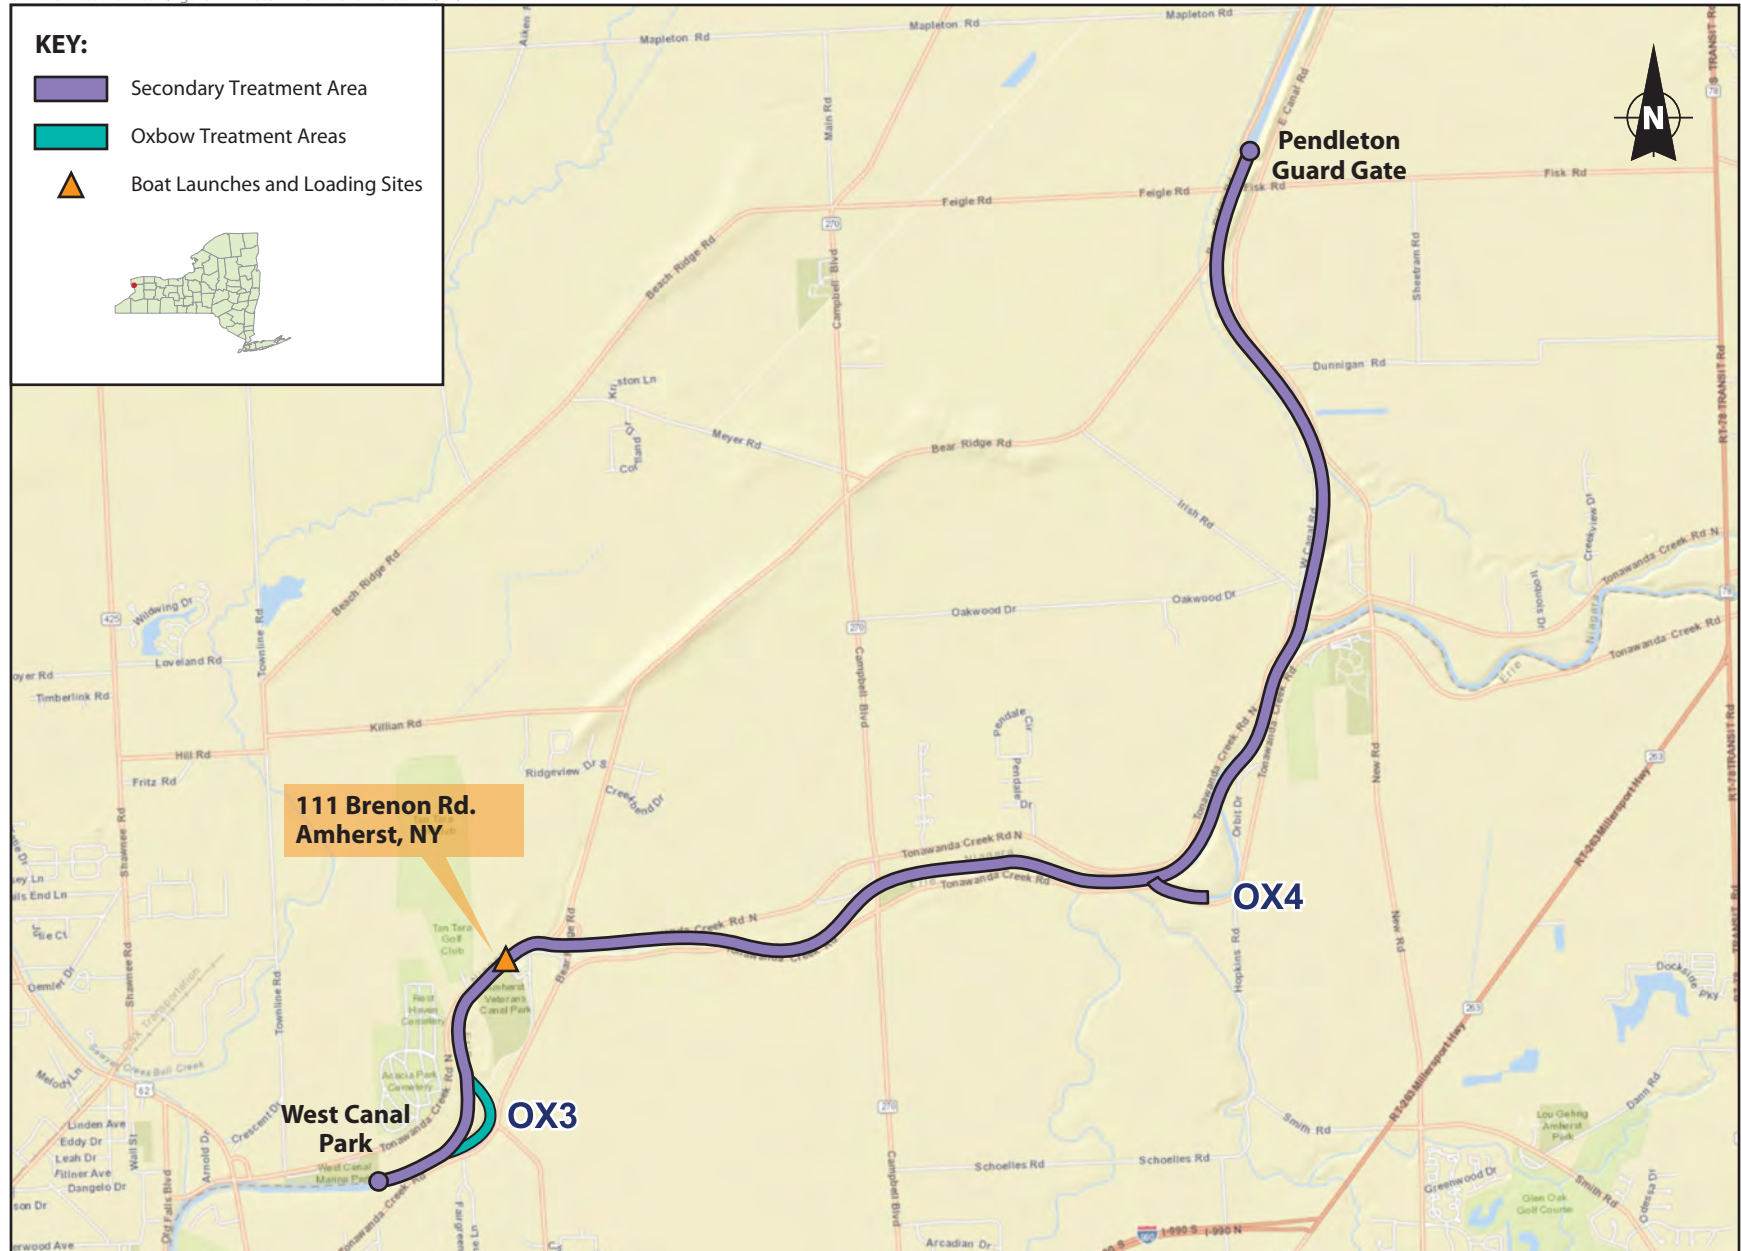
Figure 1-2 Eastern Block Treatment Areas  
Tonawanda Creek/Erie Canal

on application of the aquatic herbicide endothall (Aquathol K™). The following two areas were treated (see Figures 1-1 and 1-2):

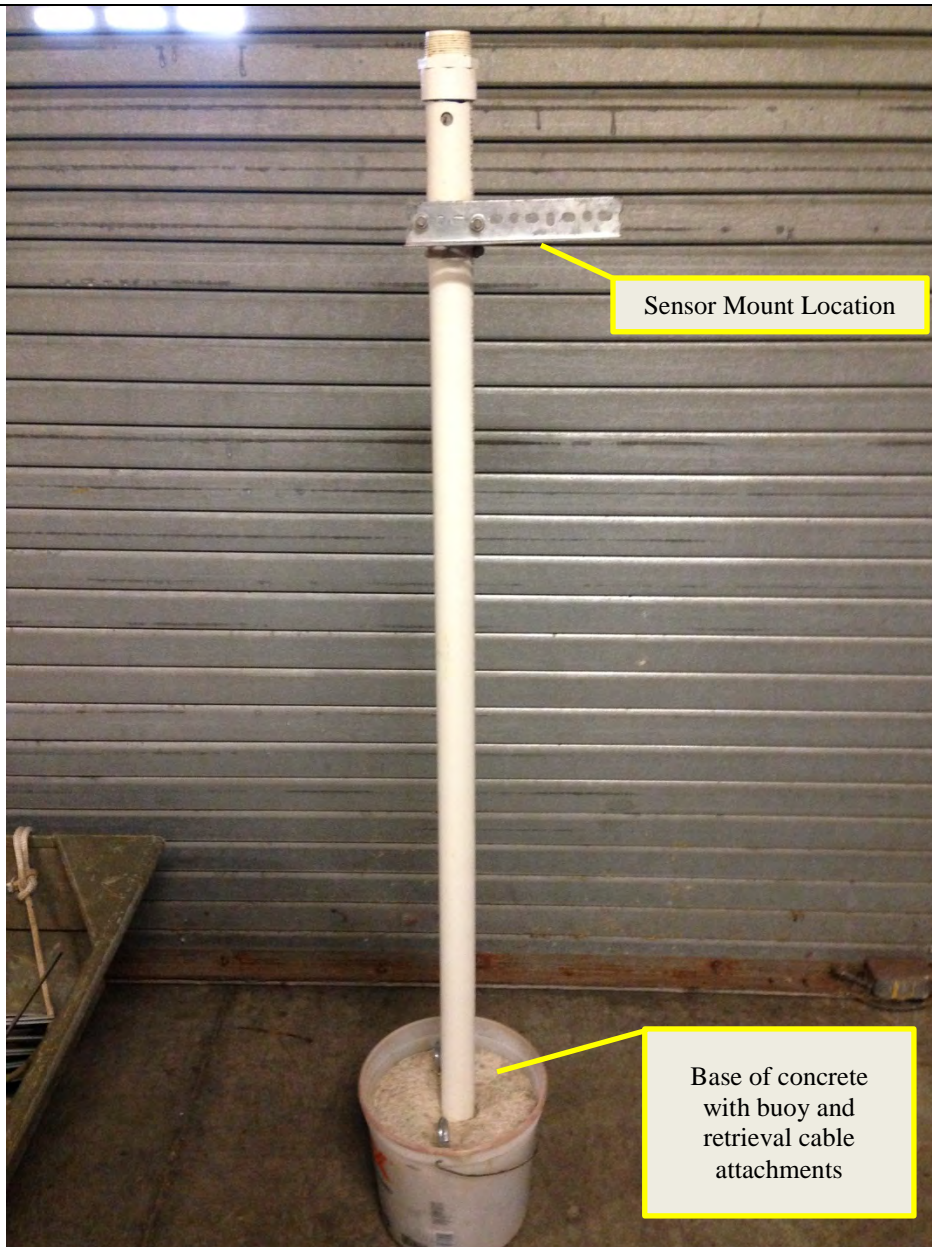
**Subject:** Sensor Mount

**Description:** Concrete bucket with attachments for retrieval cable, buoy ties and sensor cable. Sensor mount is adjustable to control for sensor height above creek bottom

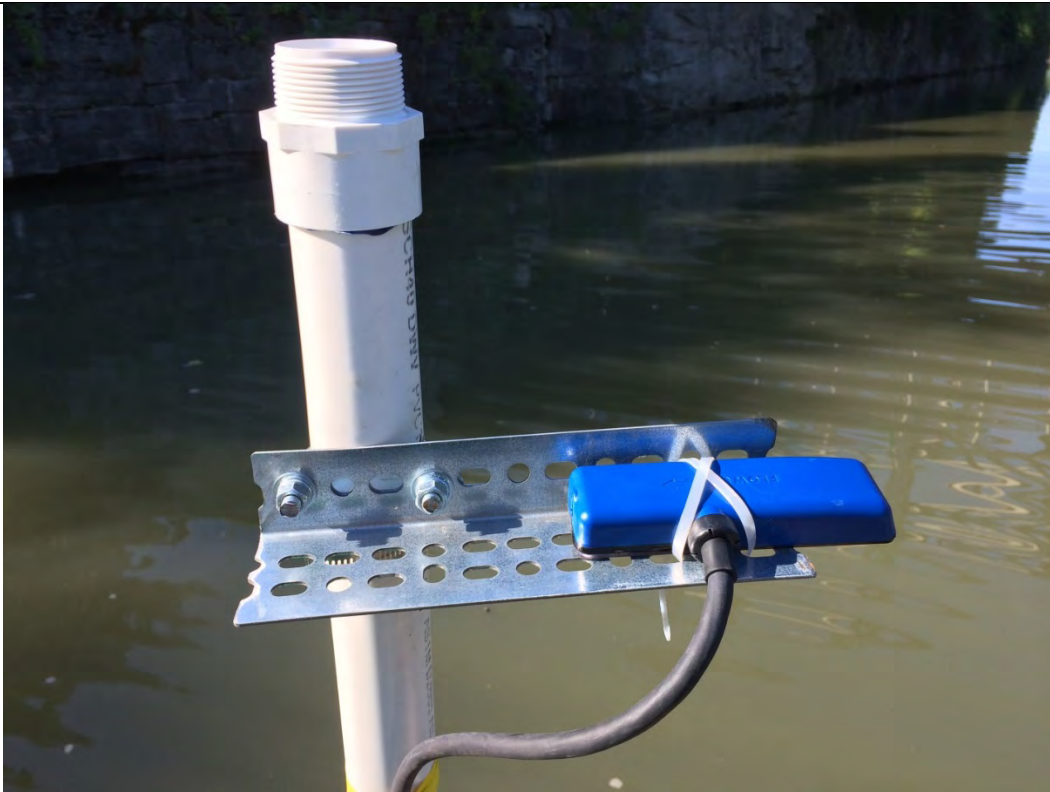
**Subject:** Mounted Sigma flow/velocity sensor

**Description:** Sensor is mounted parallel to flow direction and can measure negative and positive flows

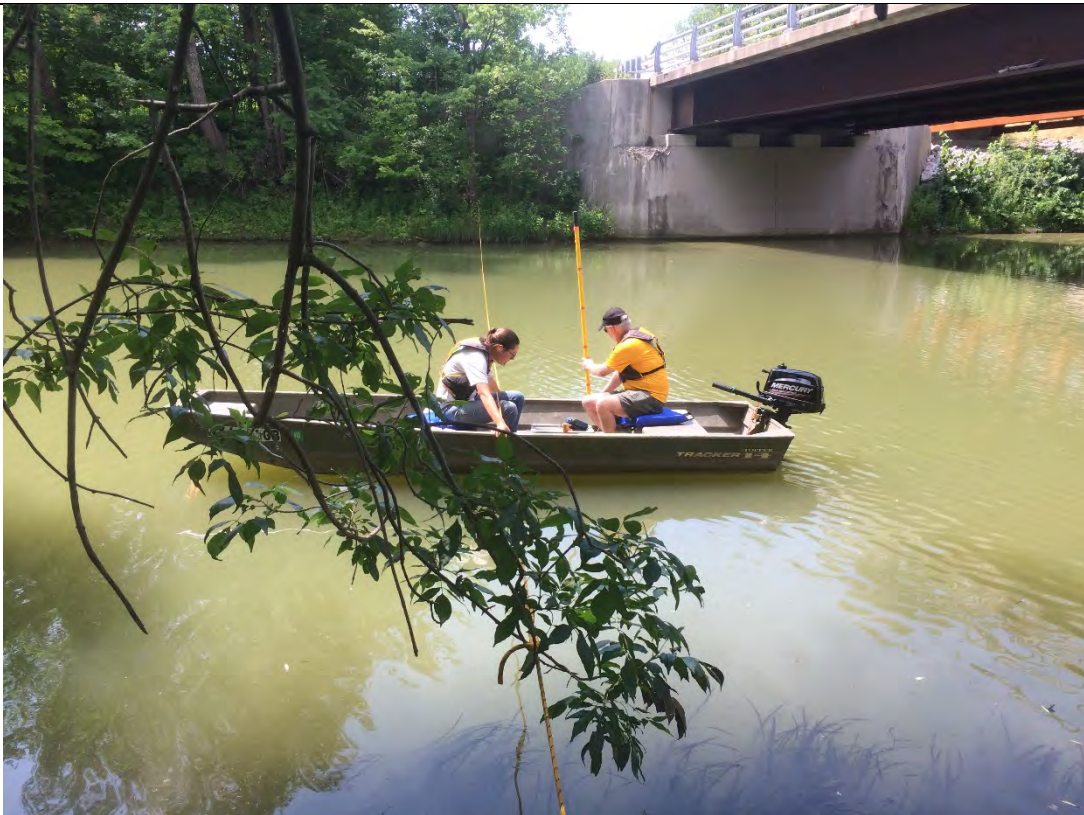
**Subject:** E&E employees at New Road Bridge in Pendleton

**Description:** E&E employees measuring flow at 6 inches, 25%, 50% and 75% of depth to determine the flow profile at New Road Bridge flow monitoring location.

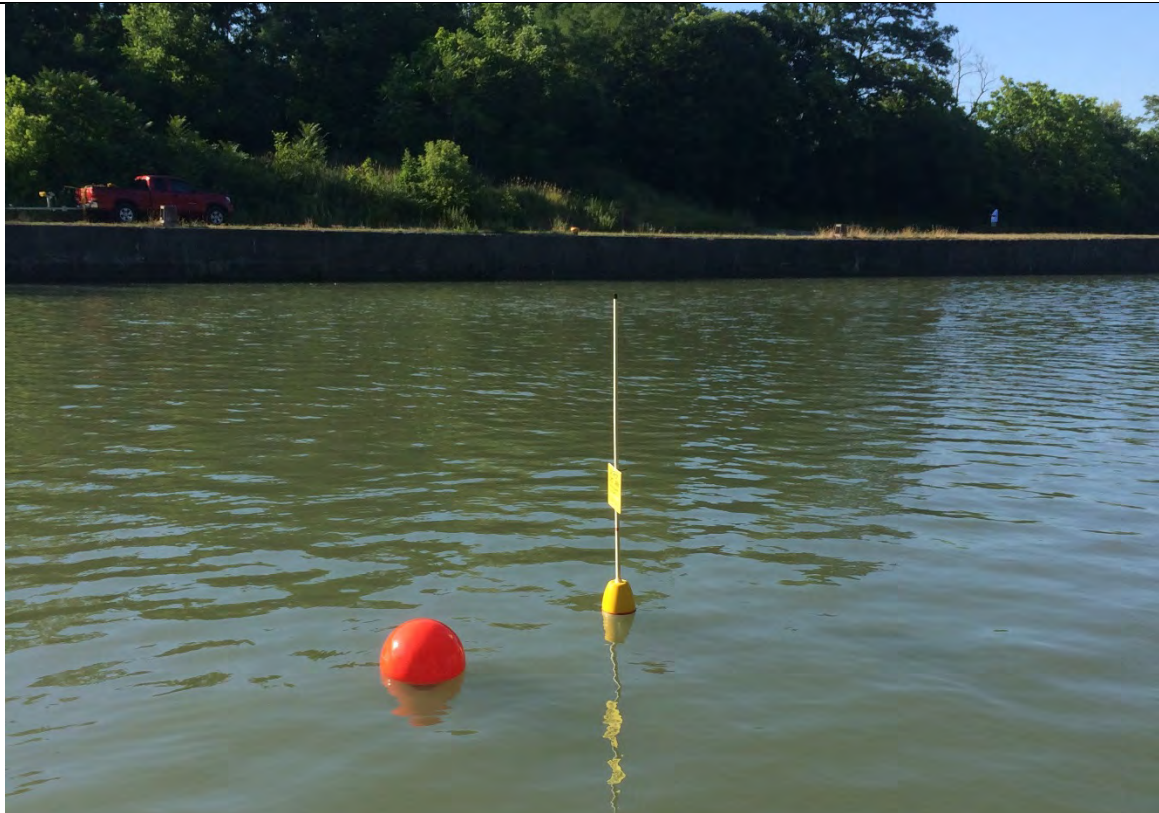
**Subject:** Buoys marking flow meter location

**Description:** Two buoys mark the location of the flow meter at Stevens St. Bridge in Lockport

The Stevens Street monitoring station was removed from the water at 1750 hours on Monday, July 26, 2016, and a buoy was taken from the station. This was not detected until the following morning and the station was replaced in the water by 1255 hours on Tuesday, July 27. Flow at the other two stations indicated that there was little flow in the creek/canal during this time. This is reflected in the flow, velocity, and level graphs in Appendix D.

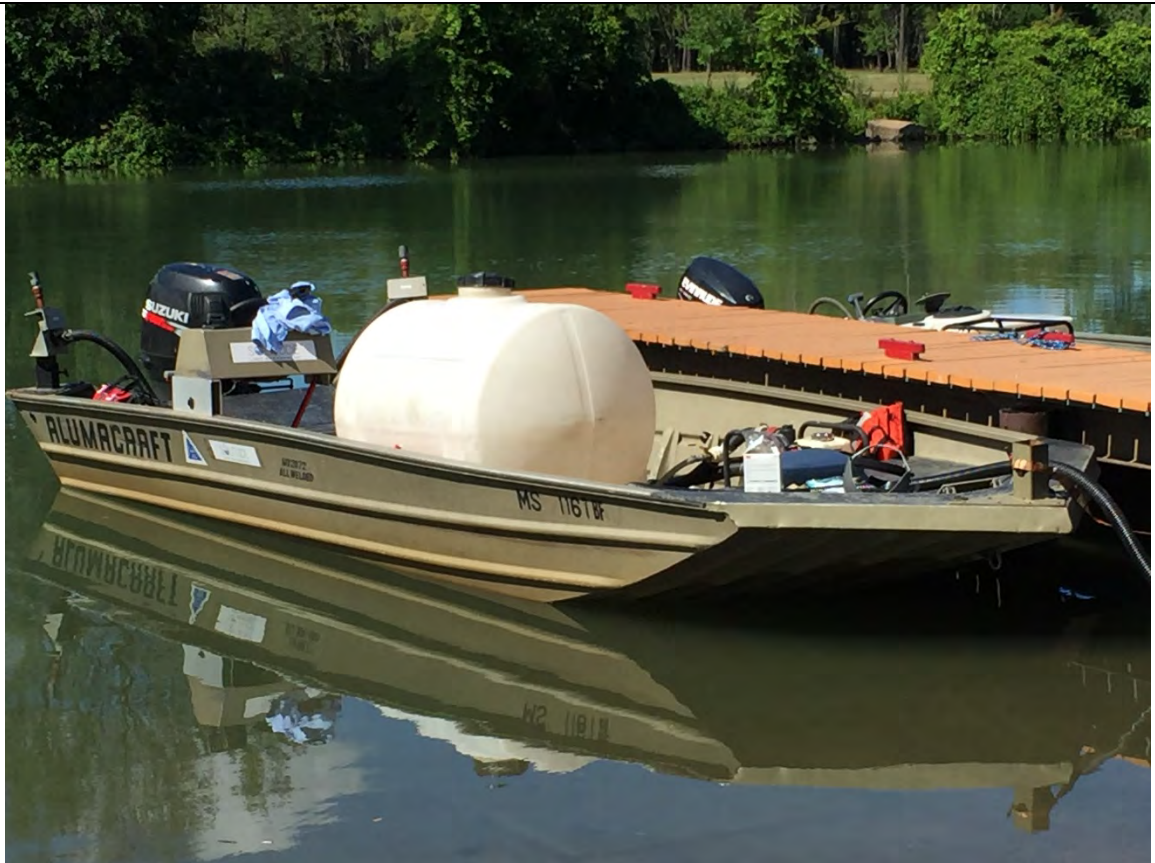
<b>Date:</b>	07/26/2016	<b>Direction of View:</b>	West from North shore of creek
<b>Subject:</b>	Application boat set-up		
<b>Description:</b>	Endothall was placed in the tank and dispensed into the creek through PVC pipes on back of boat.

An in-line herbicide injection system was used on the two conventional work skiffs. Each skiff was outfitted with a 225-gallon polyethylene tank. The liquid herbicide was pumped from 250-gallon totes in the chemical delivery box truck located onshore into the polyethylene tanks via 1.5-inch-diameter tubing by electric- and gasoline-powered transfer pumps. Personal protective equipment was worn by SLM staff and by the driver from the company that delivered the herbicide and assisted with the herbicide transfer to the skiffs.

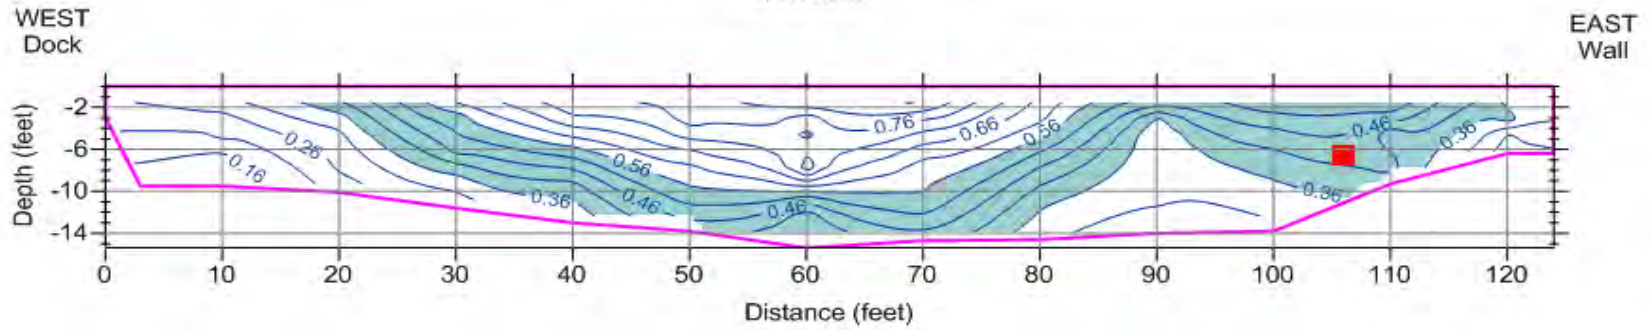
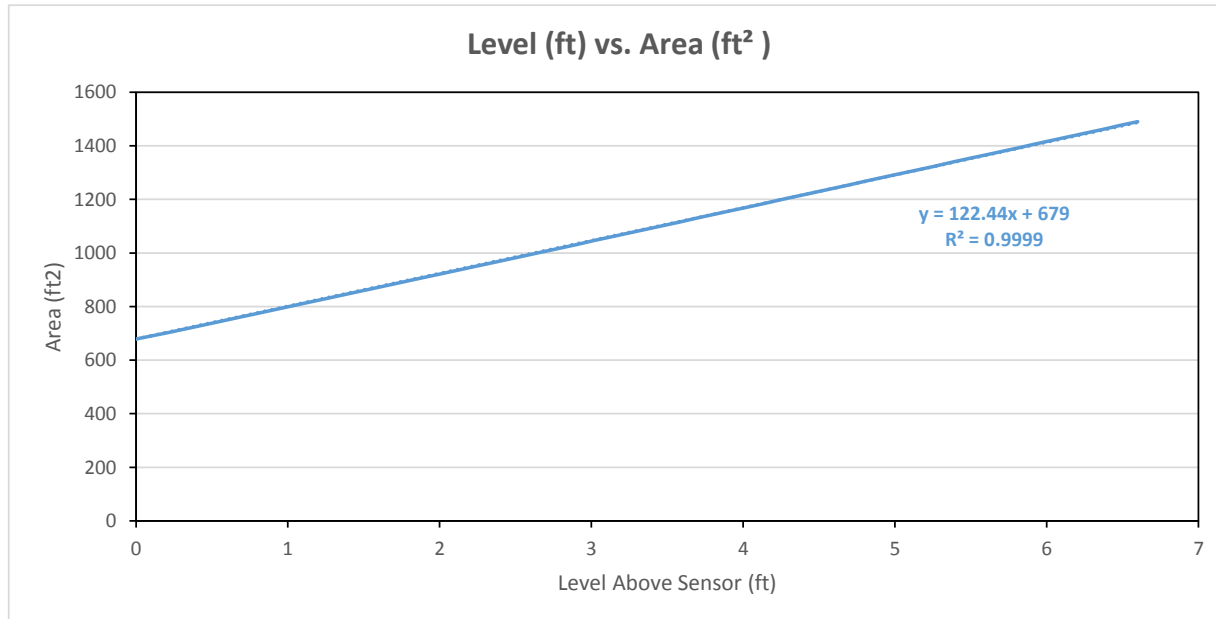
Canal Depth and Velocity Profile  
 Stevens Street Bridge, Lockport  
 7/12/2016

Key: ■ Approx. sensor location (not to scale)  Area of mean velocity ( $\pm 20\%$ ) — 0.49 — Velocity contour in feet/second — Creek boundary

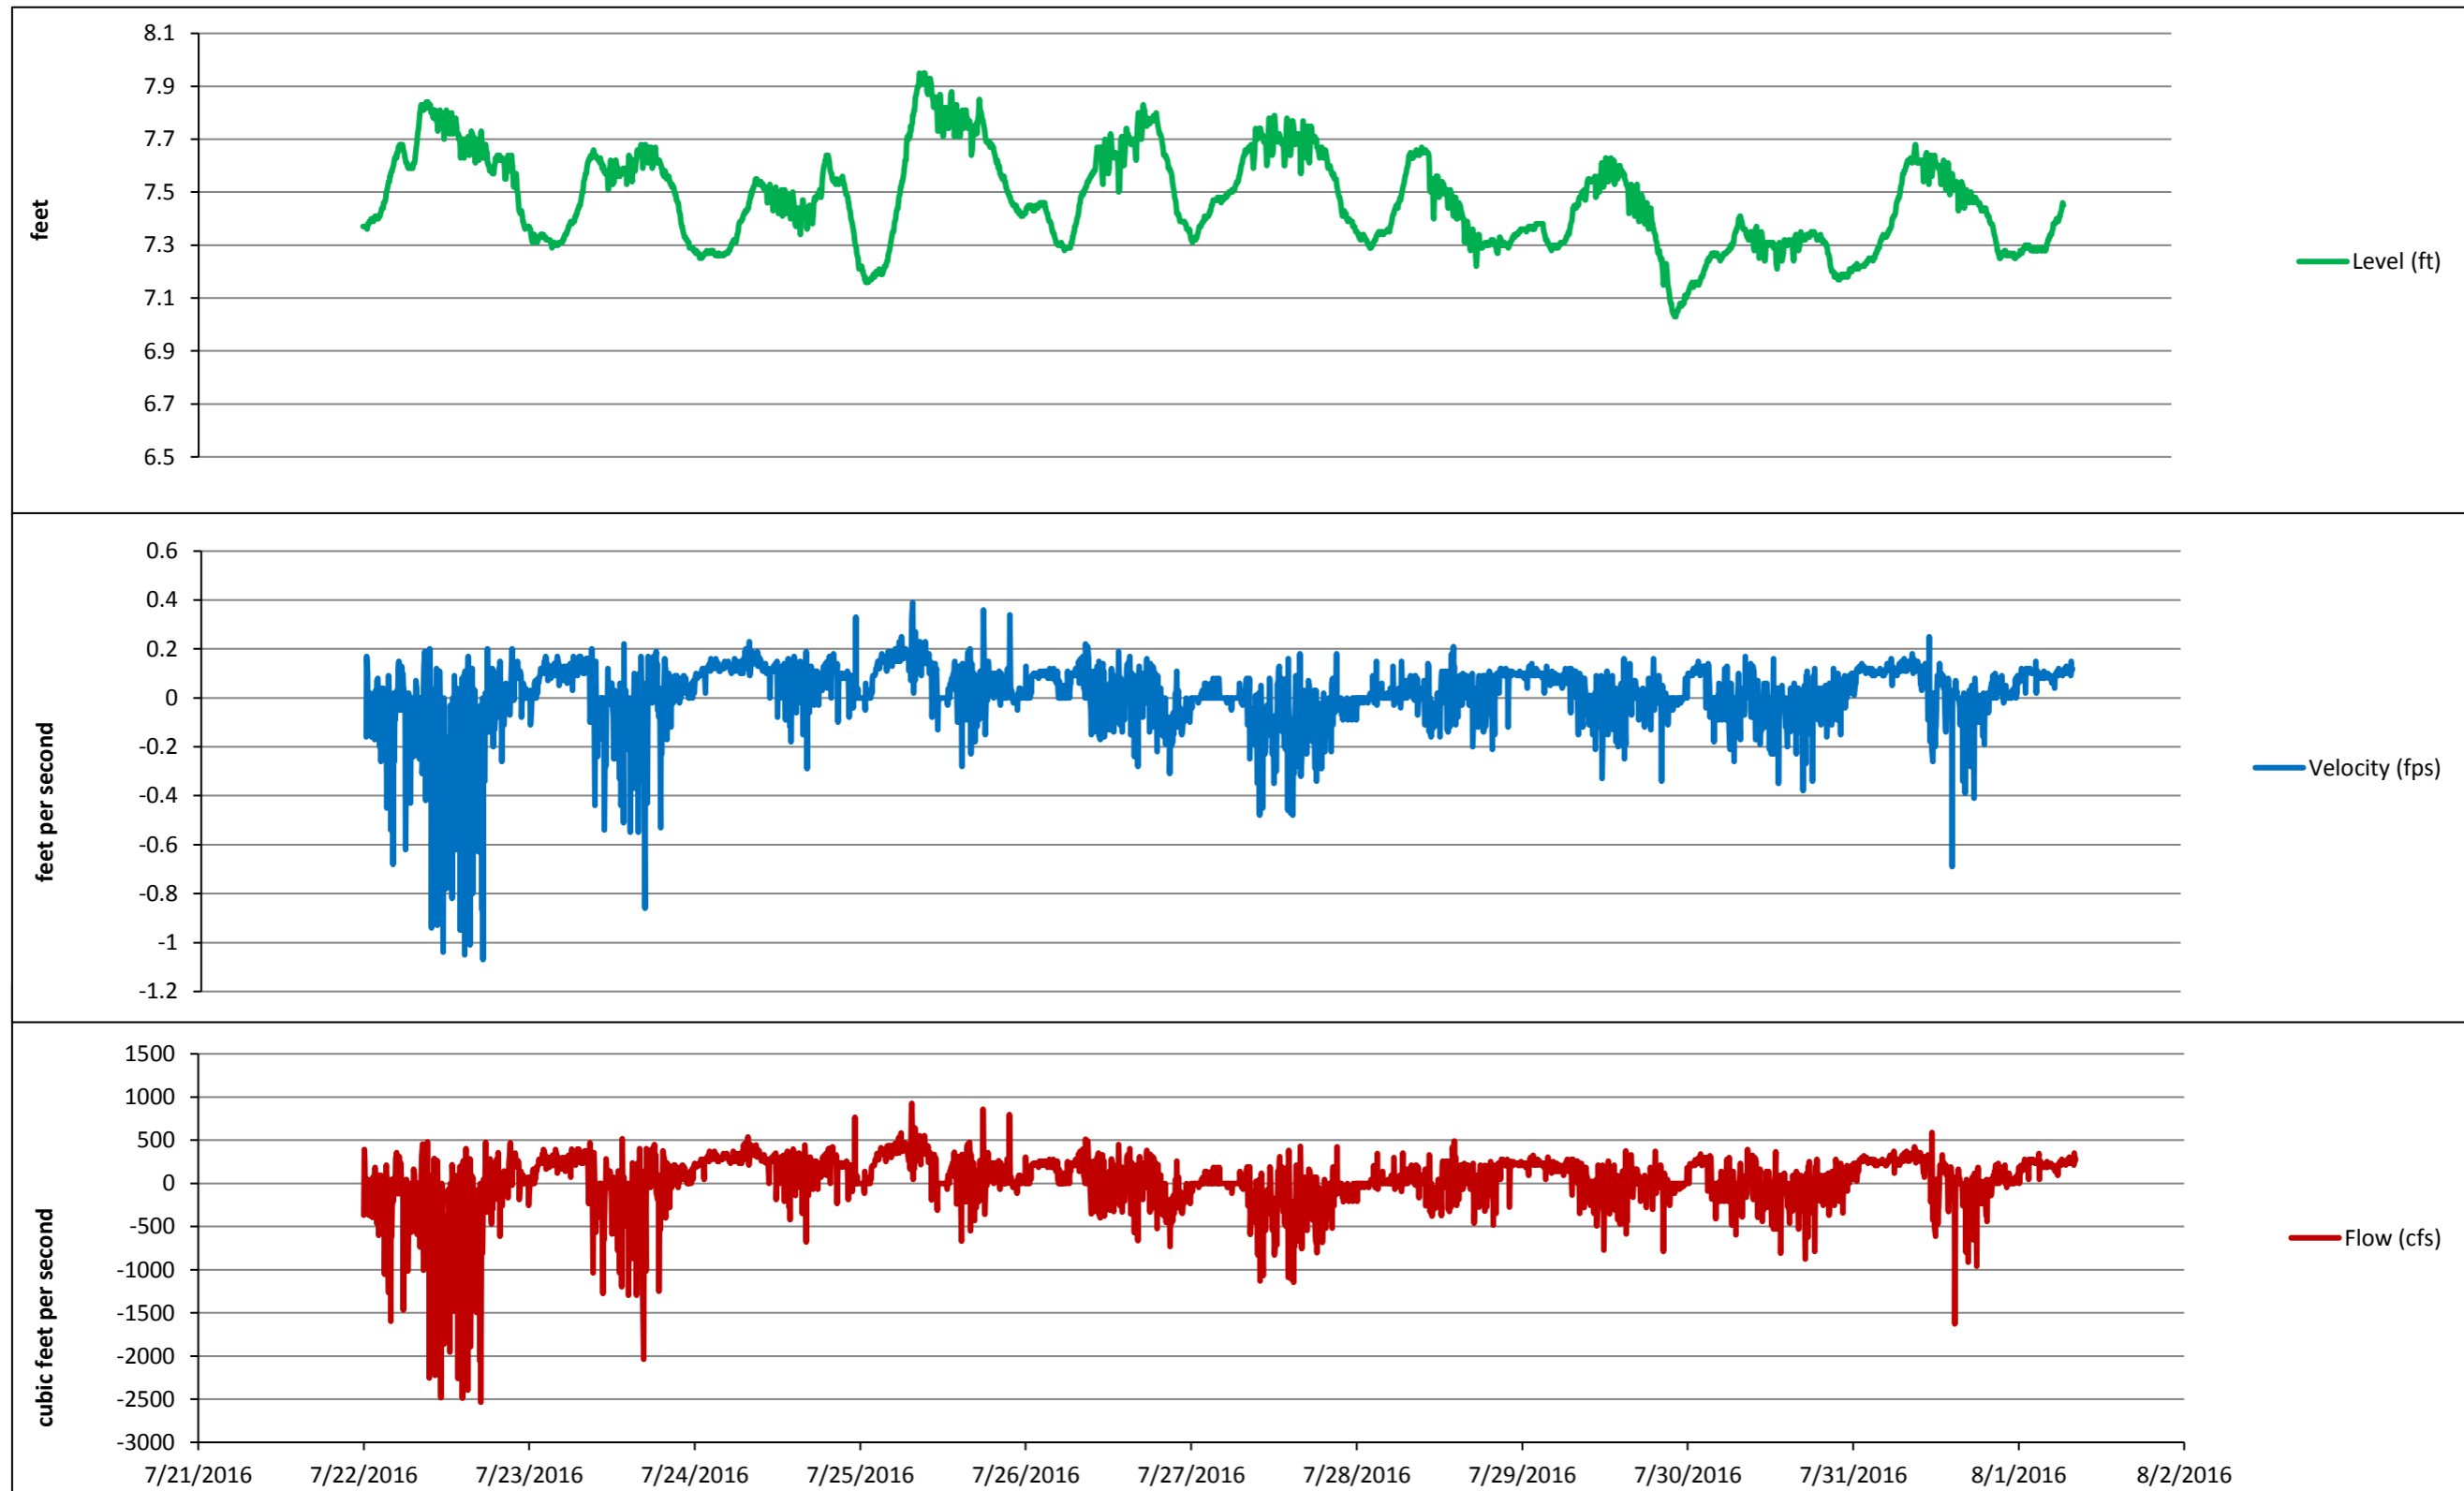
Summary Flow Data and Water Levels for Tonawanda Creek at Mayor's Park (July 22nd-August 1st, 2016)

Flows out of and into the natural channel of Tonawanda Creek (near East Canal/New Road) were all low. The majority of the time flow was from the canal, likely due to backwater conditions moving up the creek/canal resulting from Niagara River level changes. However, flow direction fluctuated towards the canal as well, especially after the second day of treatment. During the days of the treatment period, flow rates were generally measured between 0 and 100 cfs, which corroborates the United States Geological Survey (USGS) gauging station data on Tonawanda Creek in Rapids, New York (USGS Station Number 04218000). USGS data for the week of treatment showed daily flow rates increasing and then decreasing throughout the week with a maximum daily flow of 72 cfs and minimum of 20 cfs (USGS 2016).

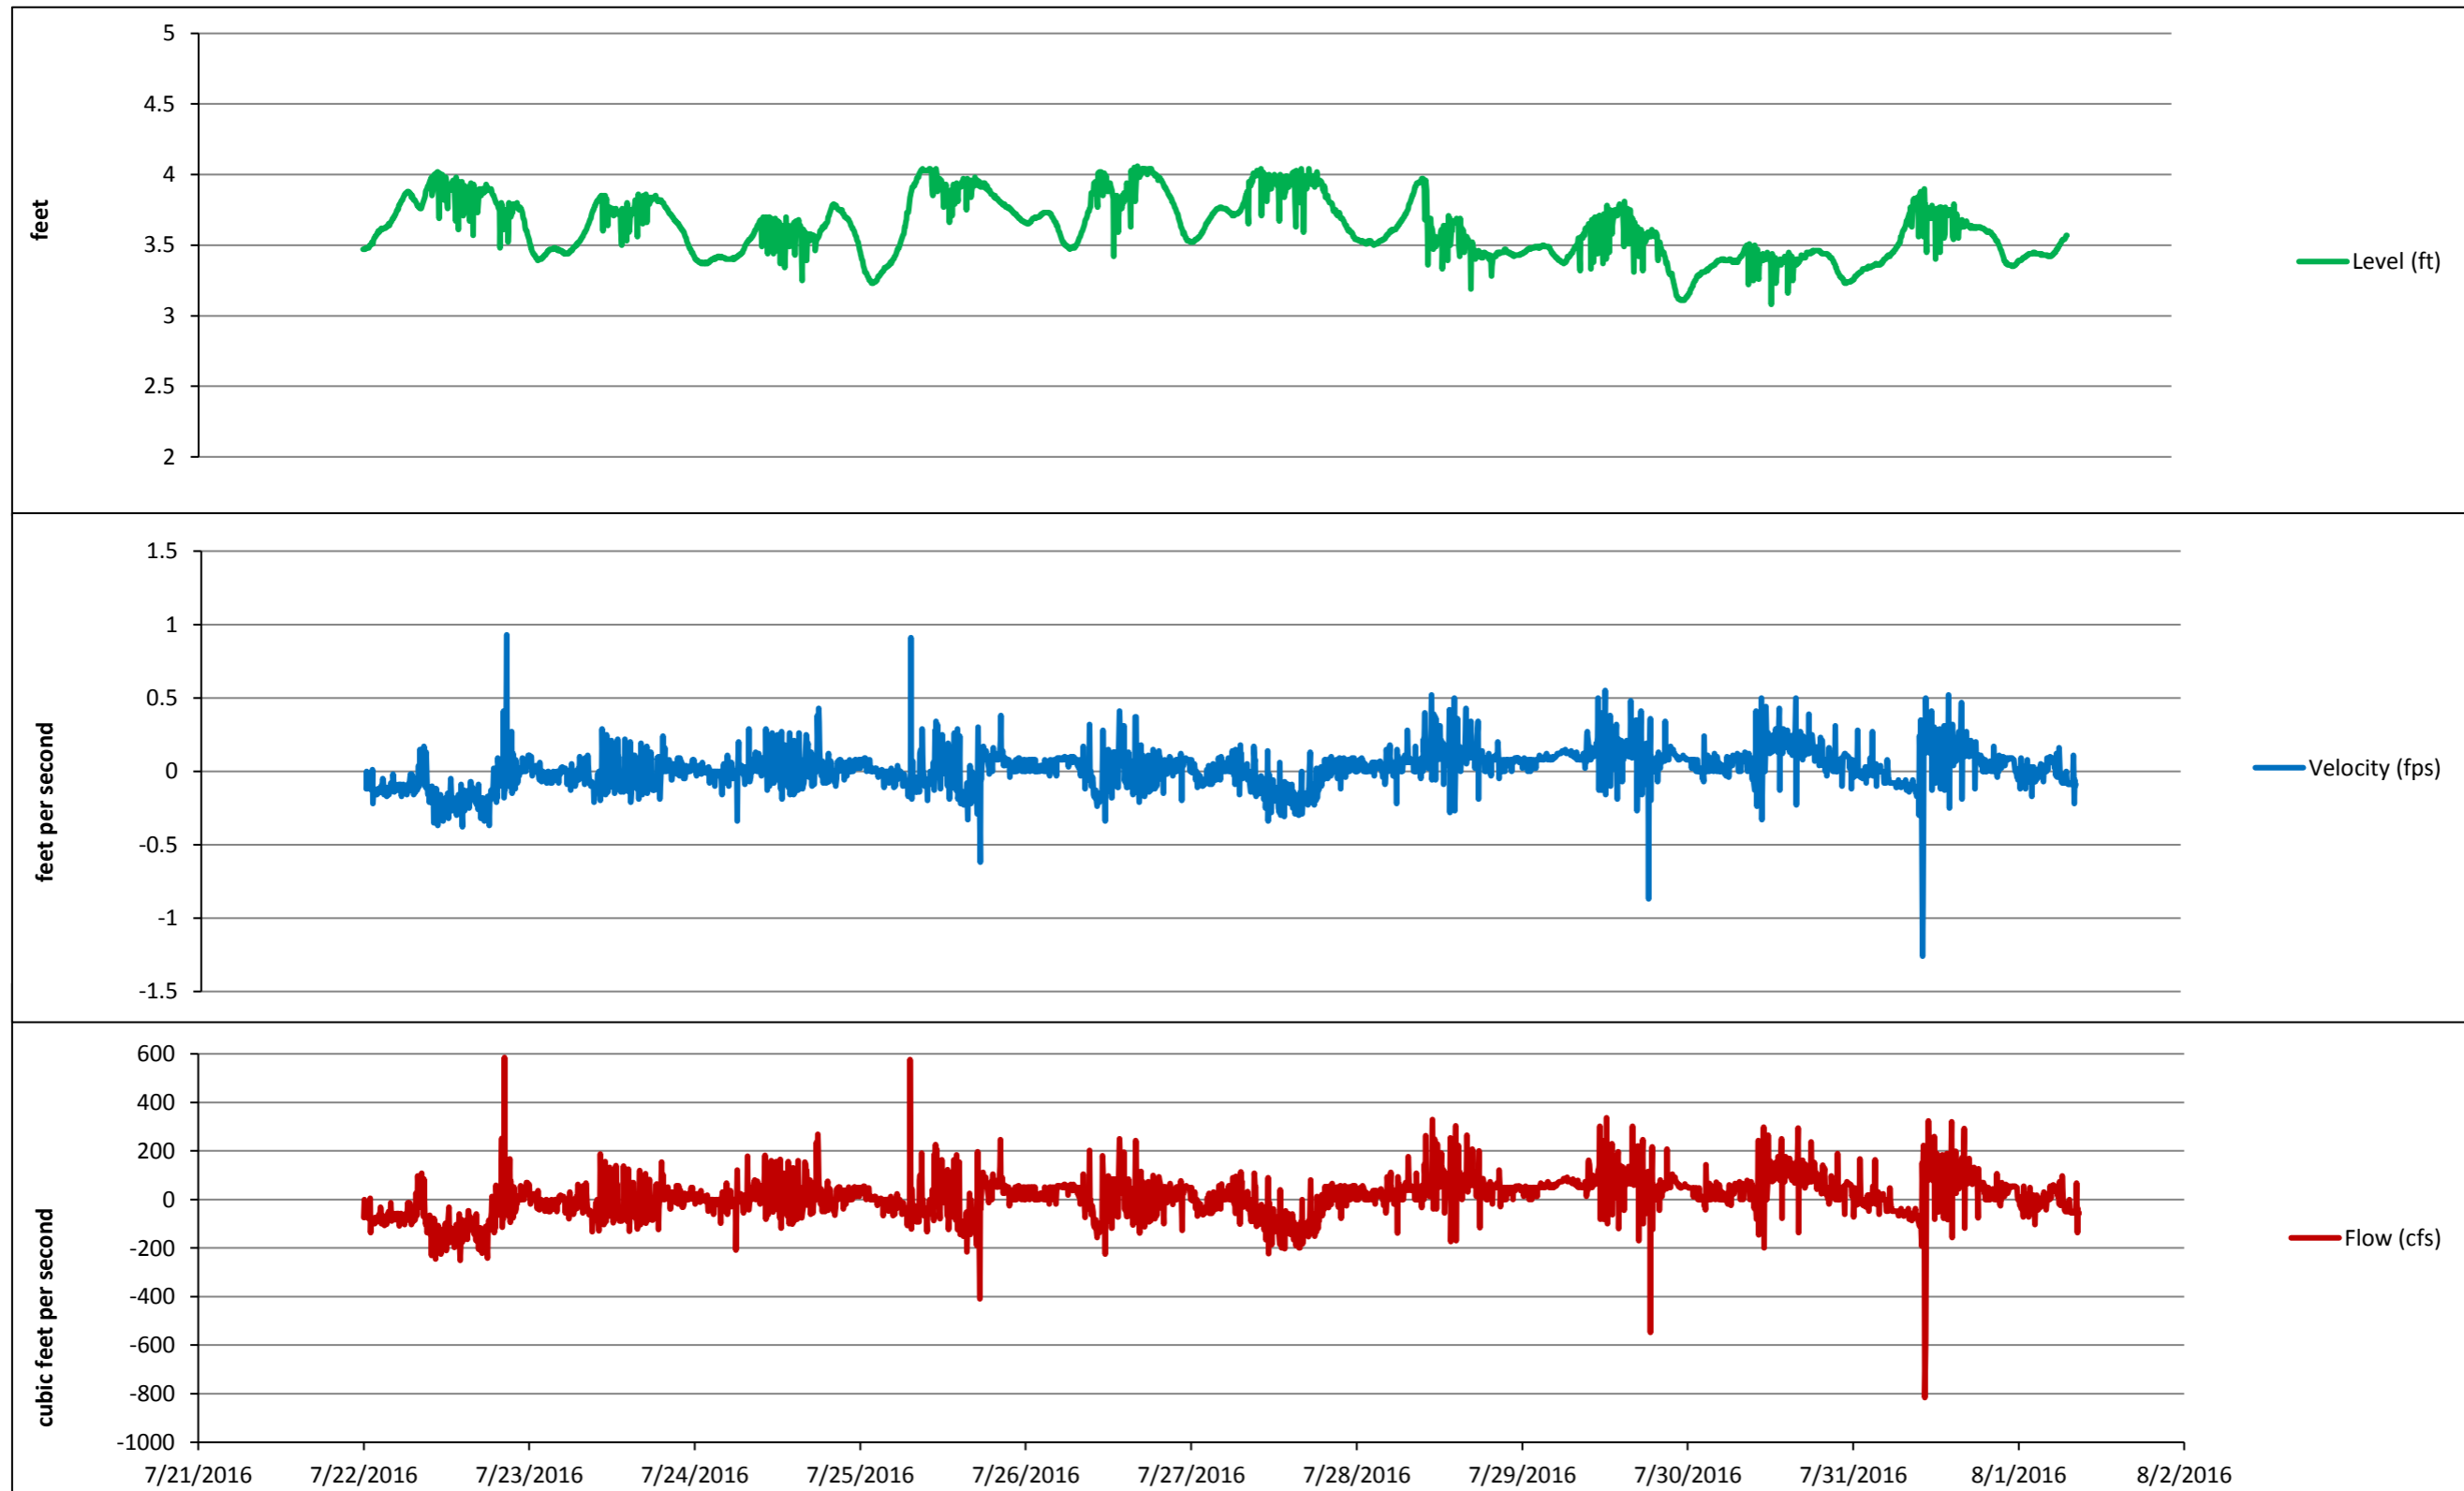
Summary Flow Data and Water Levels for Tonawanda Creek at New Road (July 22st-August 1st, 2016)

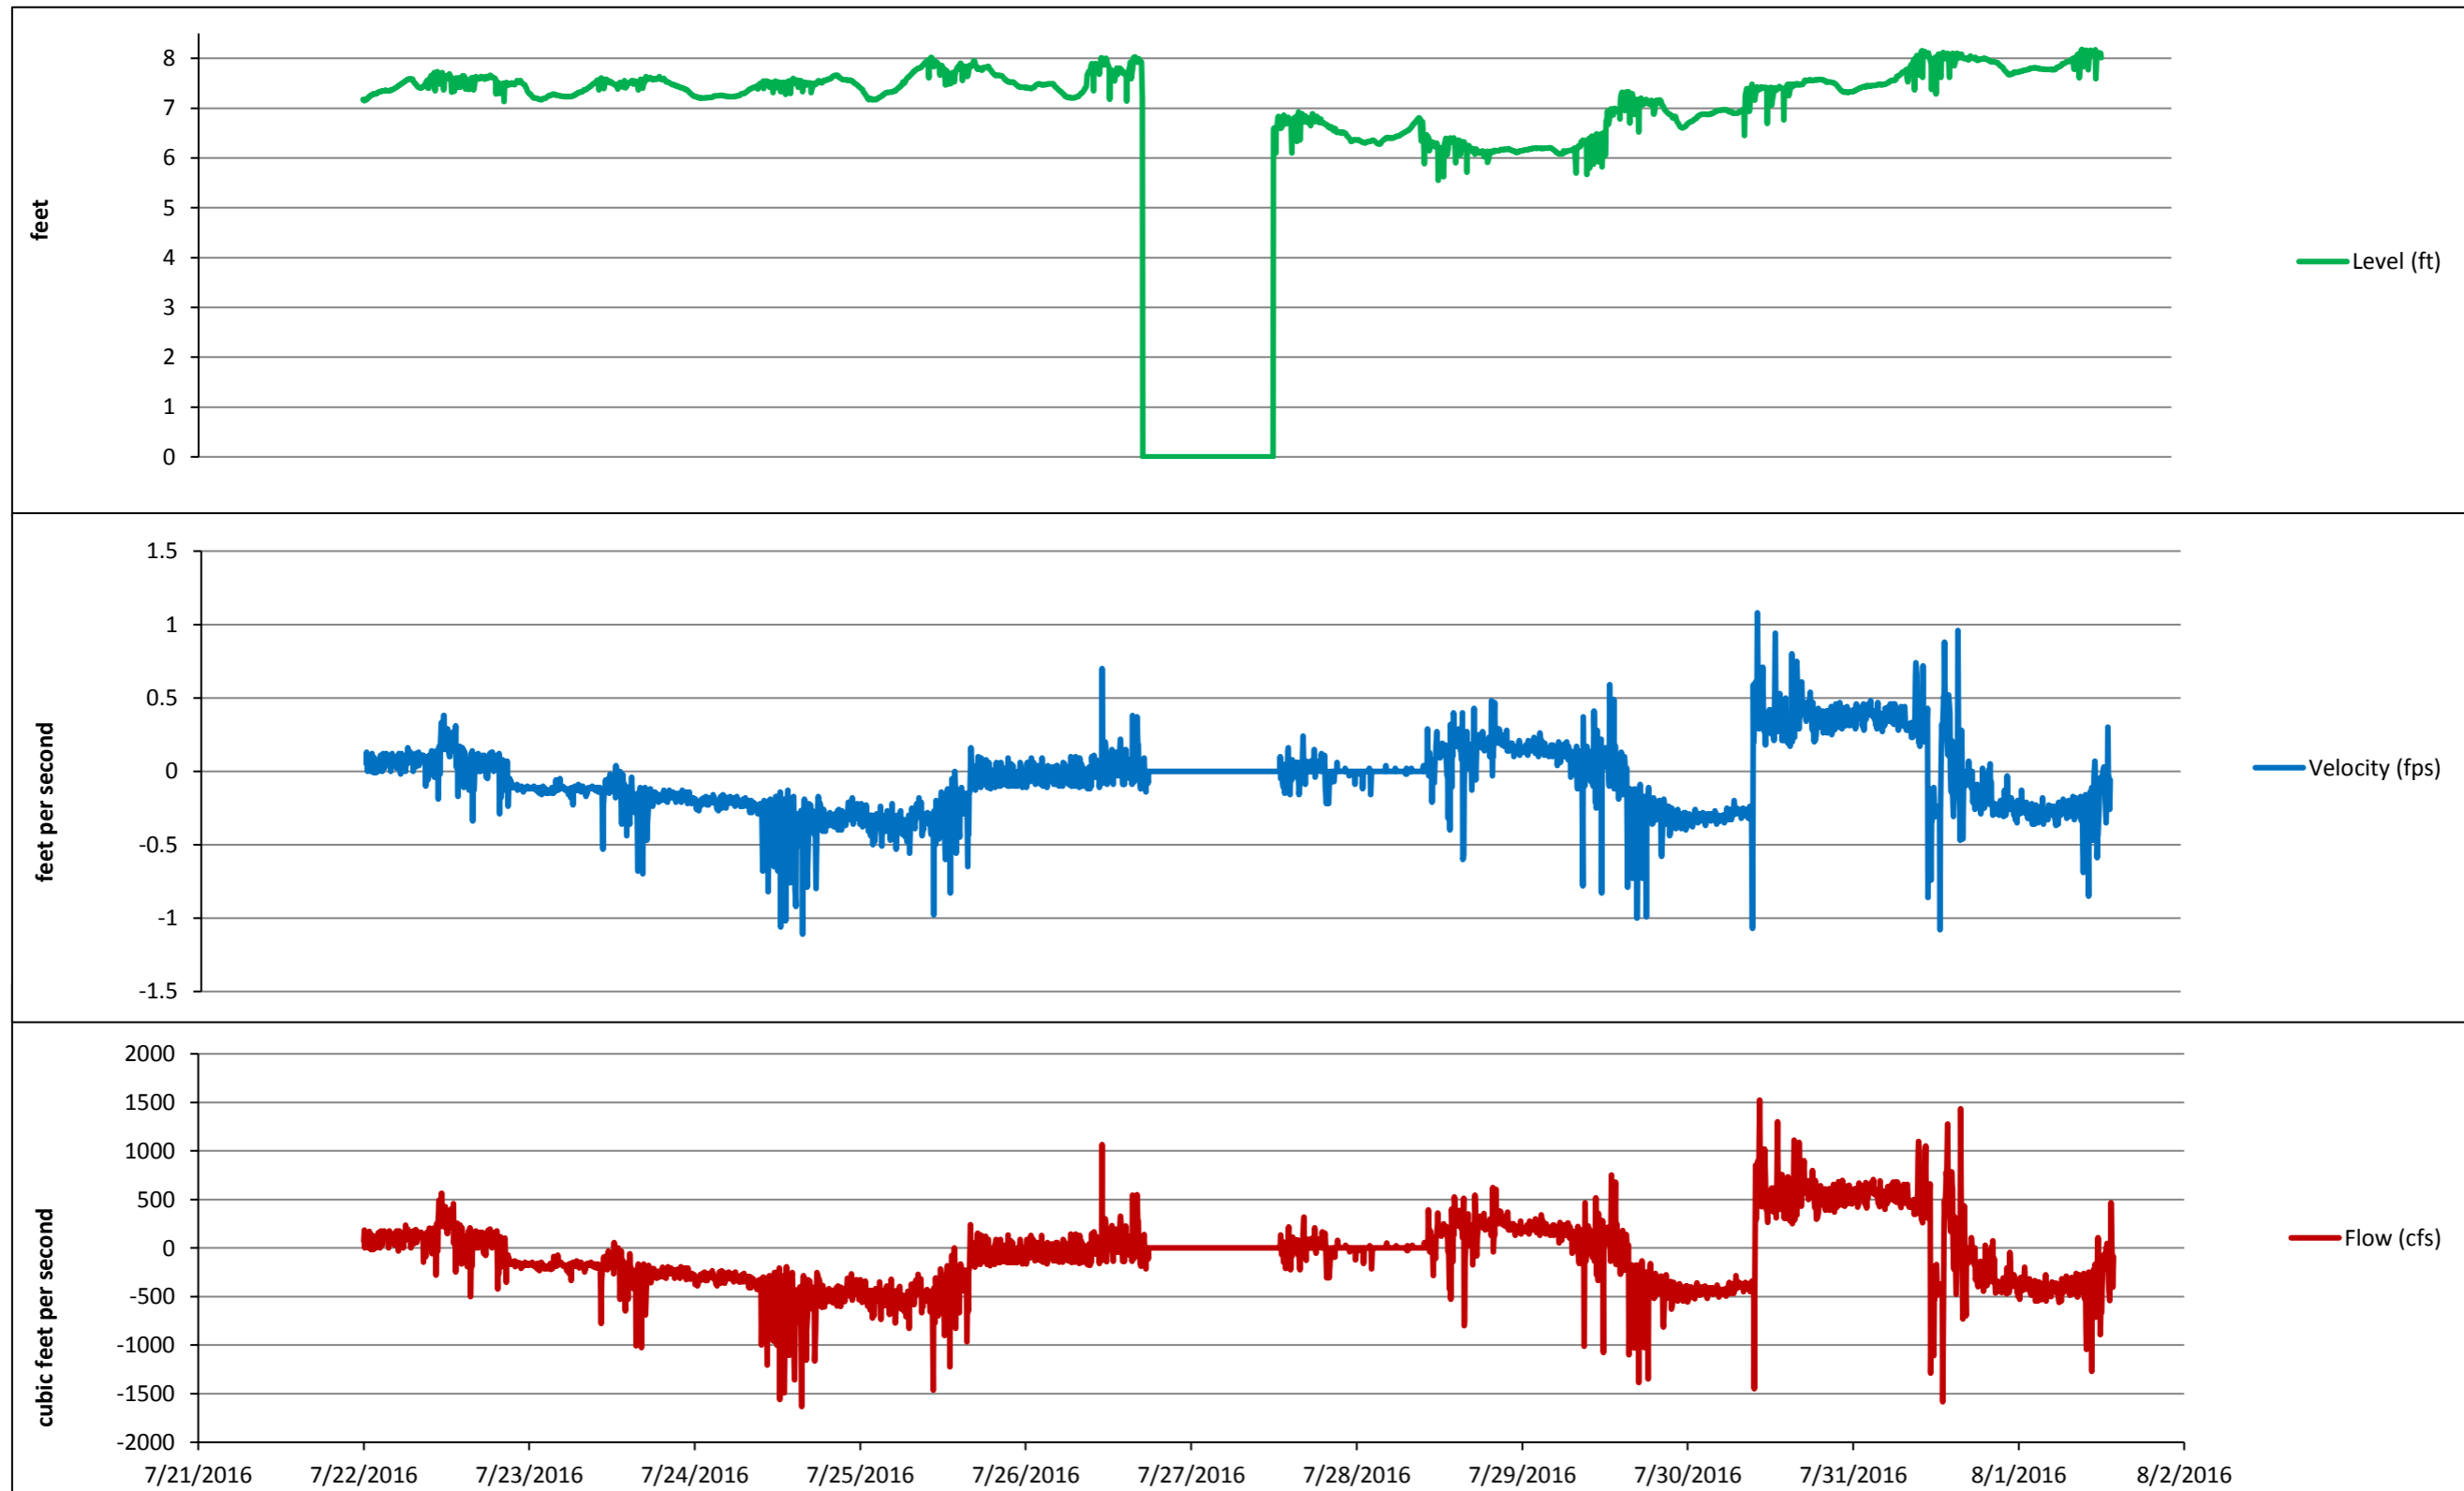
Summary Flow Data and Water Levels for Tonawanda Creek at Stevens St (July 22nd-August 1st, 2016)

Prior to the 48-hour treatment period, Canal Corp. ceased flows out of Lockport by closing the bypass gate opening at approximately 0930 hrs on July 26, 2016. As stated above, Canal Corp. reported that the Flight of Five lock gates had about 40 cfs leakage, and the City Hall gate had about 20 cfs leakage). Canal Corp. minimized lock operations, which continued during the treatment period. Typically, when Locks 34/35 are filled, this causes a short-term increase in flow rate towards the locks at the Stevens Street Bridge (north) and a drop in water level. However, lock fills were not observed in the level data obtained near the Stevens Street Bridge and, therefore, had minimal effects on flow rates (see Appendix D). The bypass gate was reopened at approximately 1050 hours on July 28, 2016.
