**Final Post-Treatment Assessment
for Aquatic Plant Control
ERDC Demonstration Project
Tonawanda Creek/Erie Canal
2018**

Contract No. W912P4-16-D-0002

January 2019

**US Army Corps
of Engineers®**
Buffalo District
BUILDING STRONG®

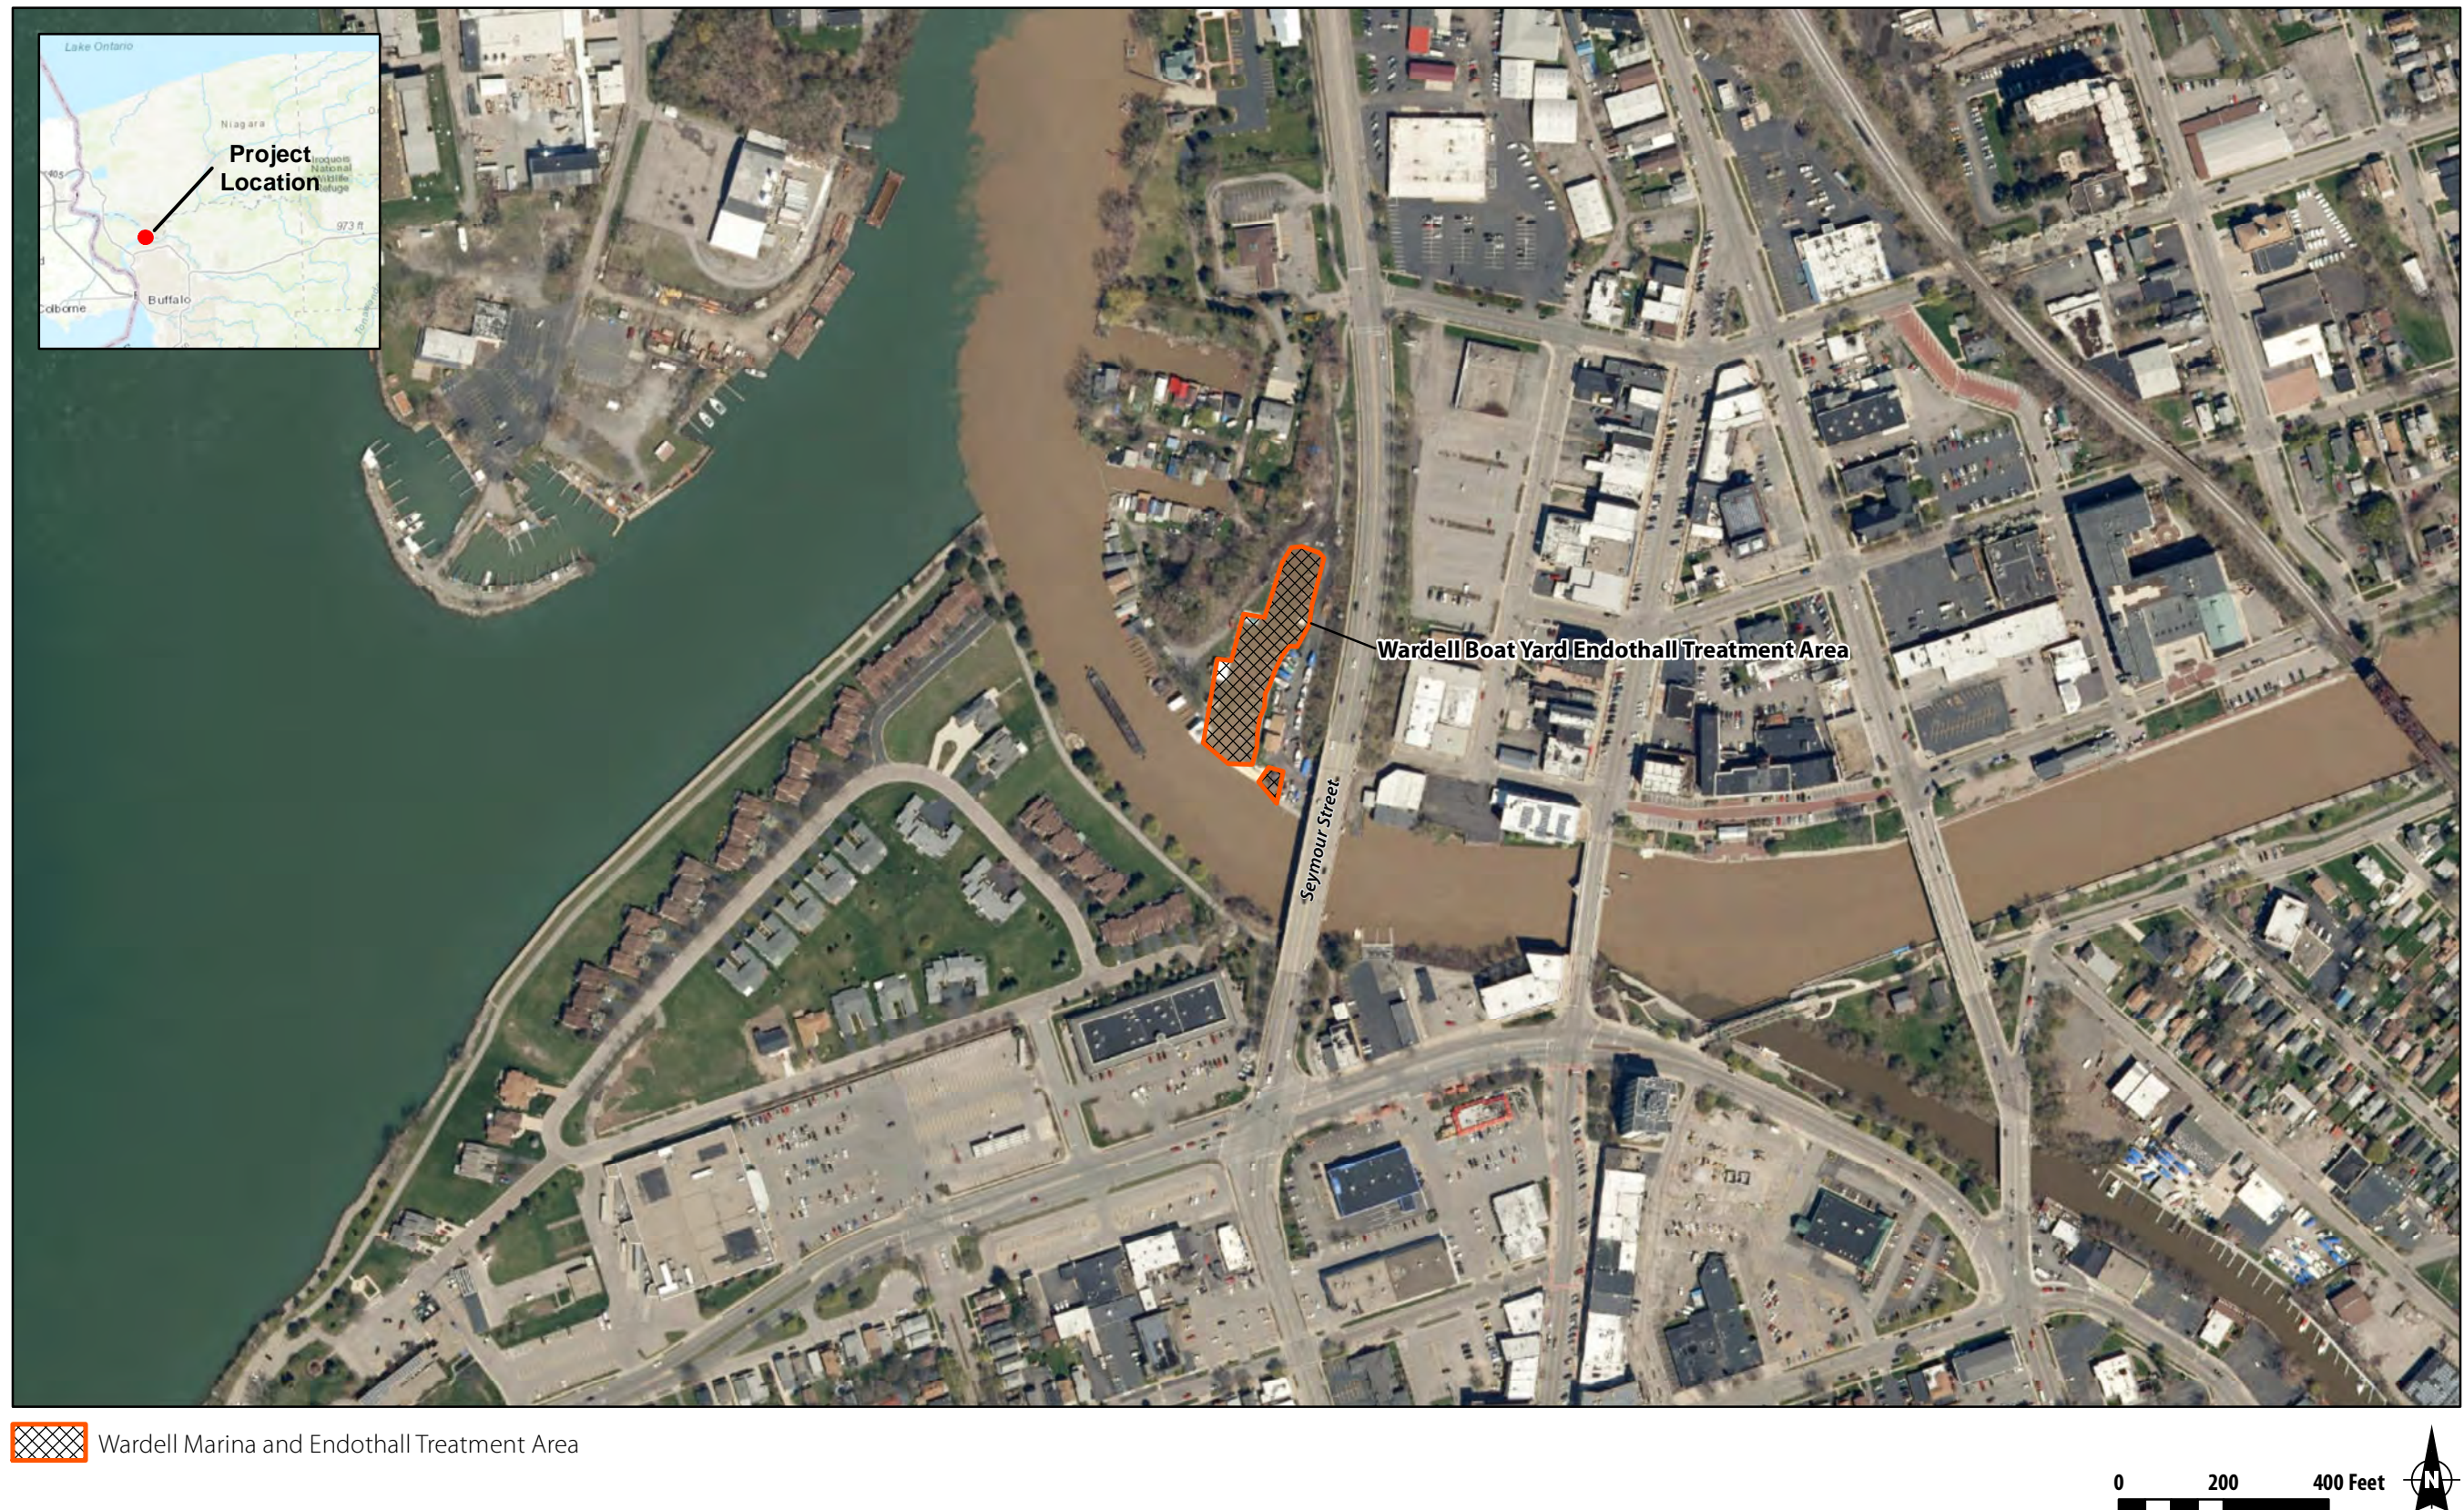
Figure 2-1 Wardell Marina Endothall Treatment Areas

Before treatment began, a limnocorral was installed in the Wardell Marina and the area was treated using a hand-held spray gun. This area was isolated with a 60-foot-long, floating limnocorral secured to the creek bottom with cinder blocks and to the shoreline on each end. The limnocorral extended from above the surface of the water to the creek/canal bed in order to isolate the Hydrilla bed from the surrounding flowing water. SLM noted on July 25, 2018, that the limnocorral had been cut away from the shore and was addressed in the field. The limnocorral then remained in place until SLM removed it on September 5, 2018.

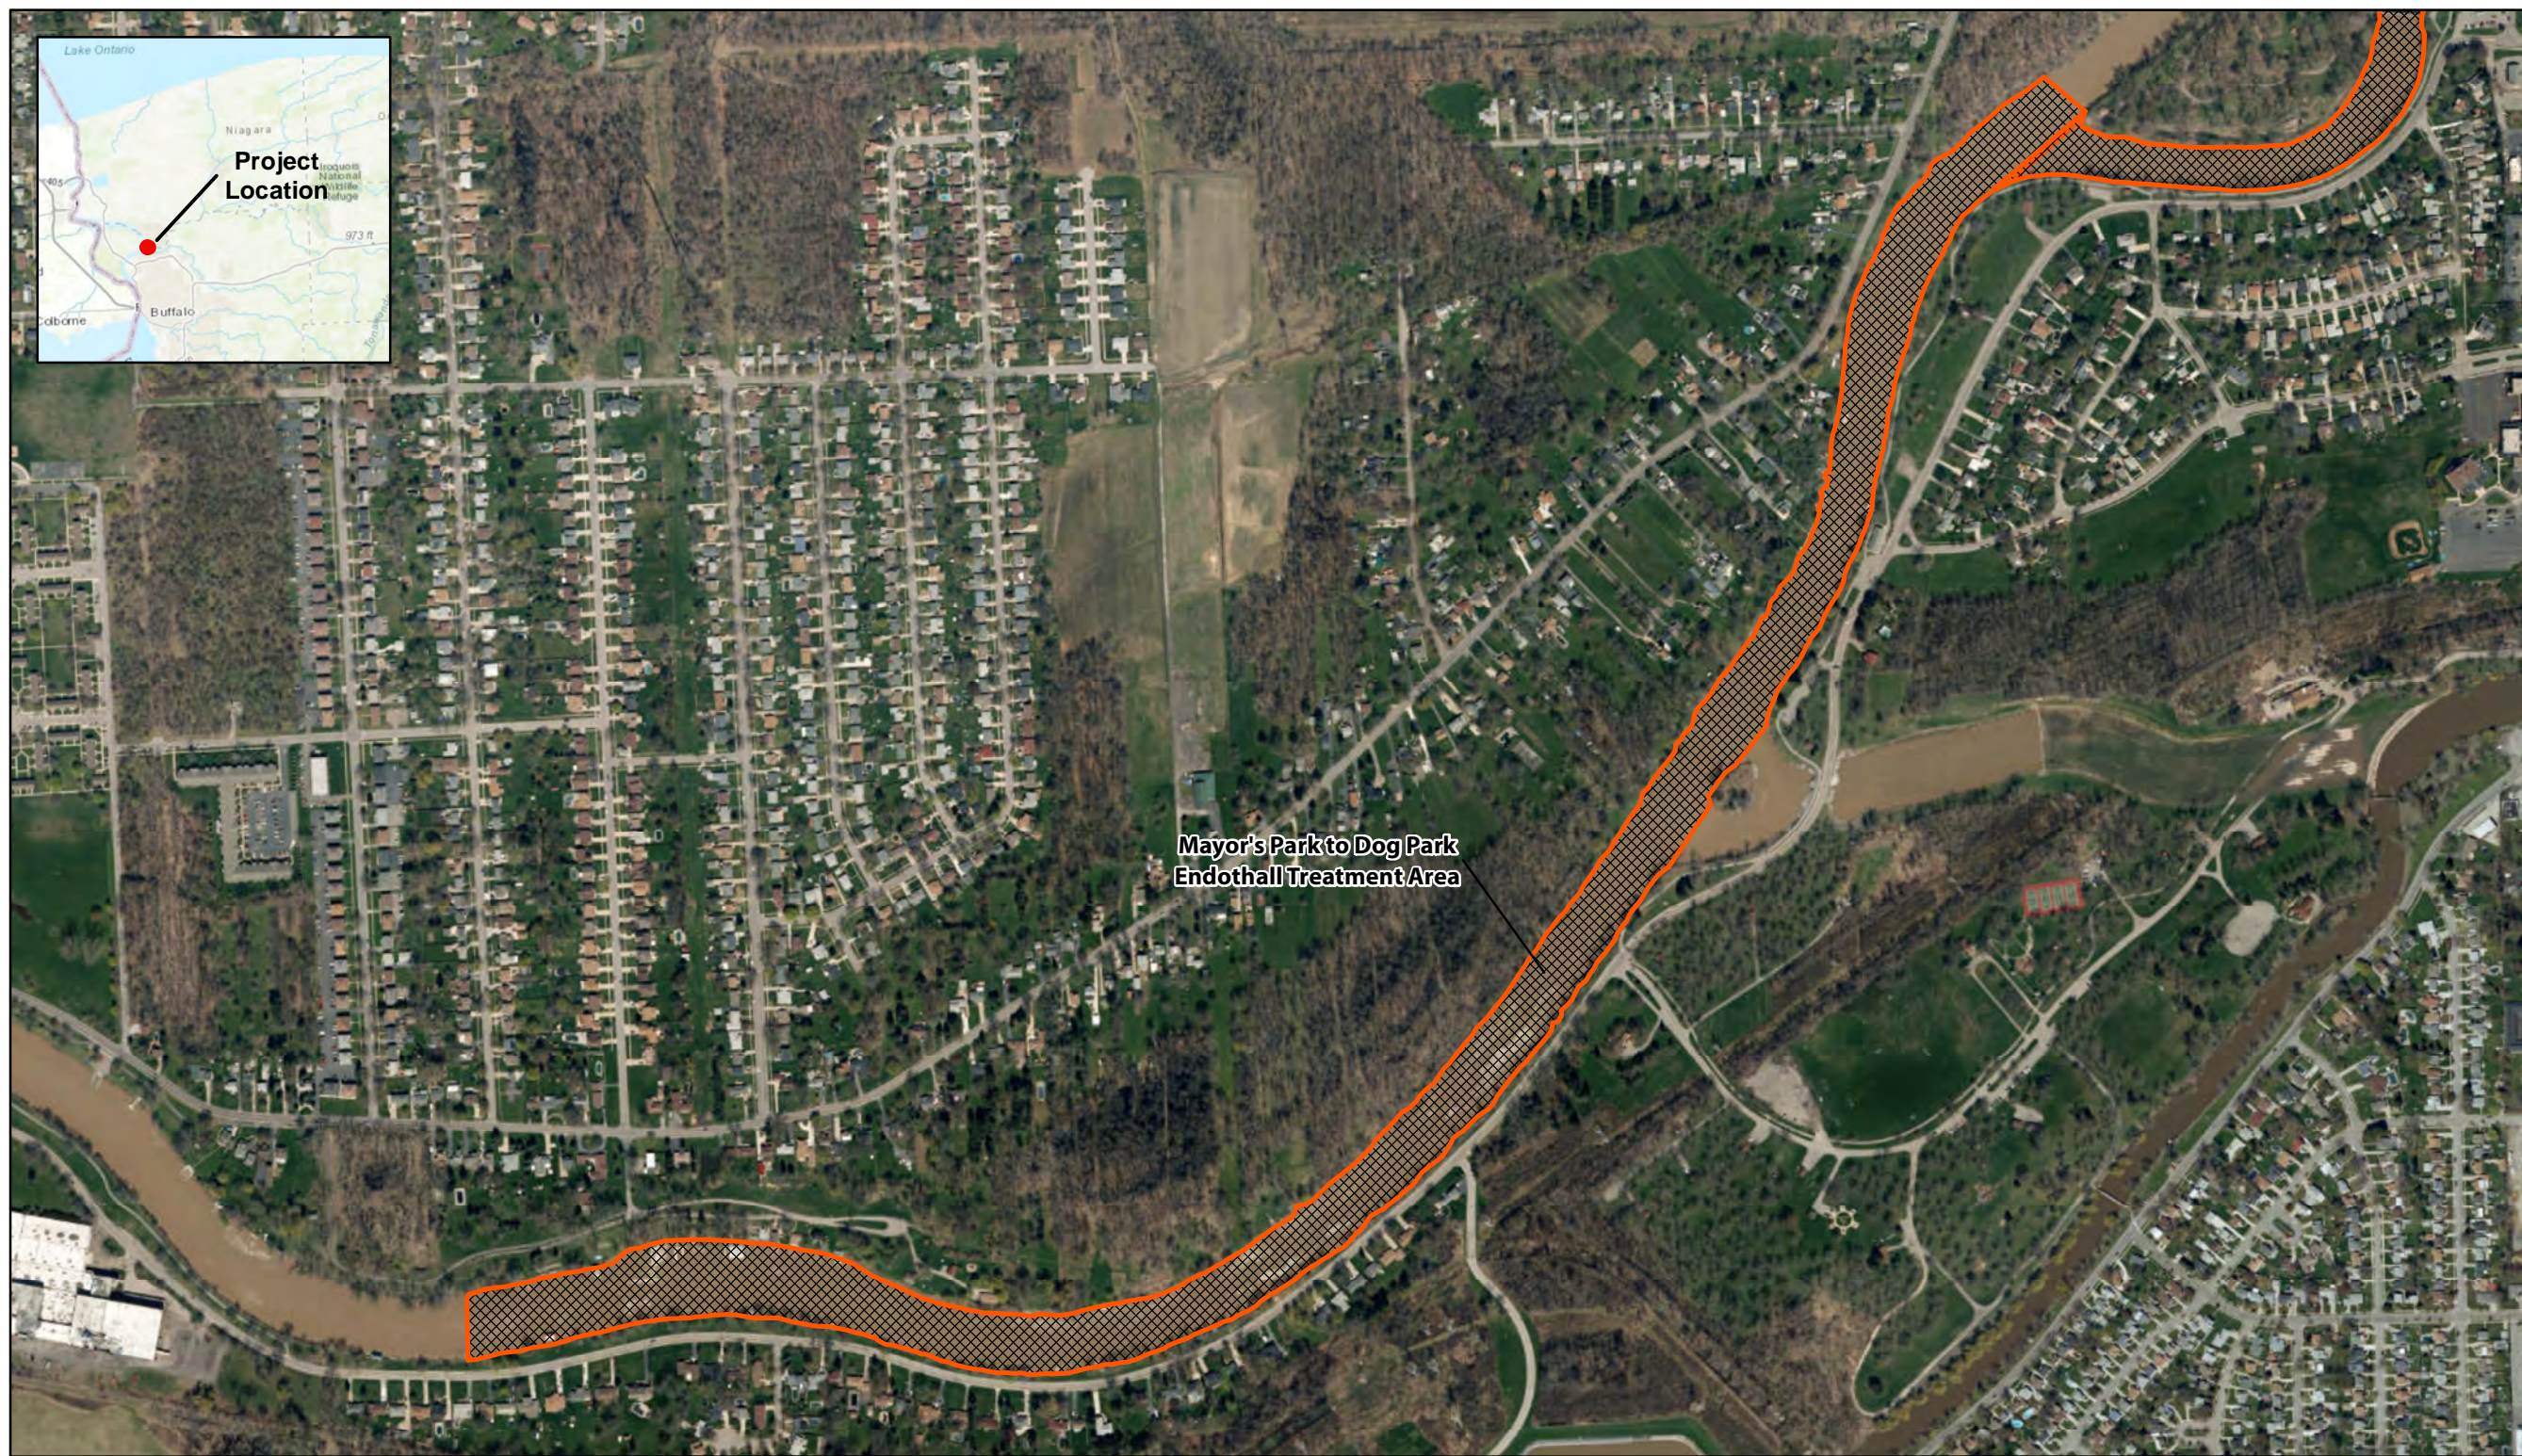
Figure 2-2 Mayor's Park to Dog Park Endothall Treatment Area
Tonawanda Creek, Erie and Niagara Counties, New York

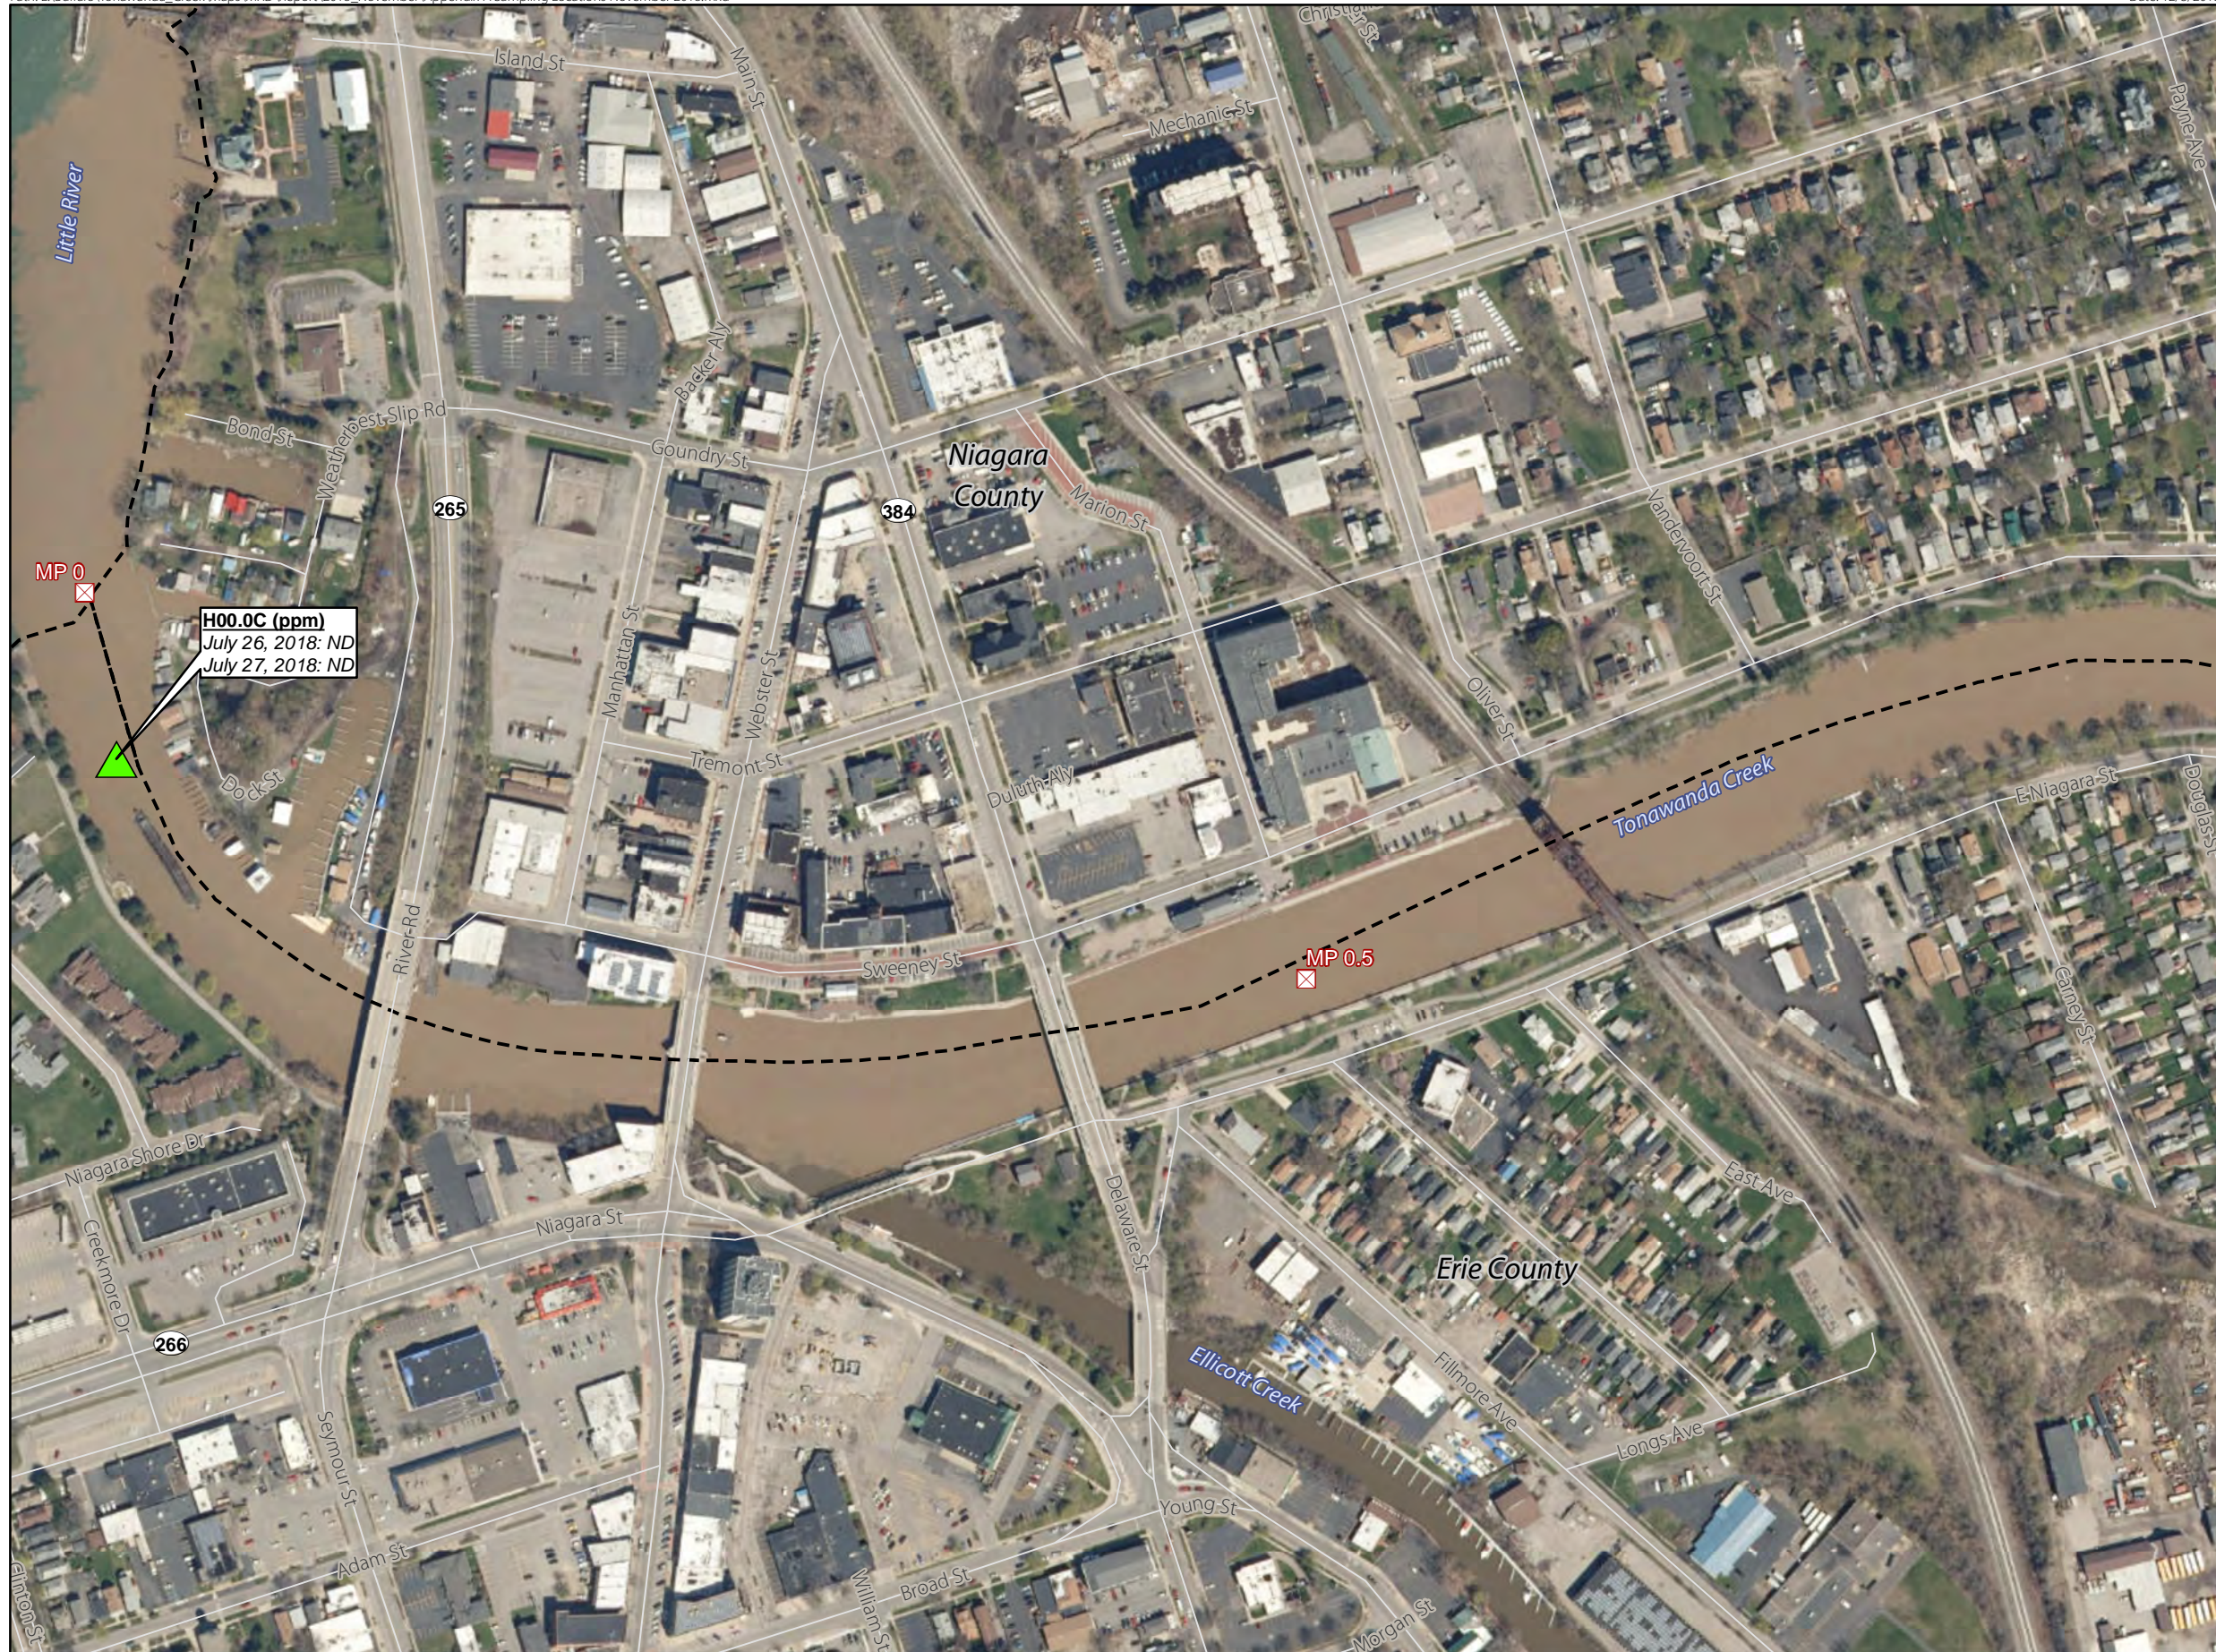
Water Sample Locations and Associated Herbicide Concentration Values
Figure A1
 Tonawanda Creek/Erie Canal
 Erie and Niagara Counties, New York

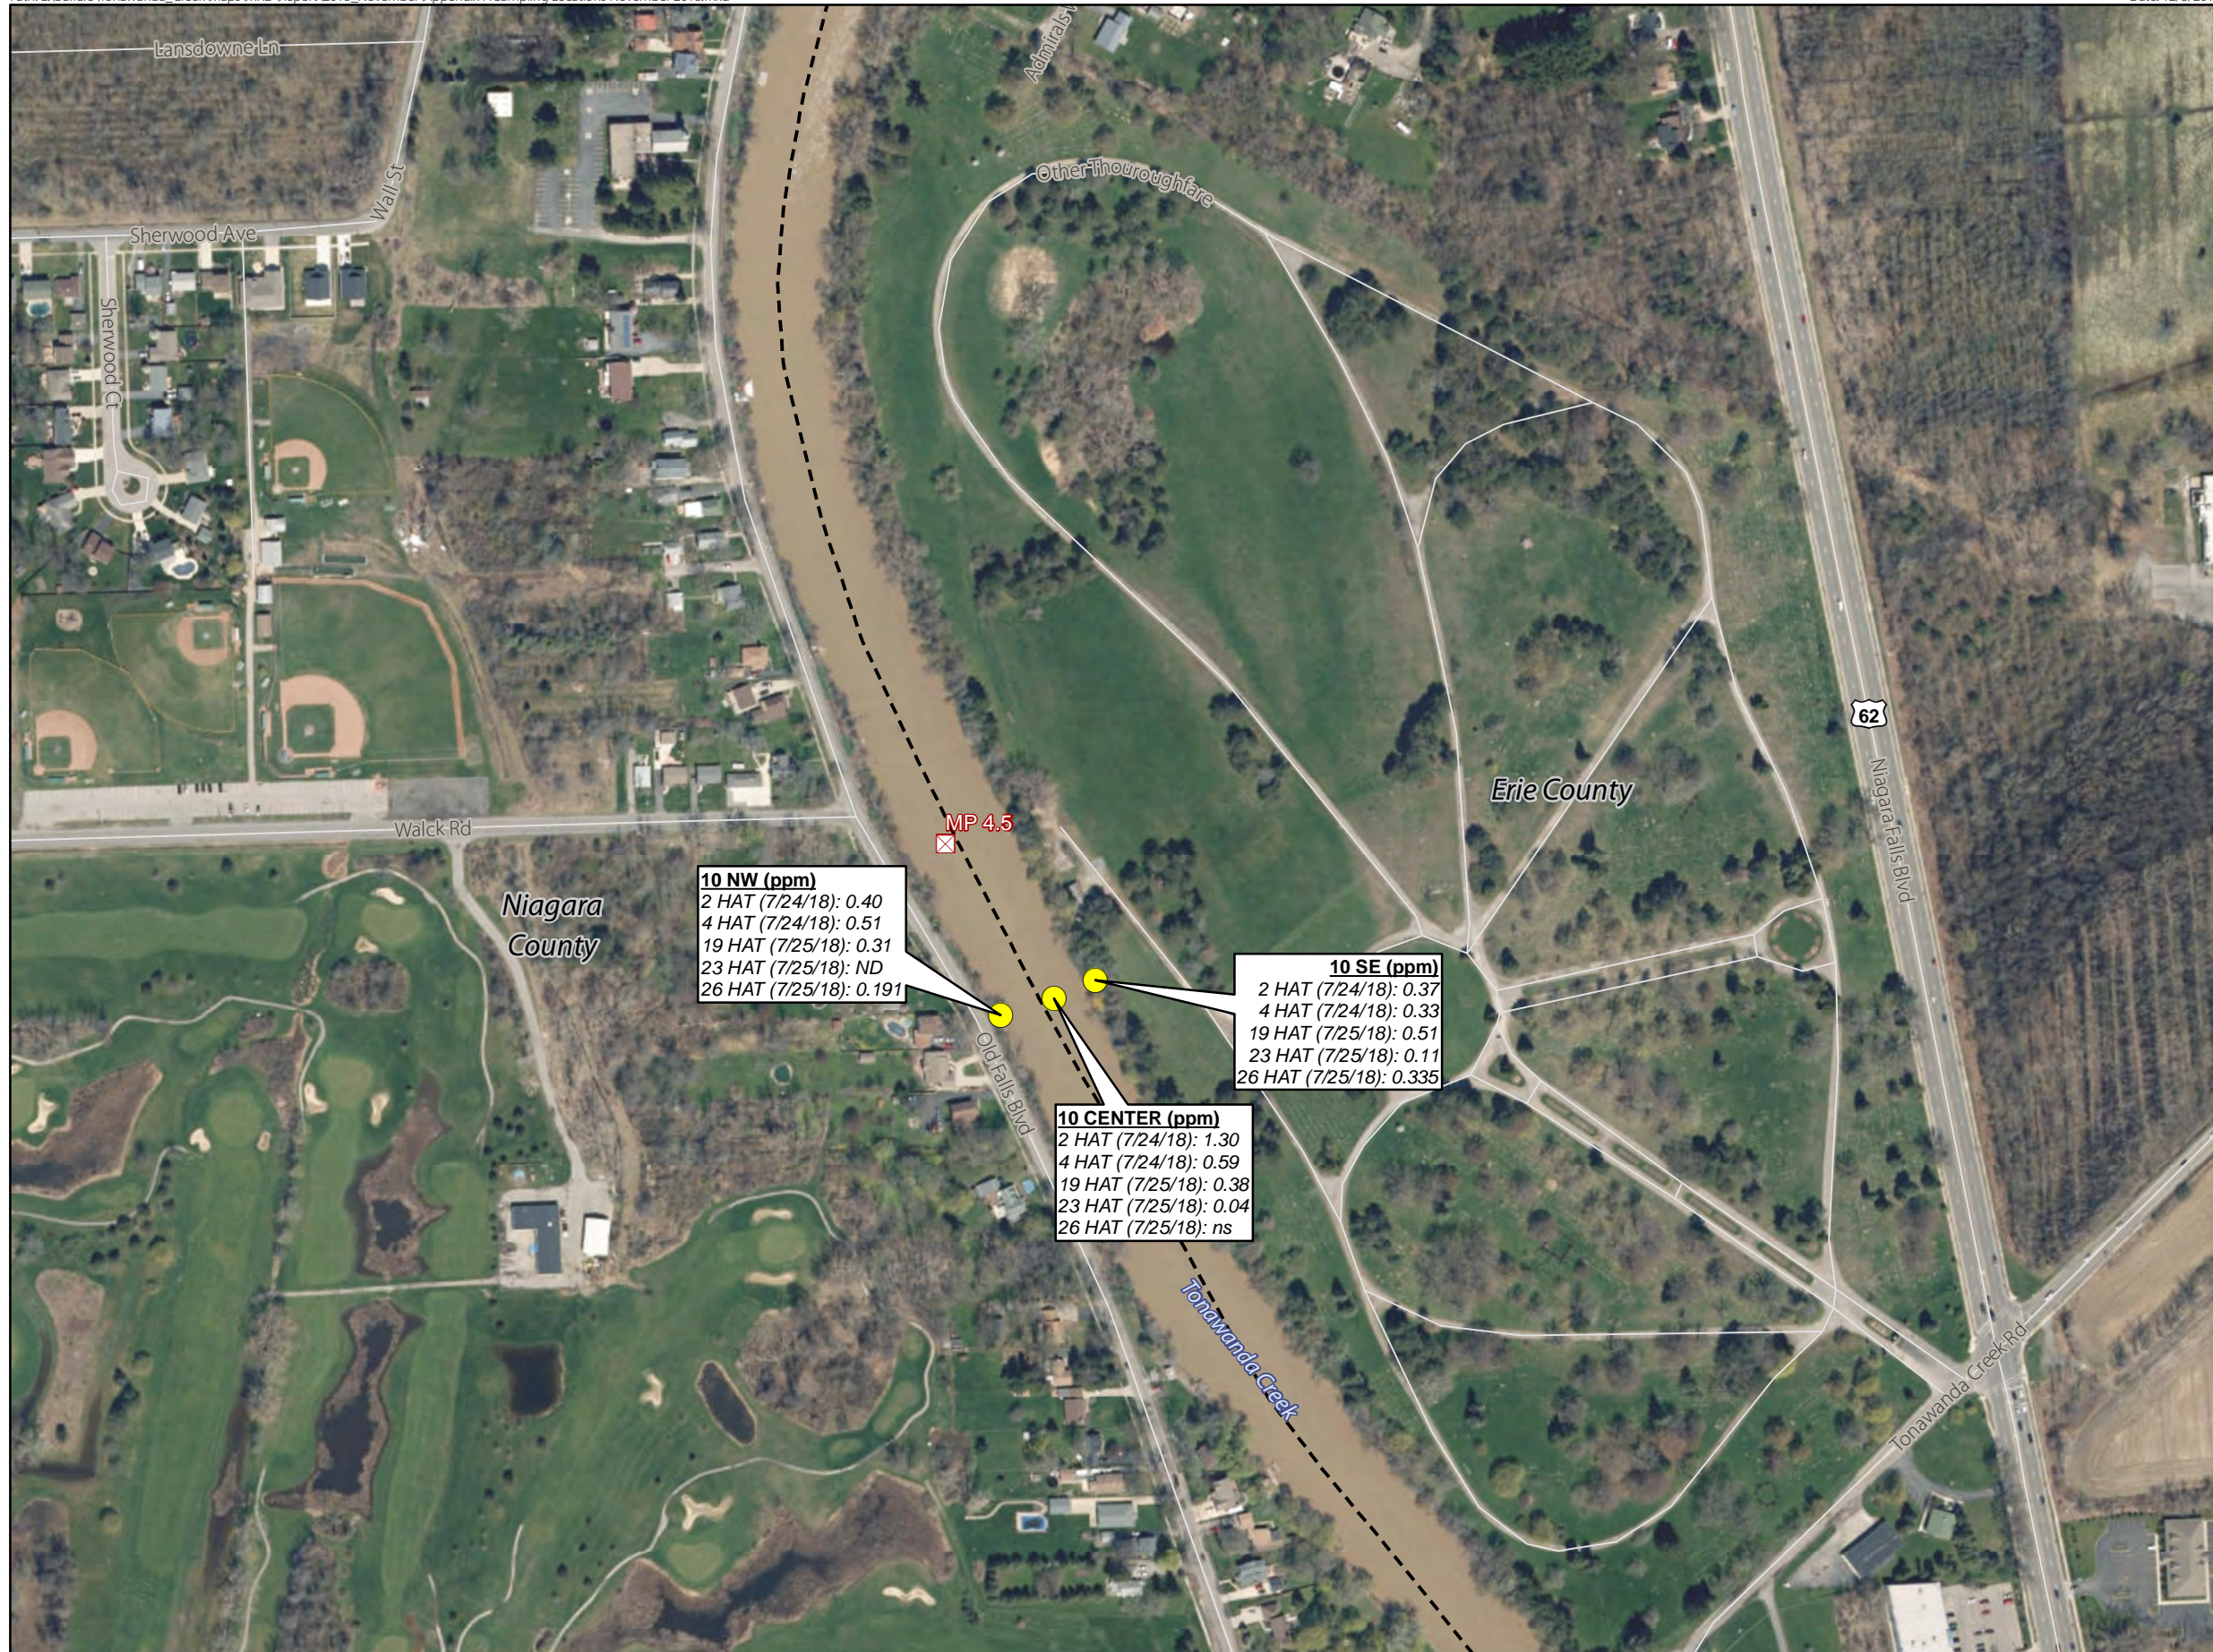
10 NW (ppm)
 2 HAT (7/24/18): 0.40
 4 HAT (7/24/18): 0.51
 19 HAT (7/25/18): 0.31
 23 HAT (7/25/18): ND
 26 HAT (7/25/18): 0.191

10 SE (ppm)
 2 HAT (7/24/18): 0.37
 4 HAT (7/24/18): 0.33
 19 HAT (7/25/18): 0.51
 23 HAT (7/25/18): 0.11
 26 HAT (7/25/18): 0.335

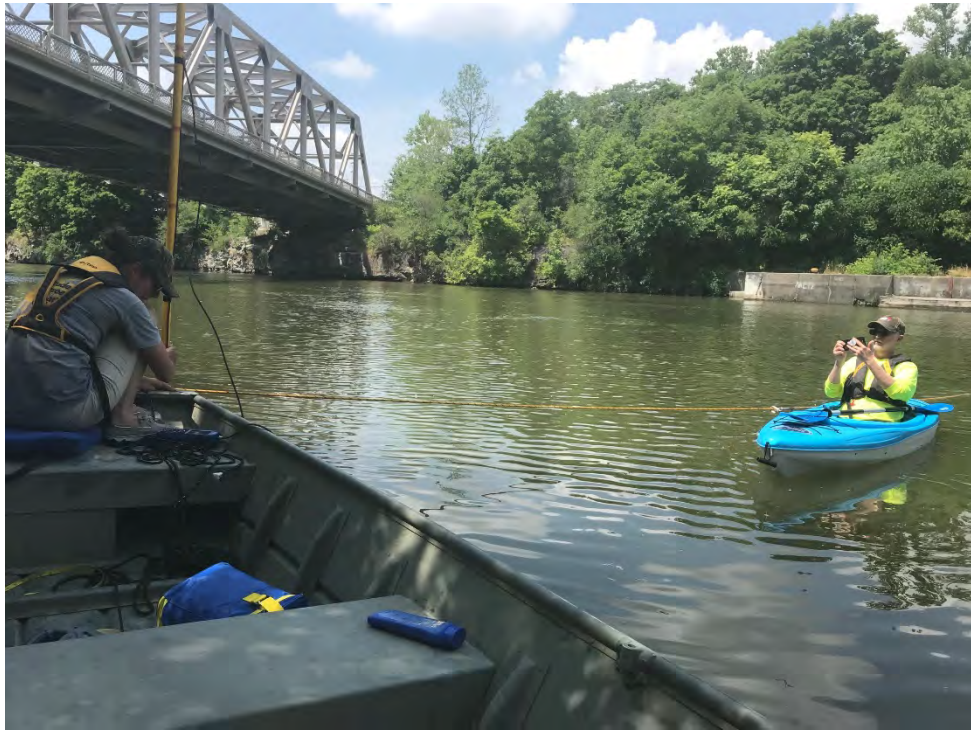
Photo 1 Velocity profiling, July 5, 2018.

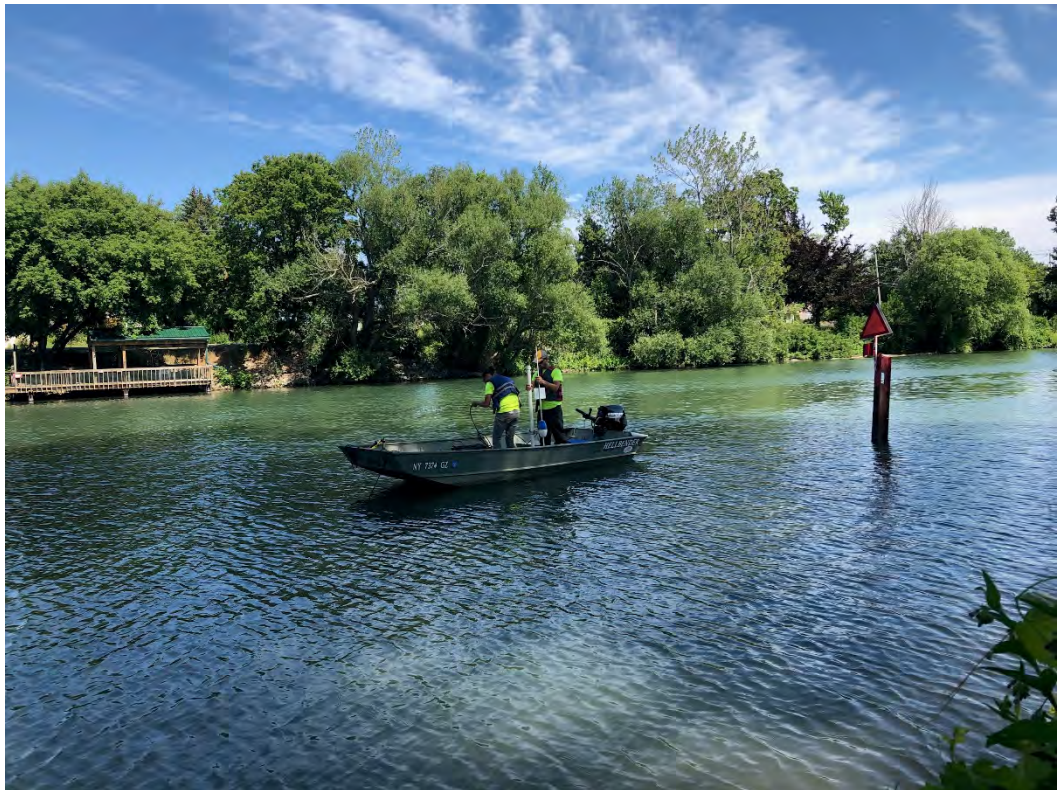
Photo 2 Velocity profiling, July 5, 2018.

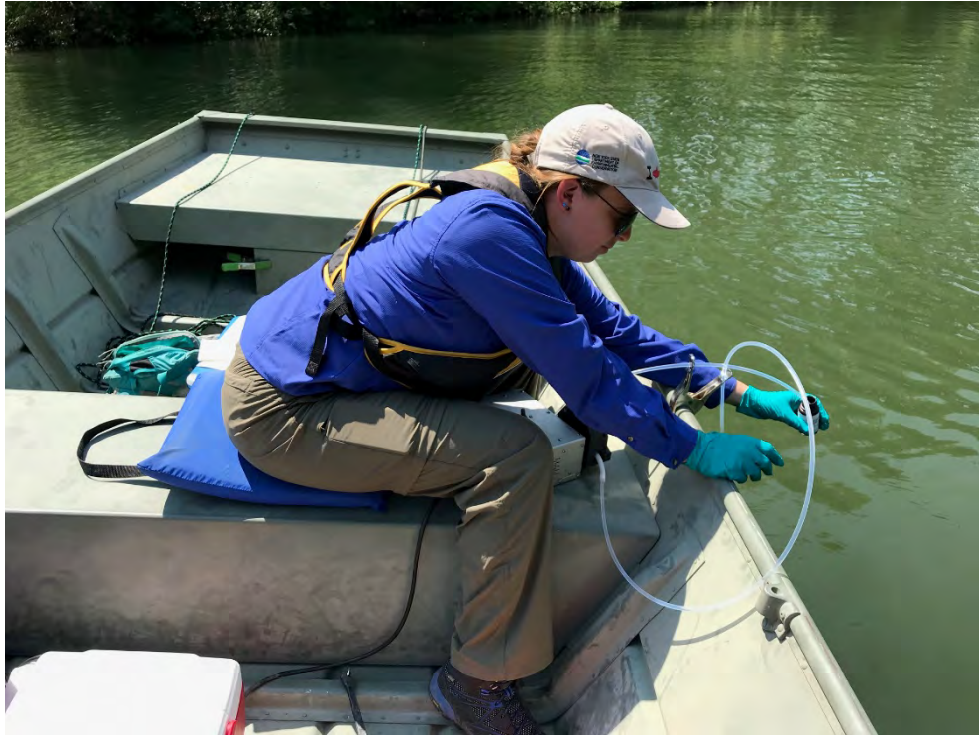
Photo 3 Water sampling July 28, 2018.

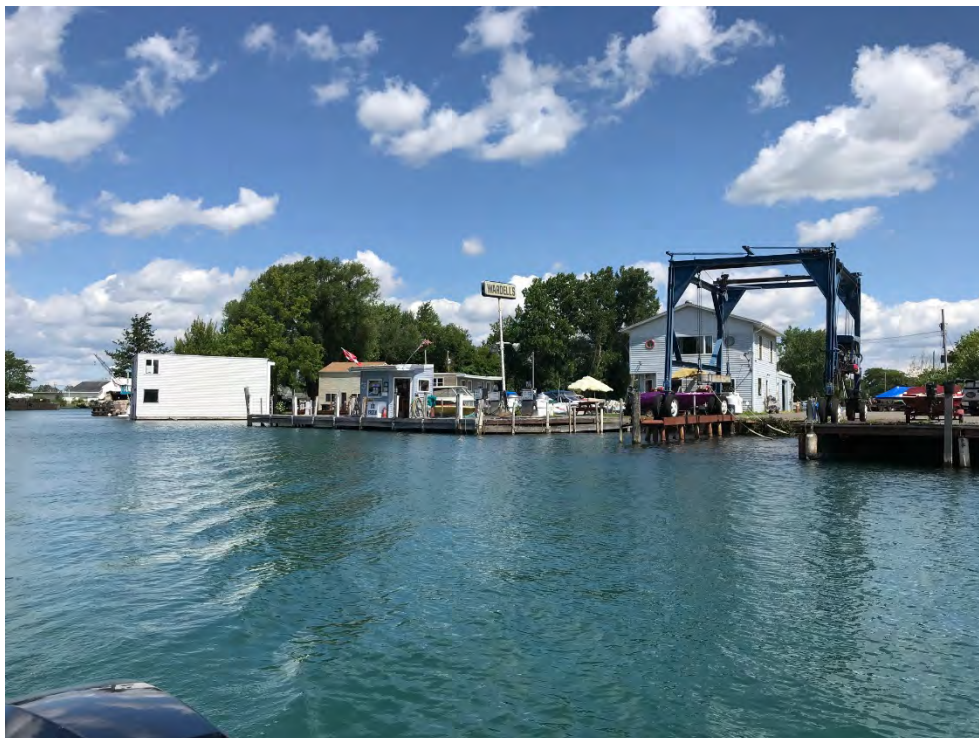
Photo 4 Water sampling near Wardell Marina, July 28, 2018.

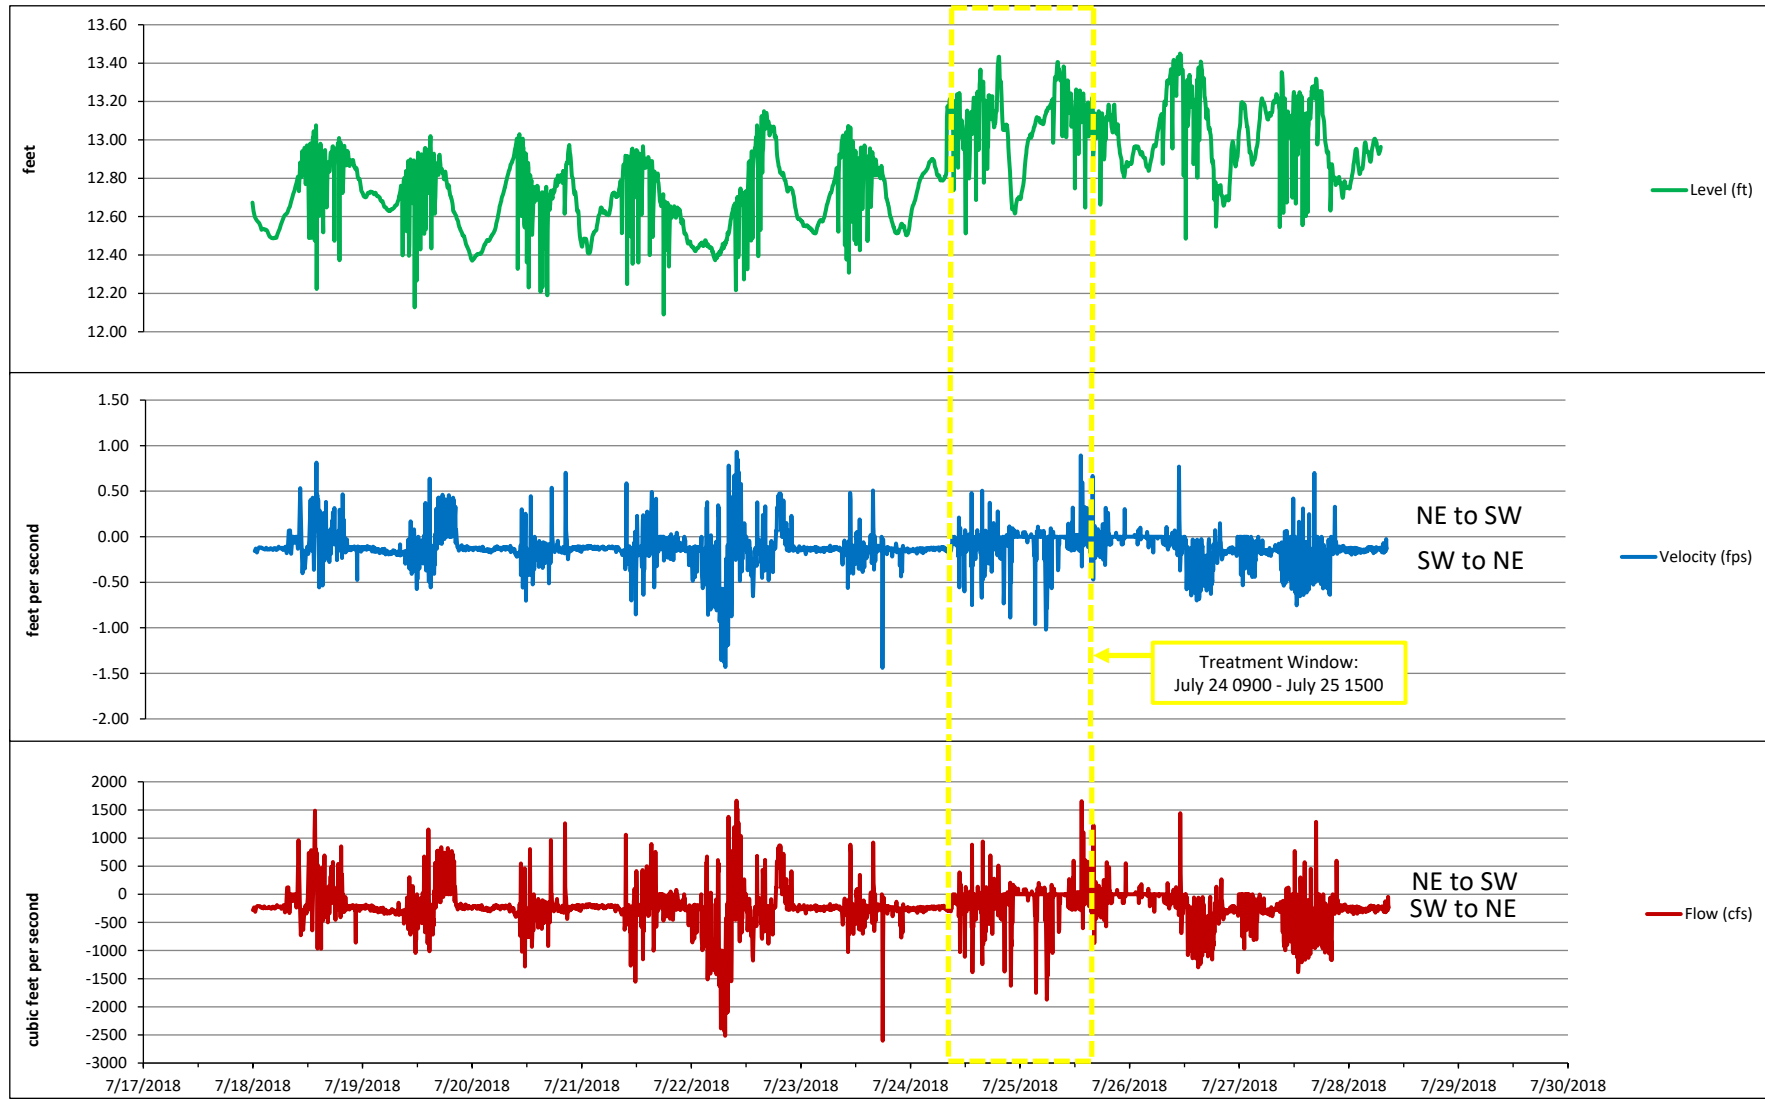
Summary of Flow Data and Water Levels for Tonawanda Creek at Stevens St (July 18th - July 28th, 2018)
