# *Monitoring and Detecting Hydrilla: Three Case Studies in New York and New Jersey*

By Chris Doyle, CLM  
*Director of Biology*

SÖLITUDE  
LAKE MANAGEMENT

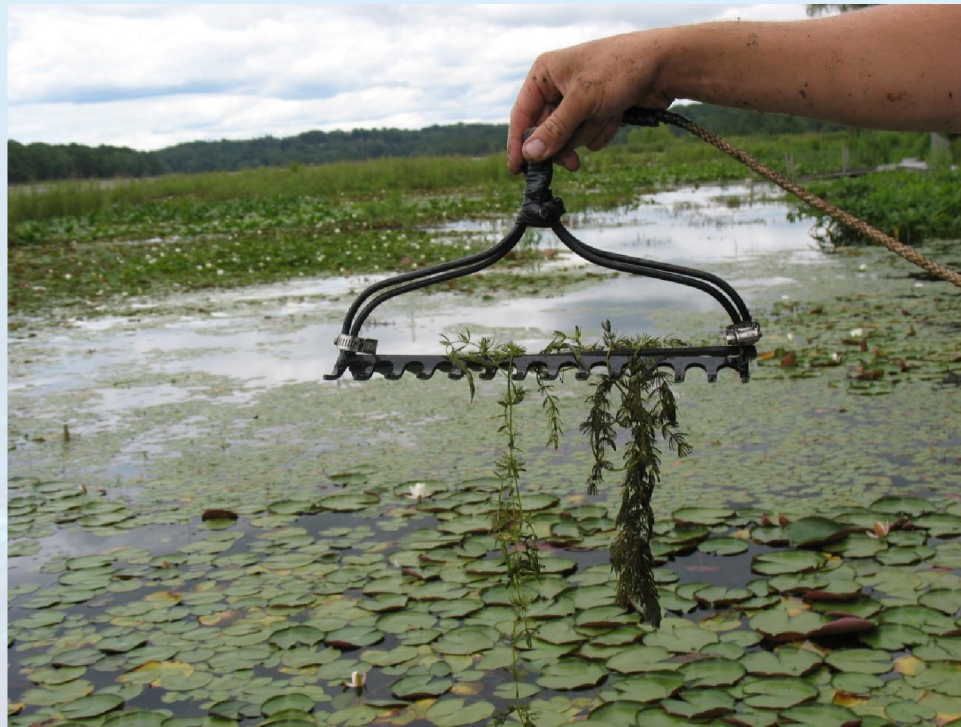
- **Developed by ACOE**
  - Modified by Cornell University
  - Tweaked by SLM
- **Accepted Methodology by Regulators**
  - Recommend one survey location/hectare
  - I prefer 1+ location per littoral zone acre (~100-125/day)
- **Assign Plant Mass Densities**
  - No plants, trace, sparse, medium, dense
  - Assigned to overall submersed plants
    - Then assigned to each different plant species

Abundance	Abundance #	Dry Weight (g/m <sup>2</sup> )	Mean Weight (g/m <sup>2</sup> )	Description
No Plants (“0”)	0	0.0	0.0	Bare Rake
Trace (“T”)	1	~0.0001-0.9999	0.5	Finger-full
Sparse (“S”)	2	~1.0000-24.9999	13.0	Hand-full
Medium (“M”)	3	~25.0000-99.9999	62.5	Covers Rake
Dense (“D”)	4	~100.0000-400.0000+	250.0	Difficult to get plant mass into the boat

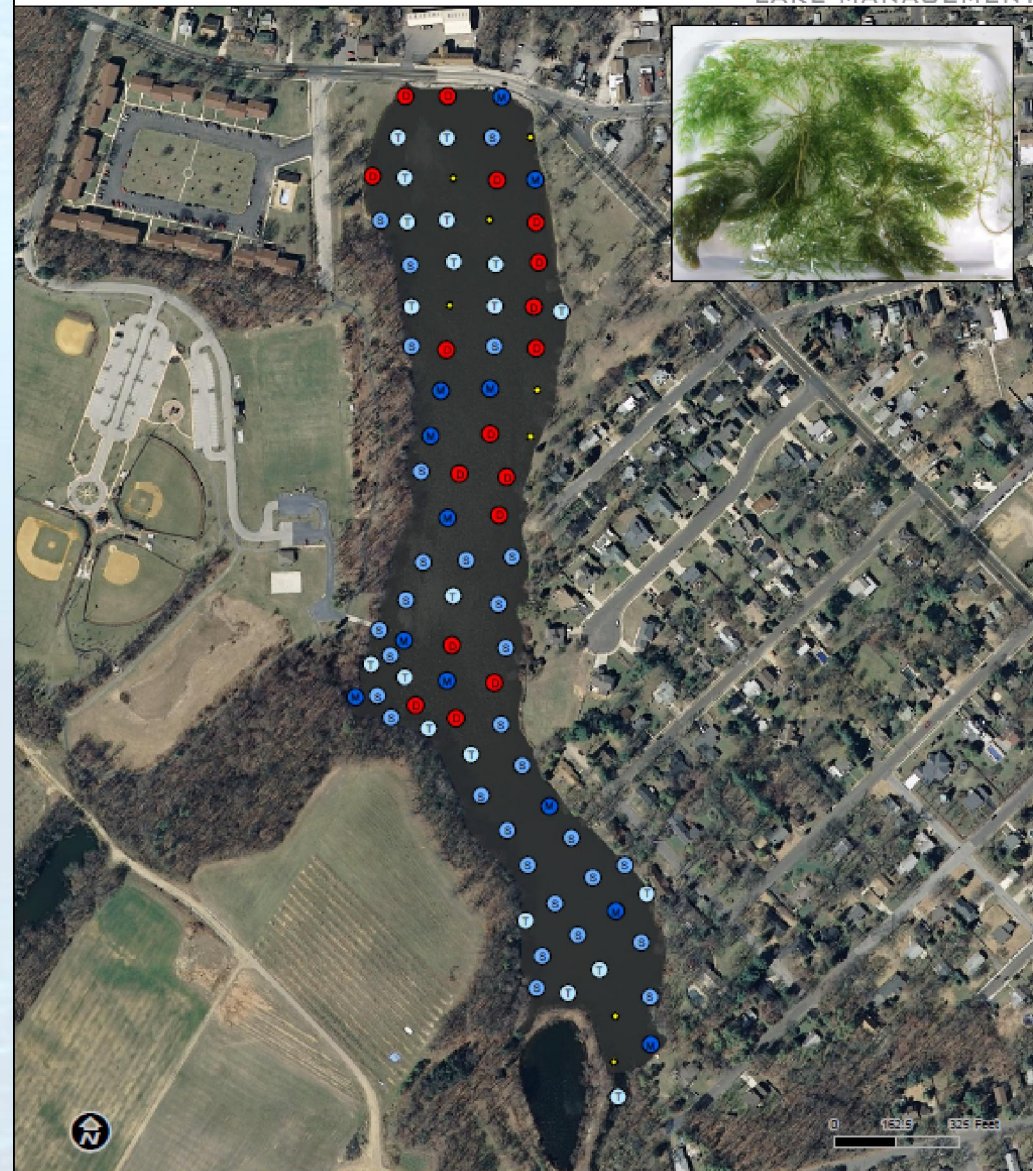
ALCYON LAKE  
Aquatic Vegetation Survey  
August 28, 2014

67 sampling points

Plant Density

- = No Plants
- = Trace Plants
- = Sparse Plants
- = Medium Plants
- = Dense Plants

Percent Distribution

Abundance	Sites	Percent
Total	79	91%
Trace	20	25%
Sparse	30	38%
Medium	12	15%
Dense	17	22%

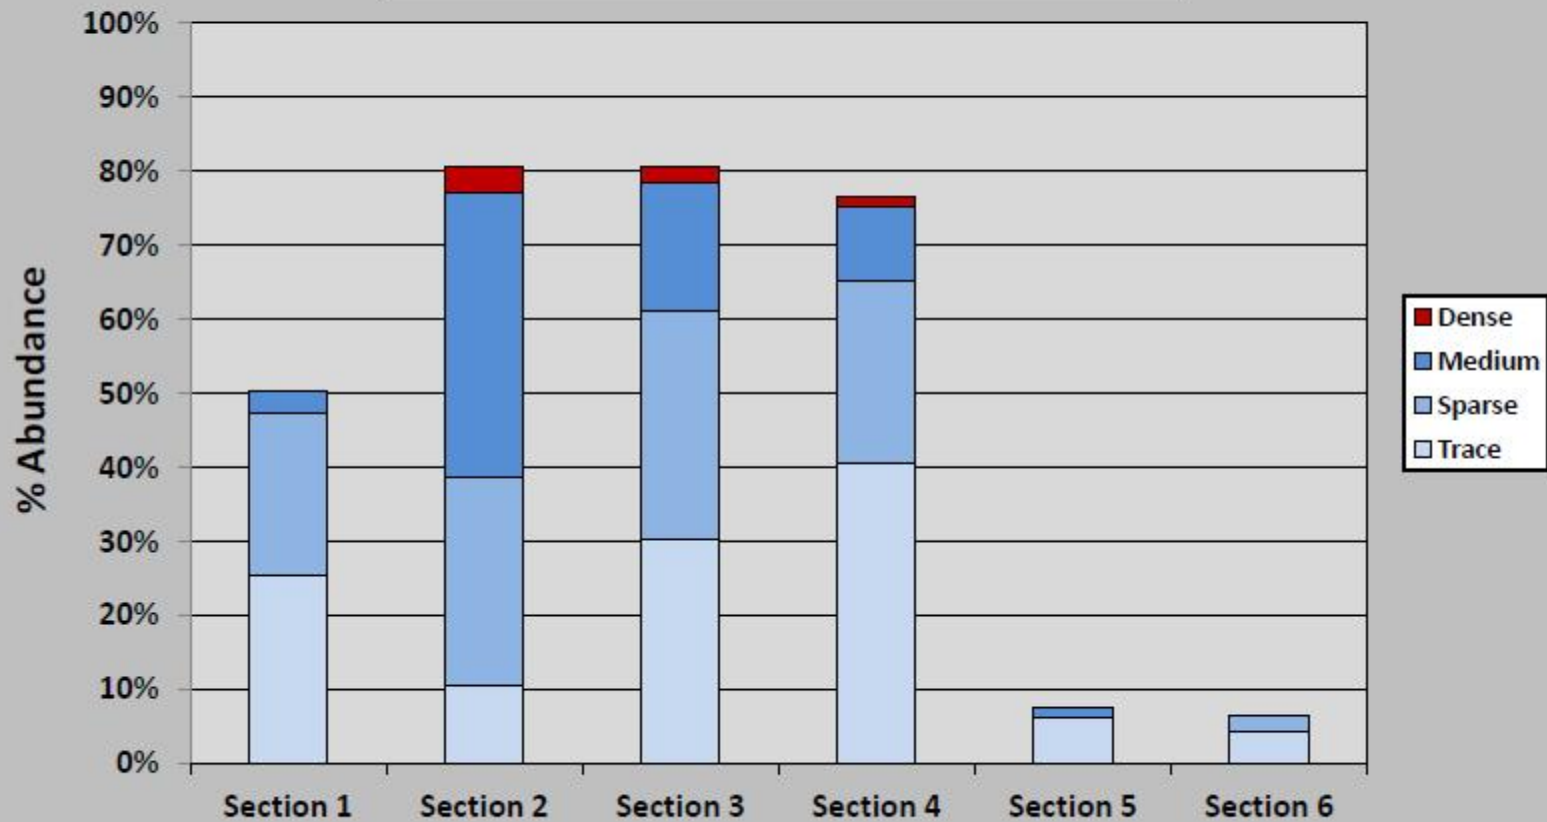
**Wild Celery (*Vallisneria americana*)**  
**Percent Abundance by Section**  
**D&R Canal**

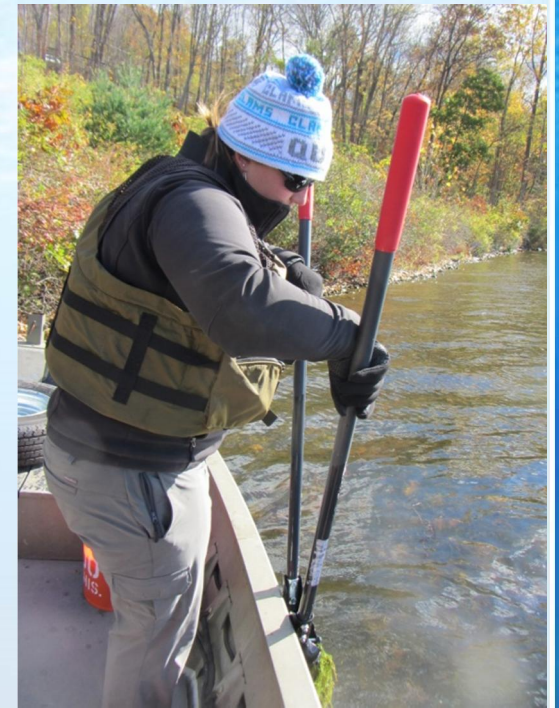
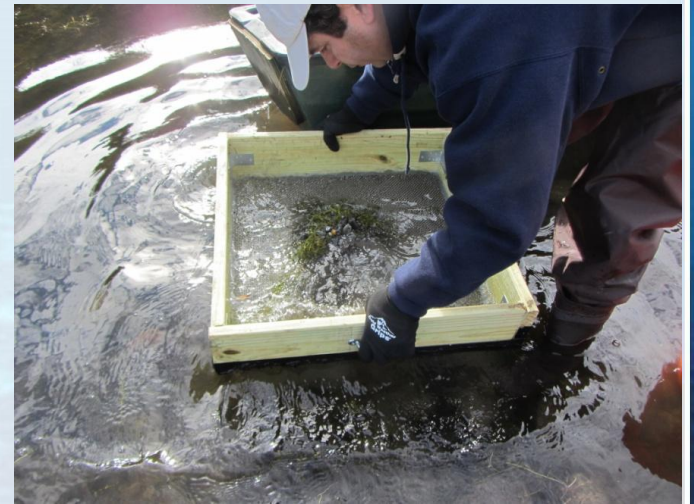
# Hydrilla Tuber Monitoring

## Hydrilla Tuber Density

- Hydrilla tuber density over time
- Based on methods described by Johnson (2013) and NC State
- Post Hole Digger
  - 187 cm<sup>2</sup> plug
  - Calculate tubers/m<sup>2</sup>
- Increase # cores over time

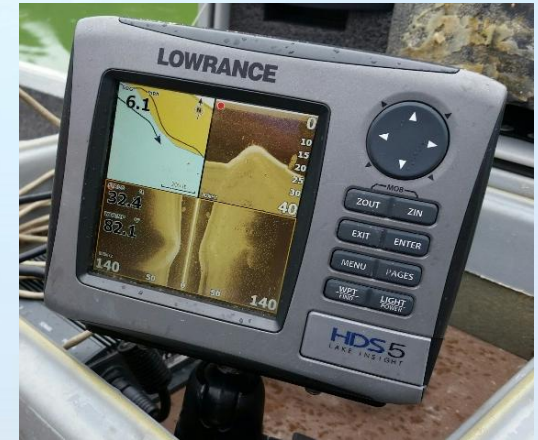
# Phase 1: Hydroacoustic Plant Mapping

## 1. Side Scan Fathometer

## 2. Data Collection

- Late August
- Boat Speed: > 8 mph
- Shorelines, coves and littoral zone
- 18 hours on water data collection
- 20-minute runs (file size)

## 3. Data Outputs

- Uploaded to Manufacturer Server (QC/Interpolation)
- Reprocessed with Spatial Analyst
- ArcMap 10.3
- Bathymetry and Bio-volume Maps

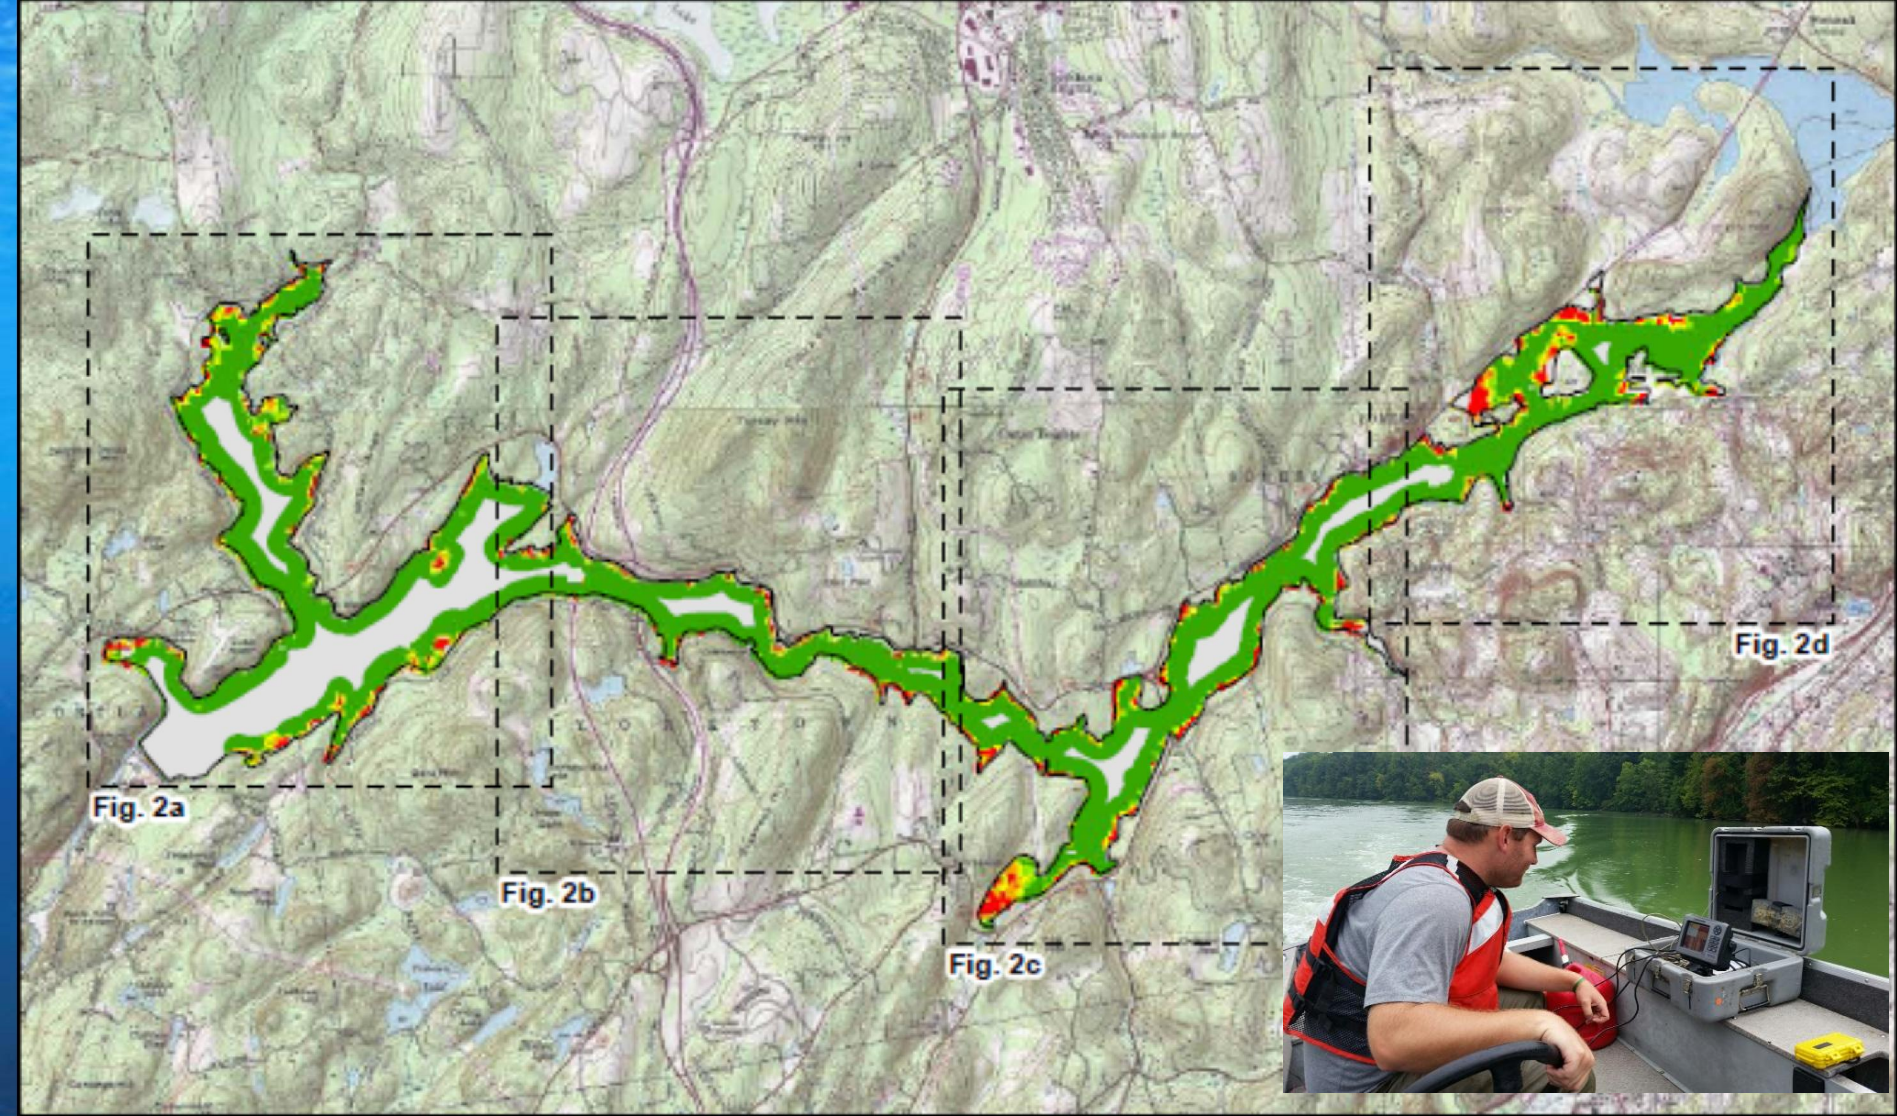
# Submersed Aquatic Plant Bio-volume

## 1. % of SAV in Water Column

- Ex. Plants at Surface = 100%
- Ex. Water Depth 10 ft.; Plant Height 5 ft. = 50%

## 2. Displayed in a Color Array

## 3. Doesn't Differentiate Species

**New Croton Reservoir**  
Westchester County, NY  
Biovolume

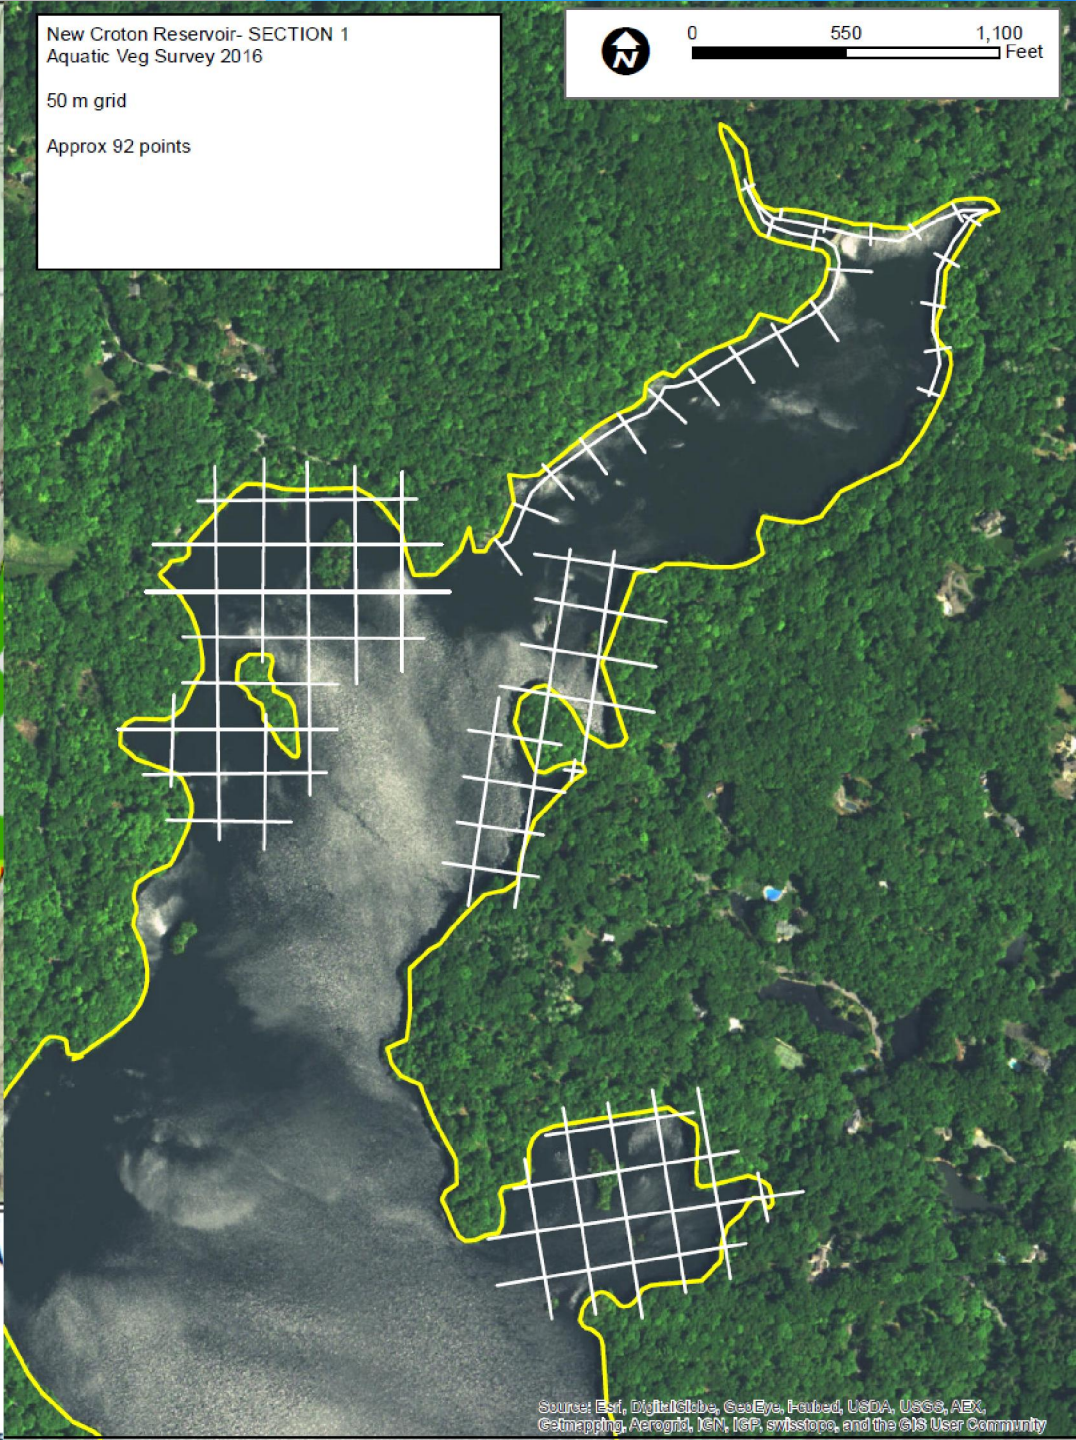
New Croton Reservoir- SECTION 1  
Aquatic Veg Survey 2016

50 m grid  
Approx 92 points

New Croton Reservoir- Overview  
Aquatic Veg Survey 2016

Sections 1-9

50 meters grid

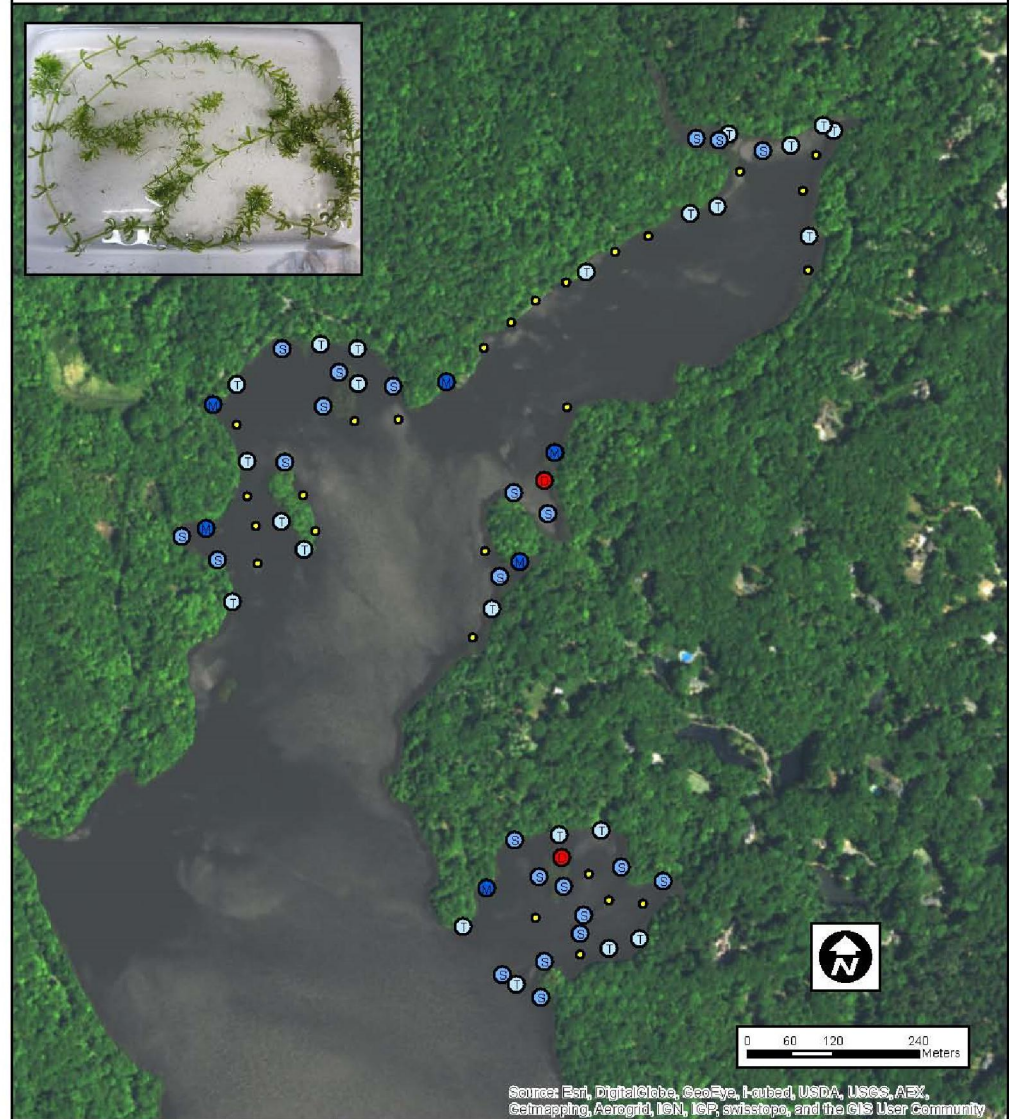
New Croton Reservoir  
Section 1

Aquatic Vegetation Survey  
September 28, 2016  
80 Sites

Percent  
Distribution

Abundance	Sites	Percent
Total	54	68%
Trace	23	43%
Sparse	23	43%
Medium	6	11%
Dense	2	4%

- Late September
- 9 Sections
- 342 Stations
- 2 tosses/station
- 50-meter grid
- All SAV species

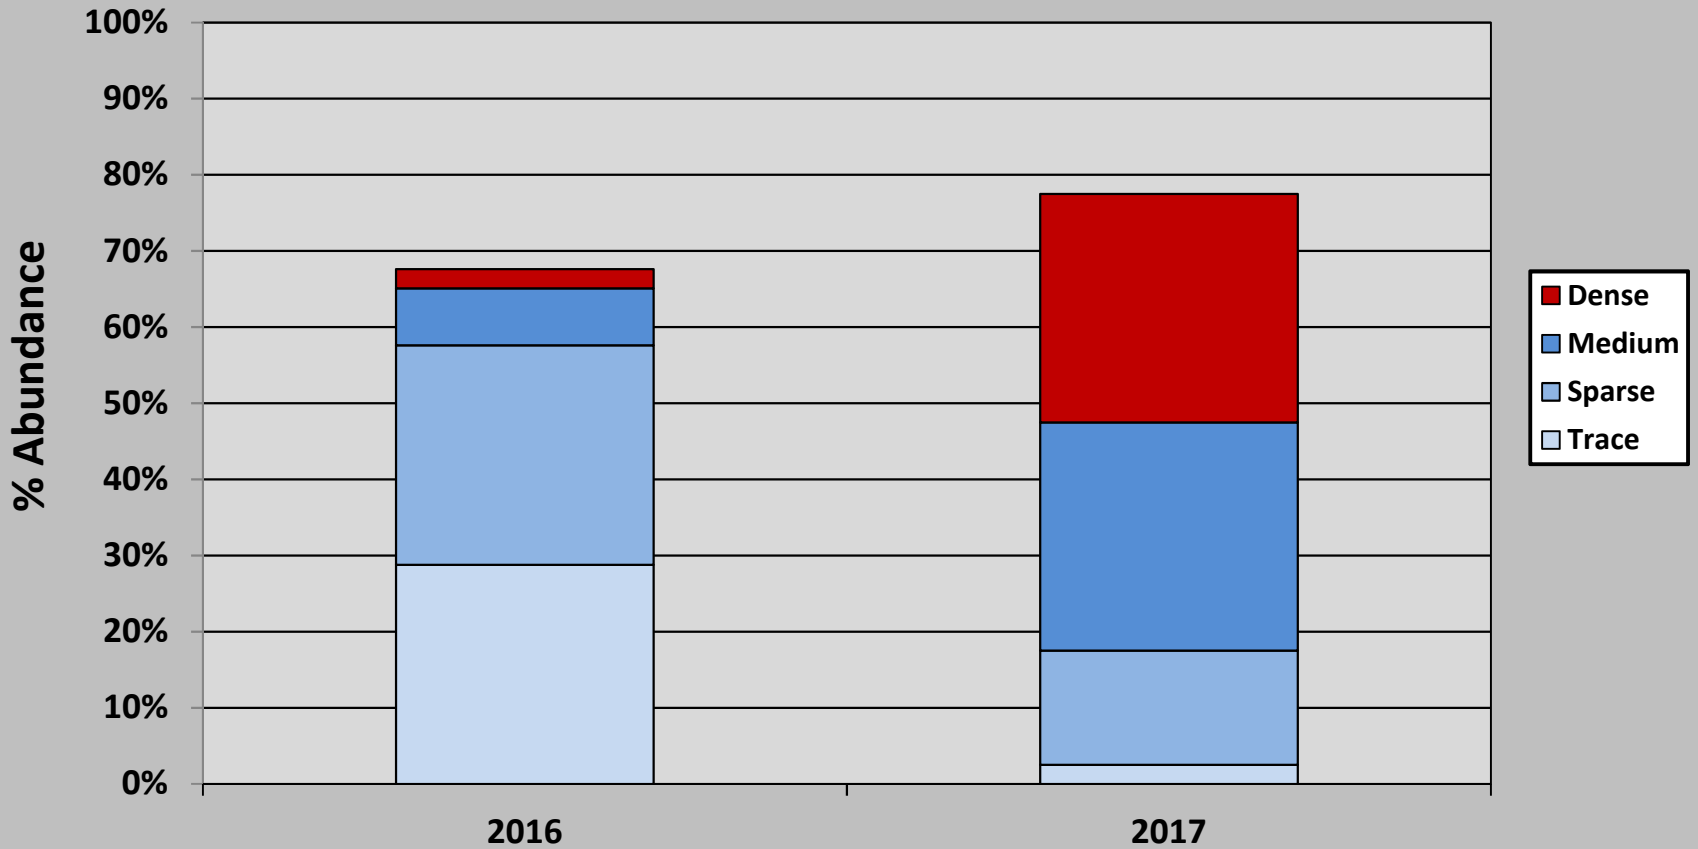
**Hydrilla (*Hydrilla verticillata*)**  
**Percent Abundance 2016/2017**  
**New Croton Reservoir**  
**Section 1**

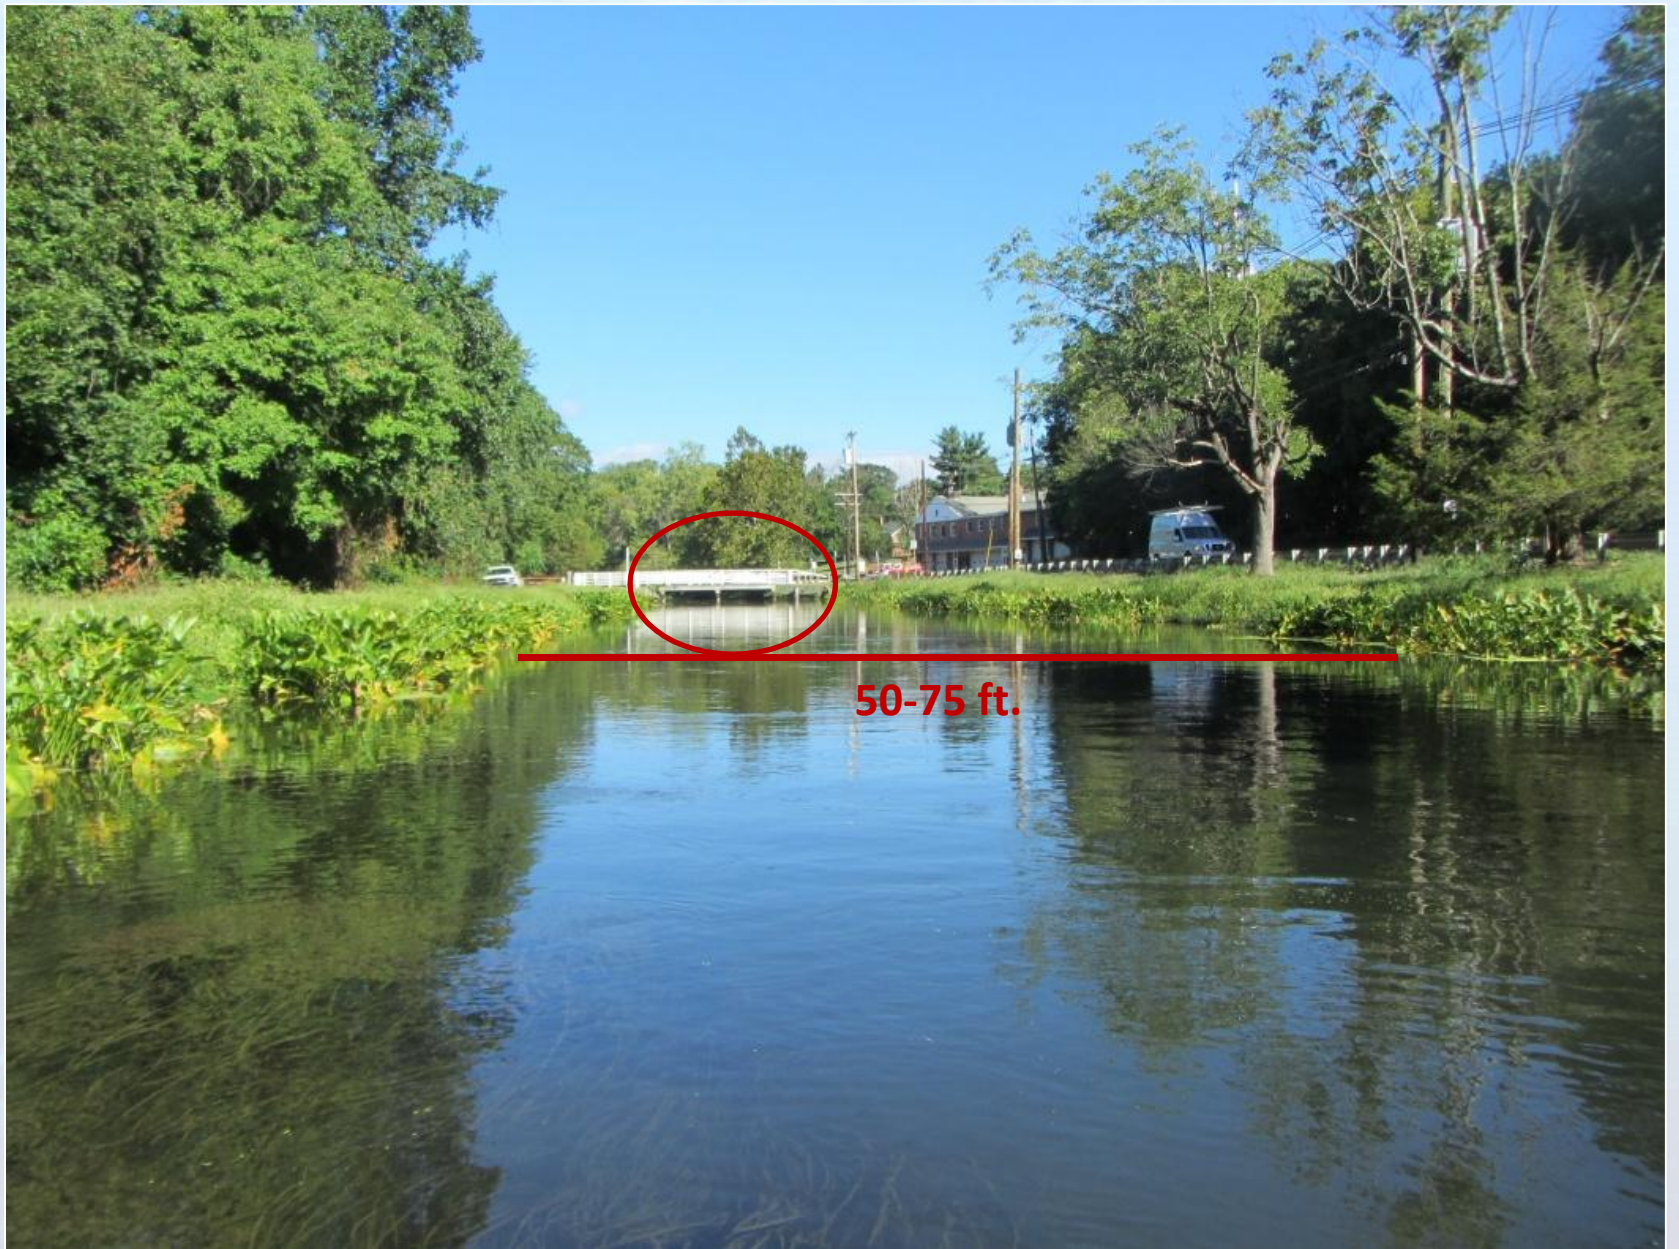
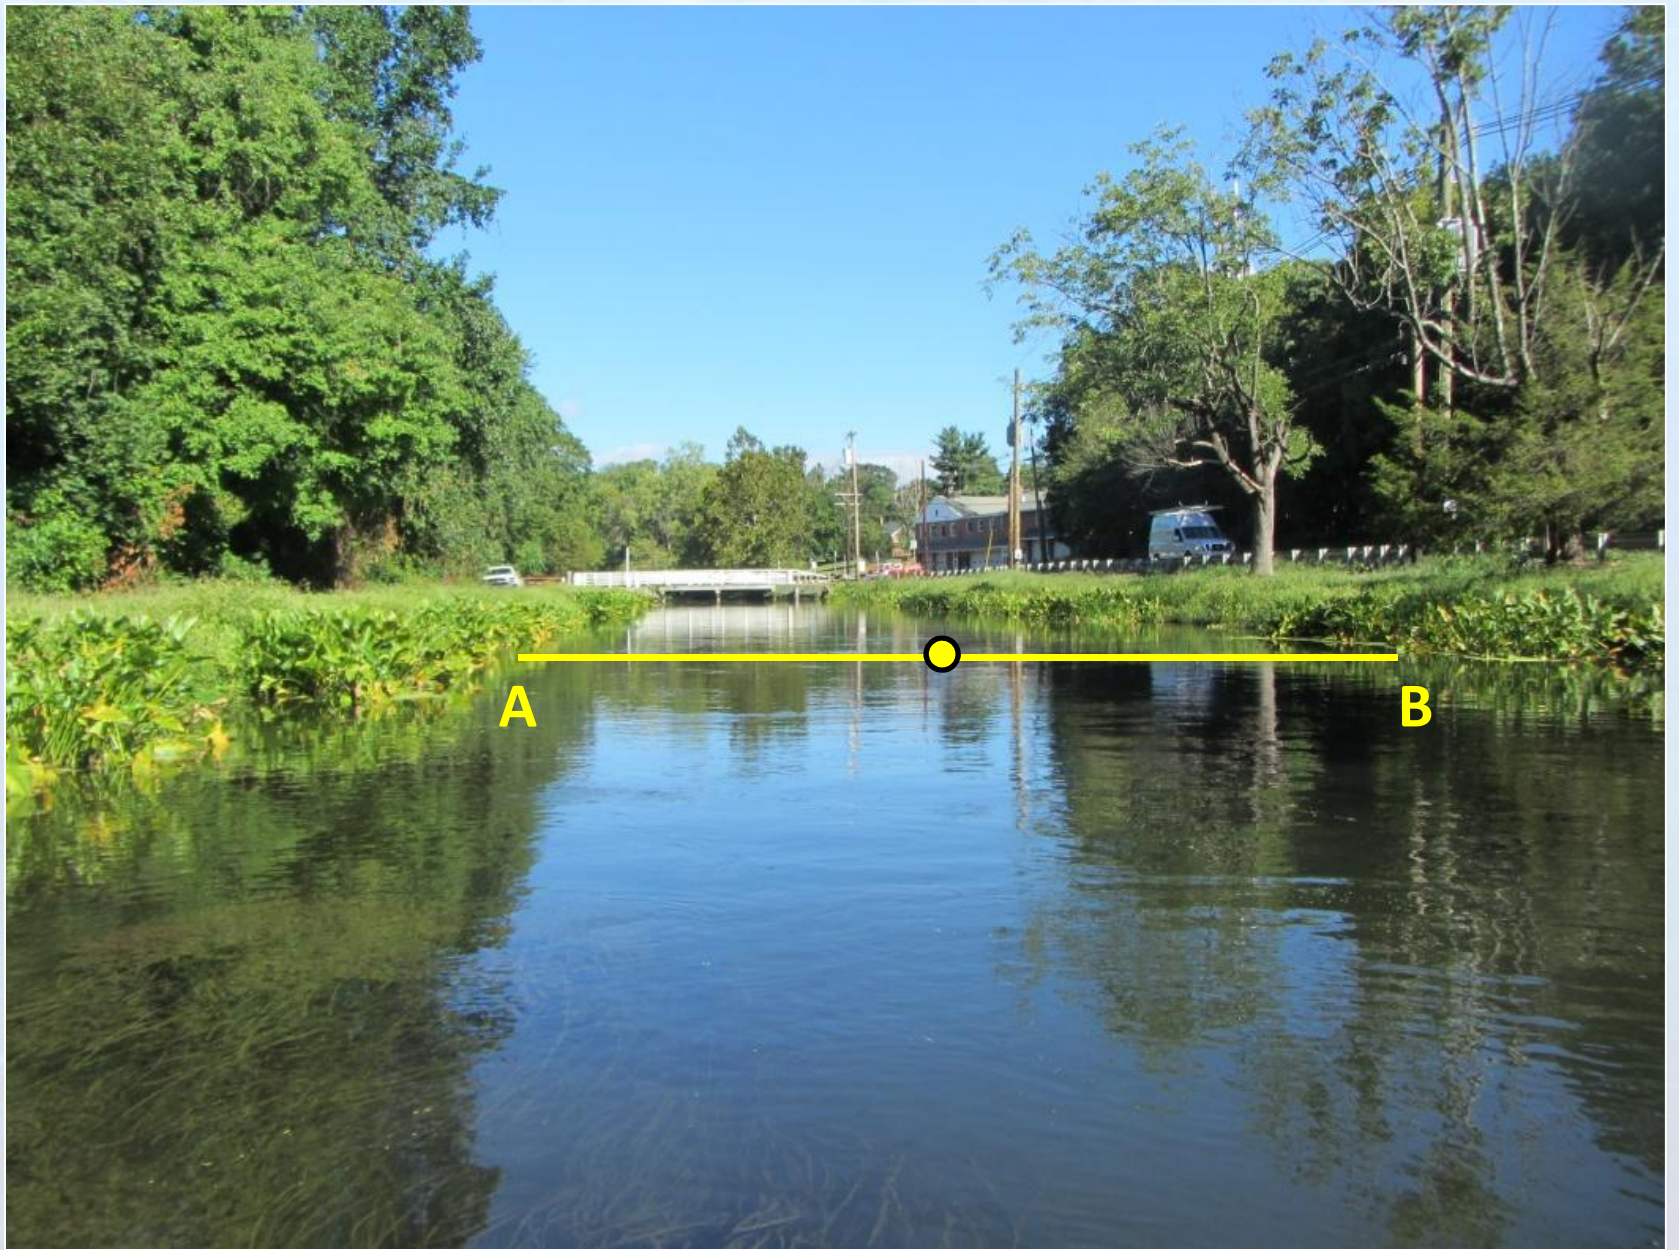
NON-TREATMENT AREA  
 OVERALL AQUATIC PLANT ABUNDANCE  
 SEPTEMBER 21, 2018

DELAWARE & RARITAN CANAL  
 Non-Treatment Area  
 Aquatic Vegetation Survey  
 September 21, 2018

Total Sample Sites: 63

Percent  
 Distribution

Abundance	Sites	Percent
Total	37	59%
Trace	36	97%
Sparse	1	3%
Medium	0	0%
Dense	0	0%

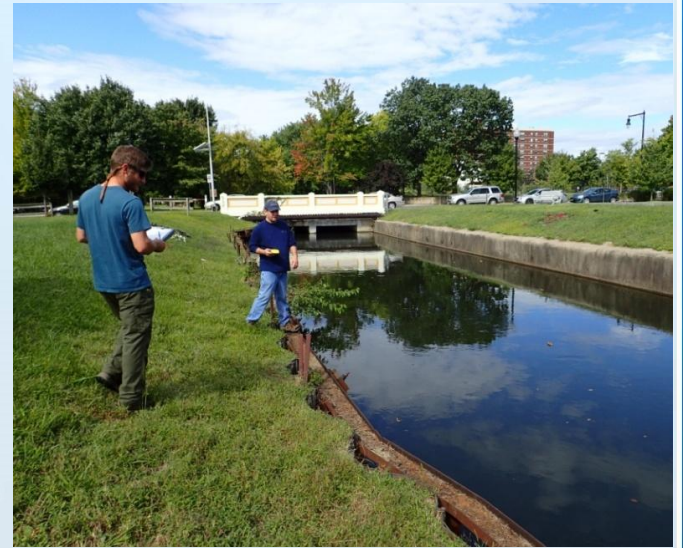
**Hydrilla (*Hydrilla verticillata*)  
2016 vs 2017 Percent Abundance by Section  
D&R Canal**

- **Low-dose Fluridone Injection (May-Sept.)**
- **2017 SAV Monitoring**
  - Re-map Treatment Area
  - Hydrilla Tuber Monitoring
  - Map Entire D&R Canal
    - 1813 GPS-referenced Stations
    - Confirmed Hydrilla Extent
    - Discovered Fanwort
  - Supplemental Weekly/Monthly Surveys
- **2018 SAV Monitoring**
  - Treatment Area and Tuber Monitoring only

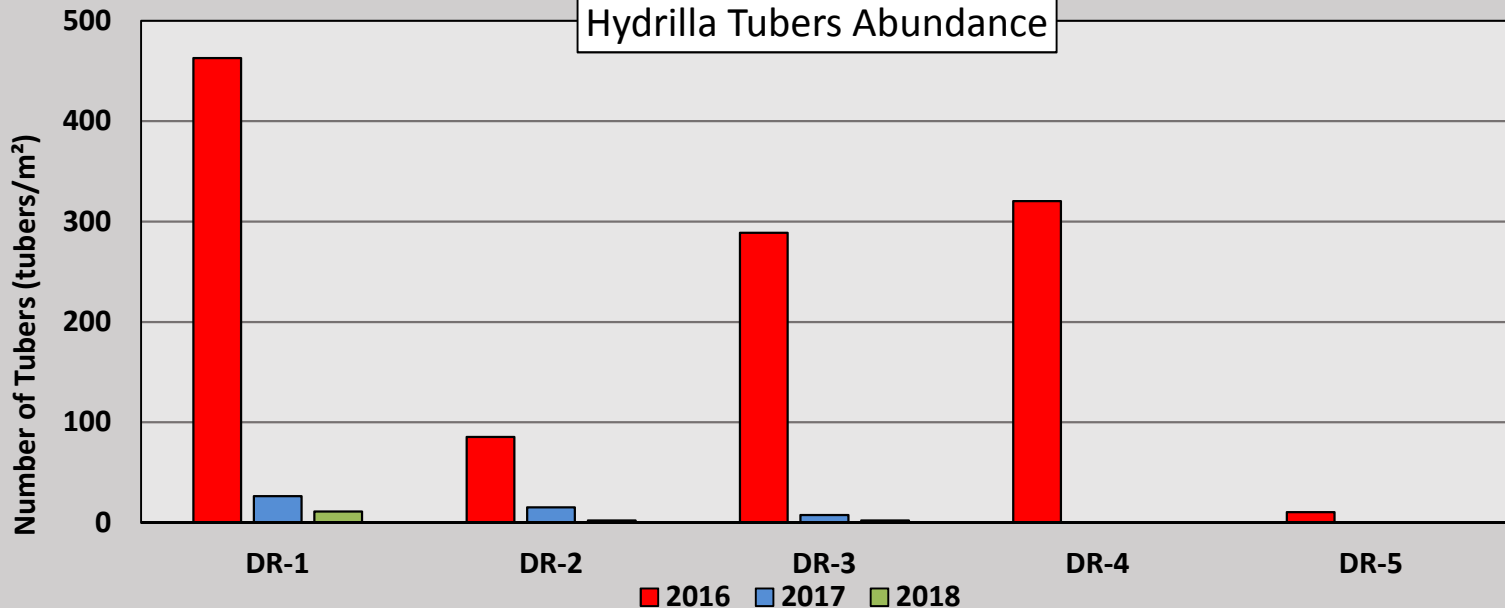
Tuber Sampling Stations	2016 (tubers/ m <sup>2</sup> )	2017 (tubers/ m <sup>2</sup> )	2018 (tubers/ m <sup>2</sup> )
DR-1	462.8	26.5	11.2
DR-2	85.6	15.2	2.2
DR-3	288.9	7.6	2.2
DR-4	320.4	0	0
DR-5	10.7	0	0

D&R Canal  
2016 vs. 2017 vs. 2018  
Hydrilla Tubers Abundance

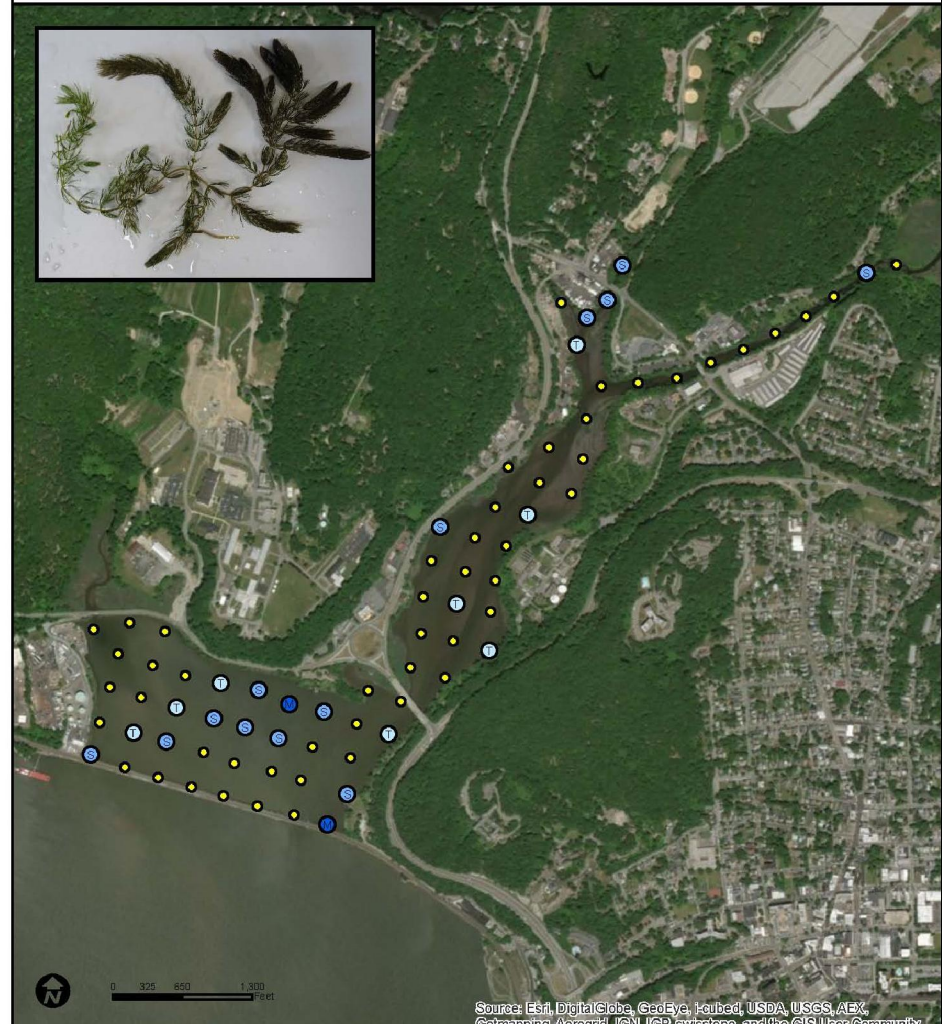
## COONTAIL (*Ceratophyllum demersum*) DISTRIBUTION

**ANNSVILLE CREEK**  
Hudson River Hydrilla Monitoring  
September 22, 2017

Sampling Stations: 75

Percent Distribution	Abundance	Sites	Percent
	Total	23	31%
	Trace	8	35%
	Sparse	13	57%
	Medium	2	9%
	Dense	0	0%
