Cayuga Lake, Aurora, NY Hydrilla Control Demonstration Project

November 14, 2017

Hydrilla Management Project

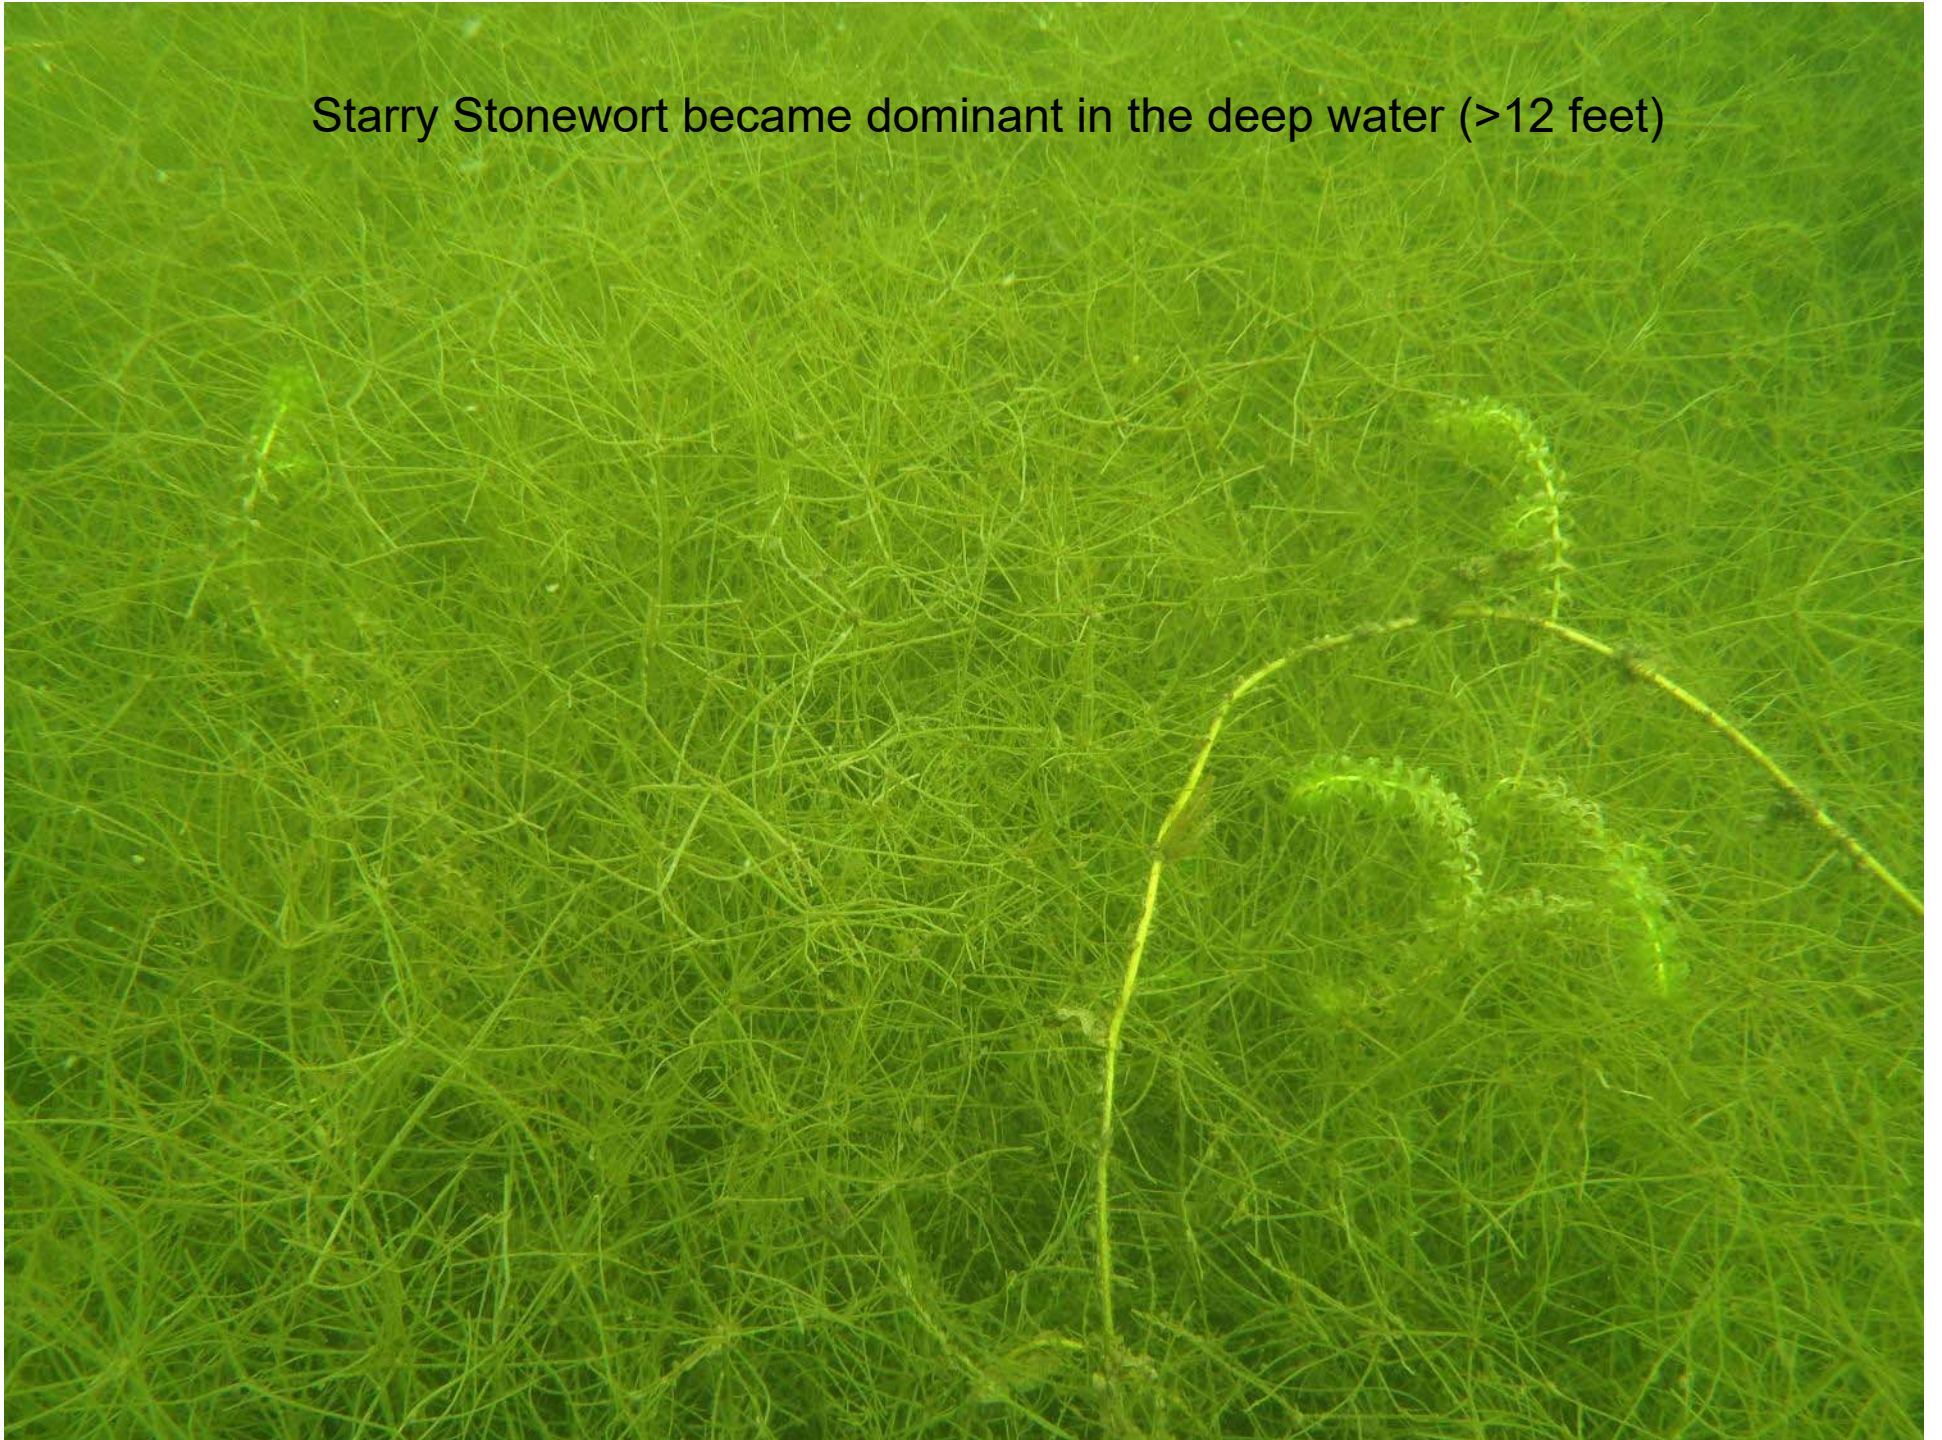
Starry Stonewort became dominant in the deep water (>12 feet)

Proliferation of Starry Stonewort in August

57% Starry Stonewort frequency in Sept 2017 vs 35% in Sept 2016

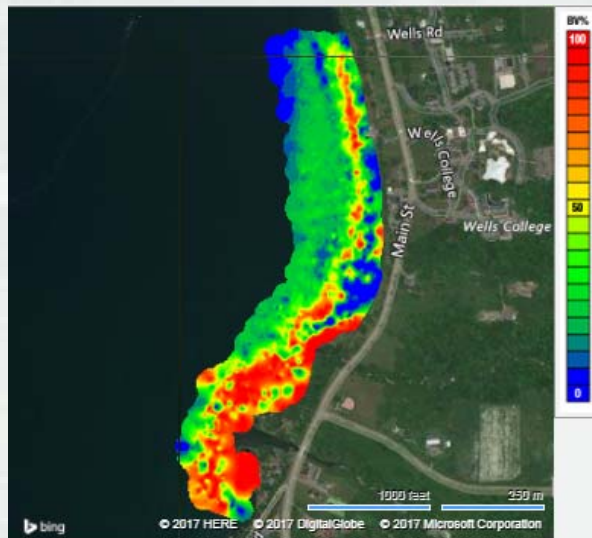
Sept 18

83% PAC 46% BVI

Maintaining good vegetative cover in the plot following use of Sonar
