**Final Post-Treatment Assessment  
for Aquatic Plant Control  
ERDC Demonstration Project  
Tonawanda Creek/Erie Canal  
2019**

**Contract No. W912P4-16-D-0002**

**May 2020**

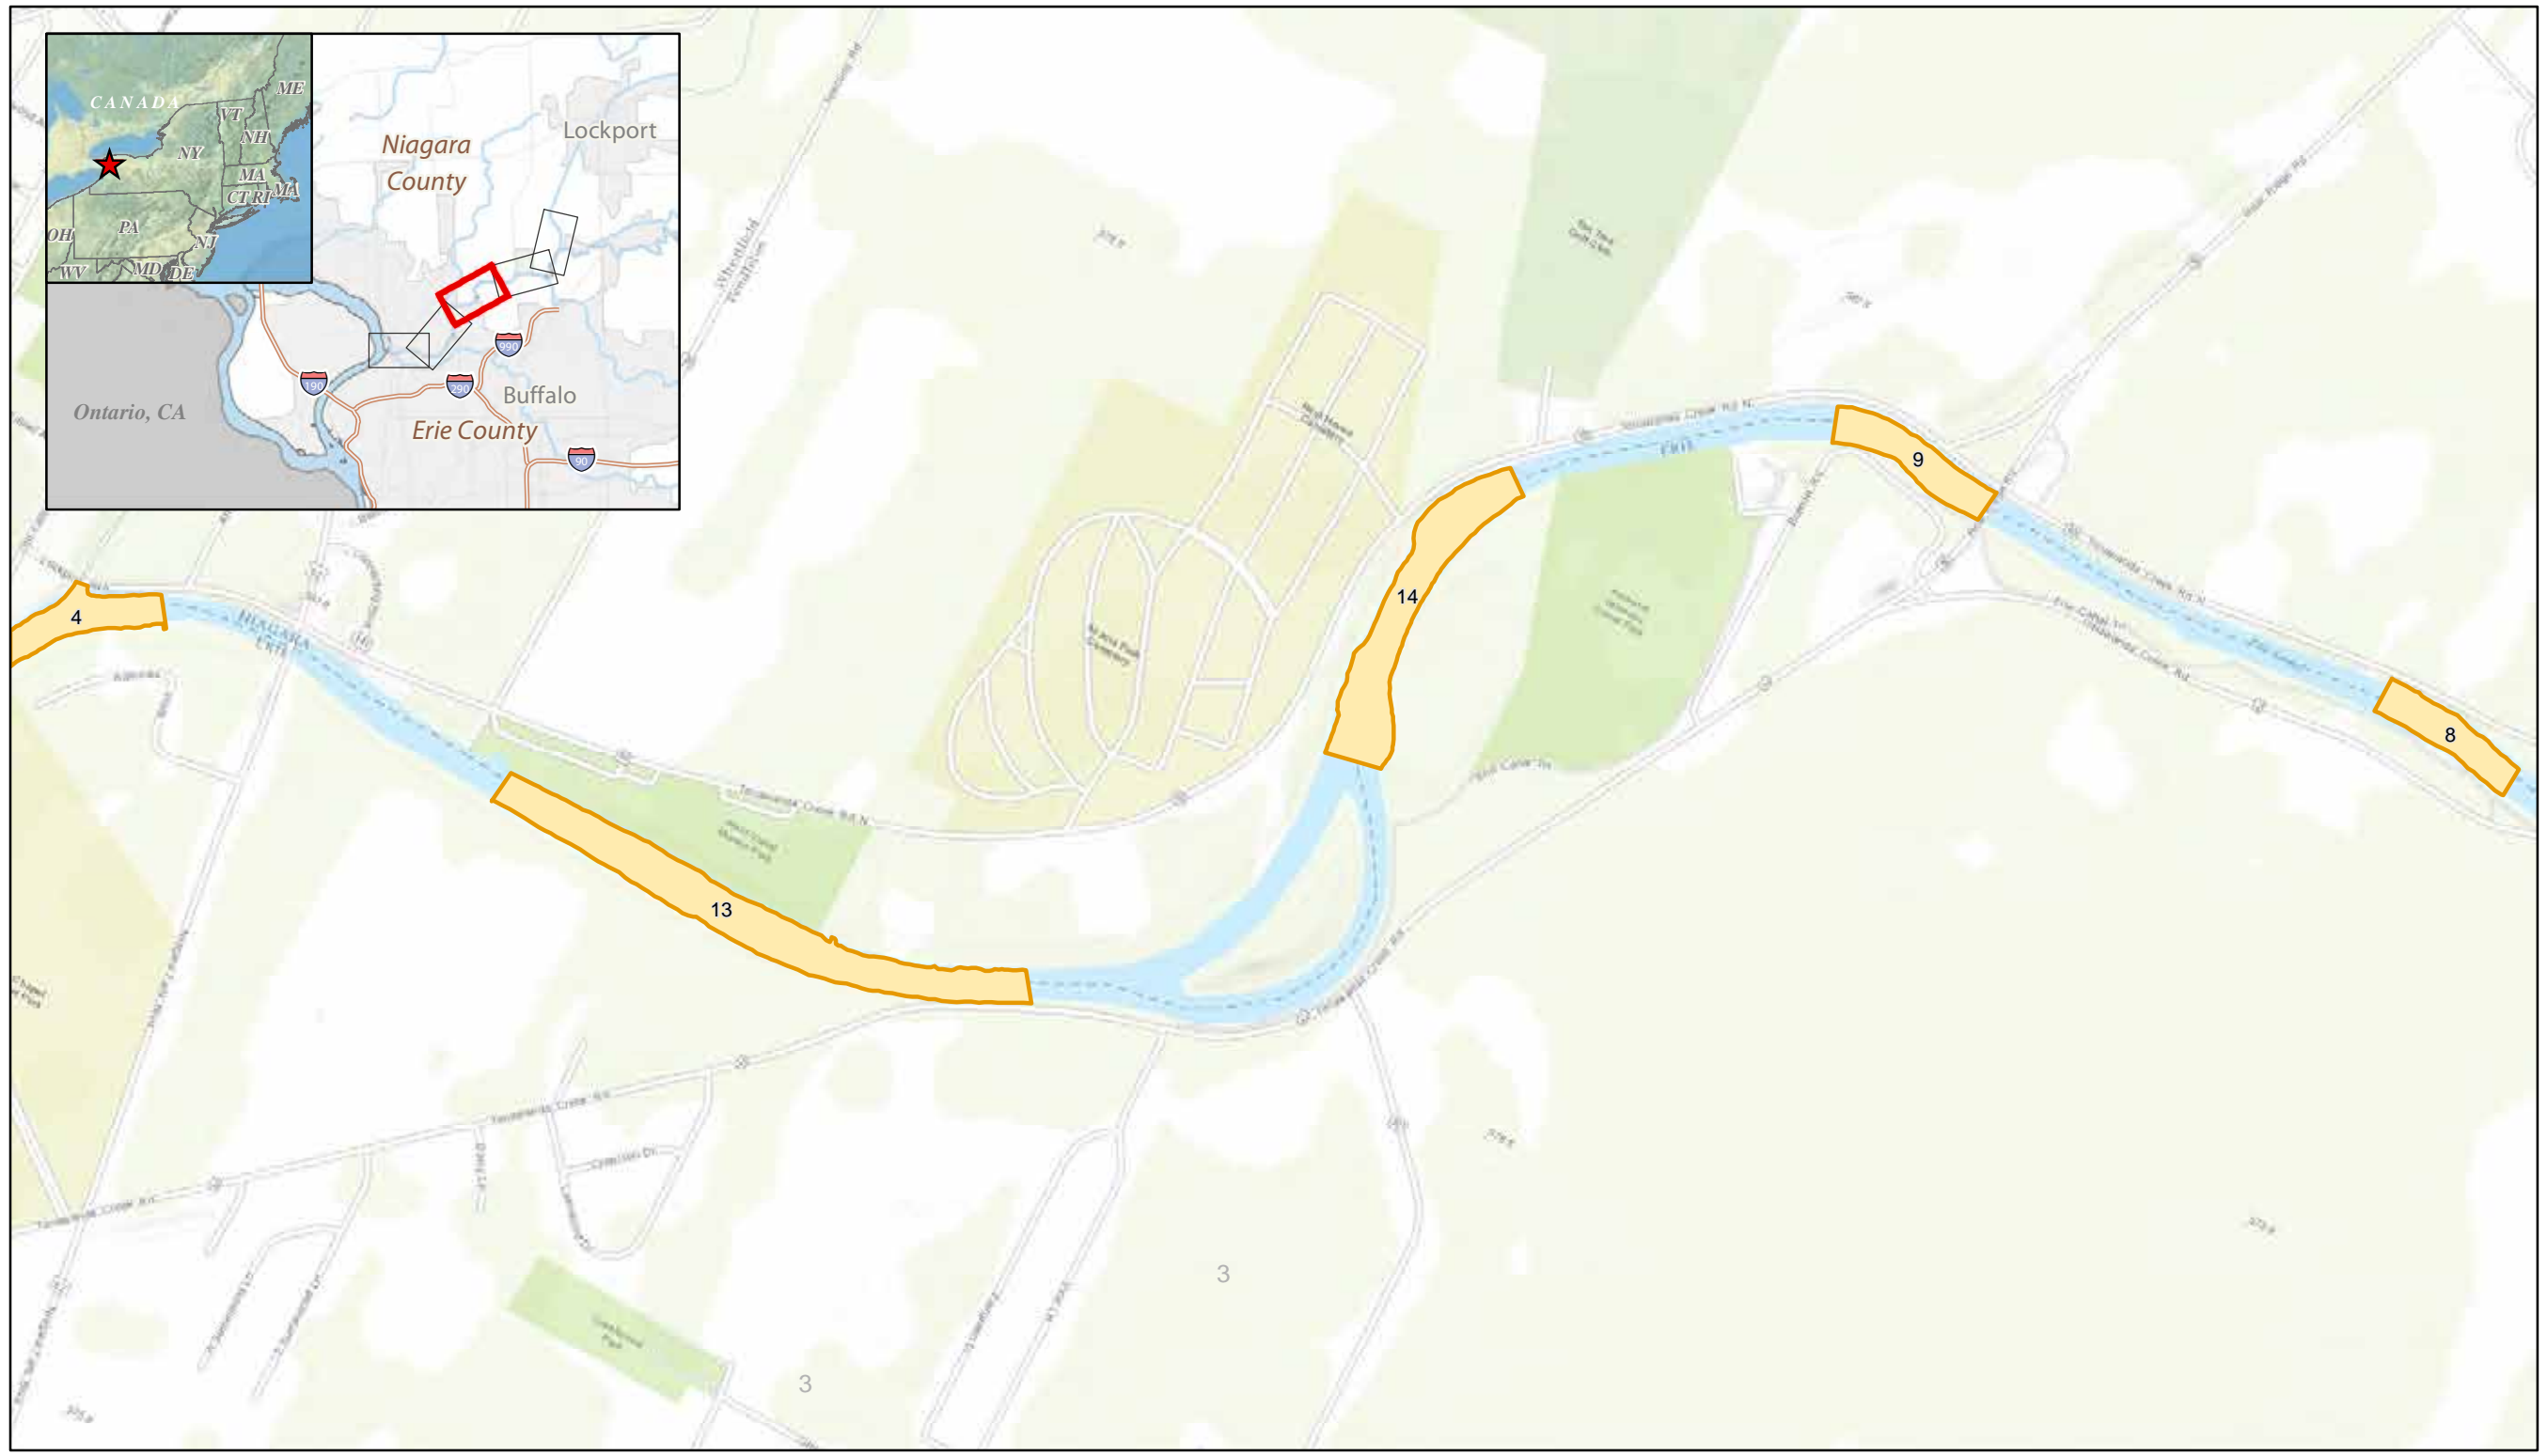
**Figure 2-1b Endothall (Aquathol®K) Treatment Areas - Treated on July 23 and July 24, 2019**  
Tonawanda Creek/Erie Canal, Erie and Niagara Counties, New York

- Treated on July 23
- Treated on July 24

The aquatic herbicide endothall (Aquathol® K) was applied in designated sections of the creek/canal on July 23 and 24, 2019, and spot treatment using chelated copper (Komeen Crystal™) occurred on July 24, 2019 (see Figures 2-1a through 2-1e). [Note: As discussed below, the Komeen treatment was cancelled due to a defective batch of the herbicide.] Additional spot treatments occurred on August 13 and 14, 2019, and utilized endothall (both Aquathol® K and Aquathol® Super K) and chelated copper (Harpoon®). The herbicides were applied by SLM in accordance with the *Architect-Engineer Scope of Work (SOW) Aquatic Plant Control ERDC Demonstration Project Tonawanda Creek/Erie Canal* dated May 21, 2019, and the modification to that SOW dated August 8, 2019 (USACE 2019).

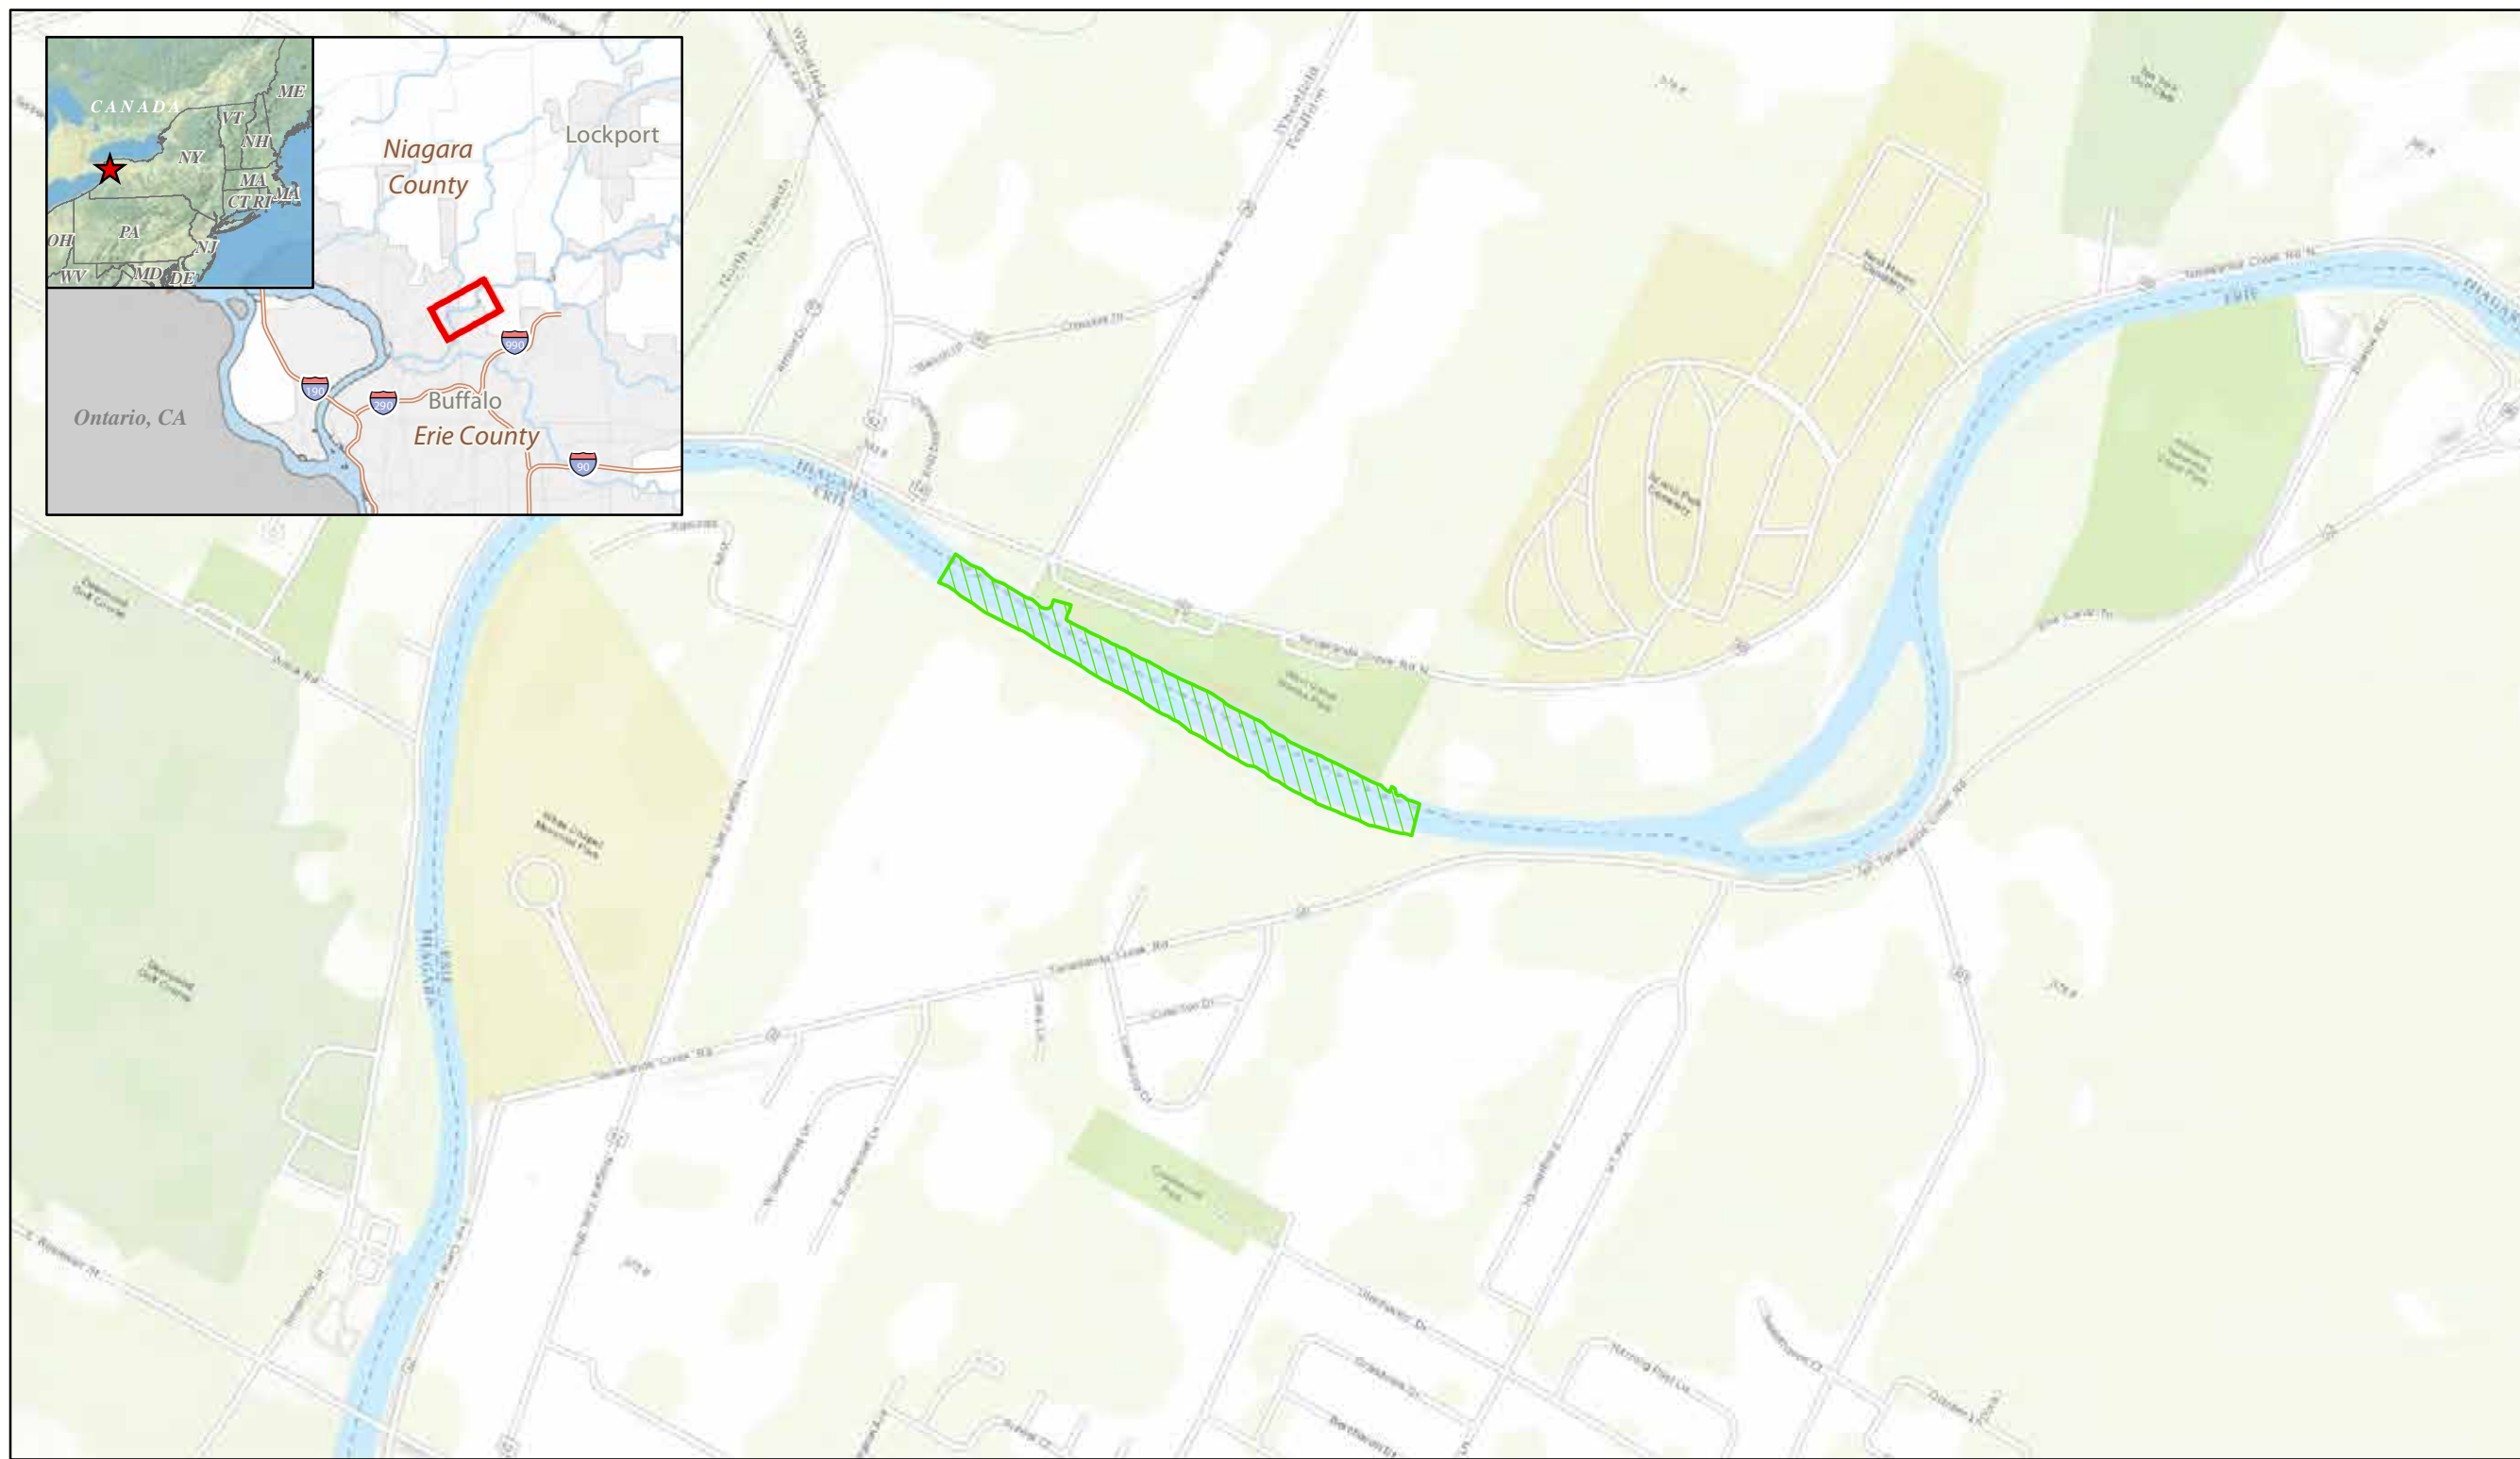
**Figure 2-1e Endothall (Aquathol®K) Treatment Areas - Treated on July 23 and July 24, 2019**

August Endothall (Aquathol®K) Spot Treatment

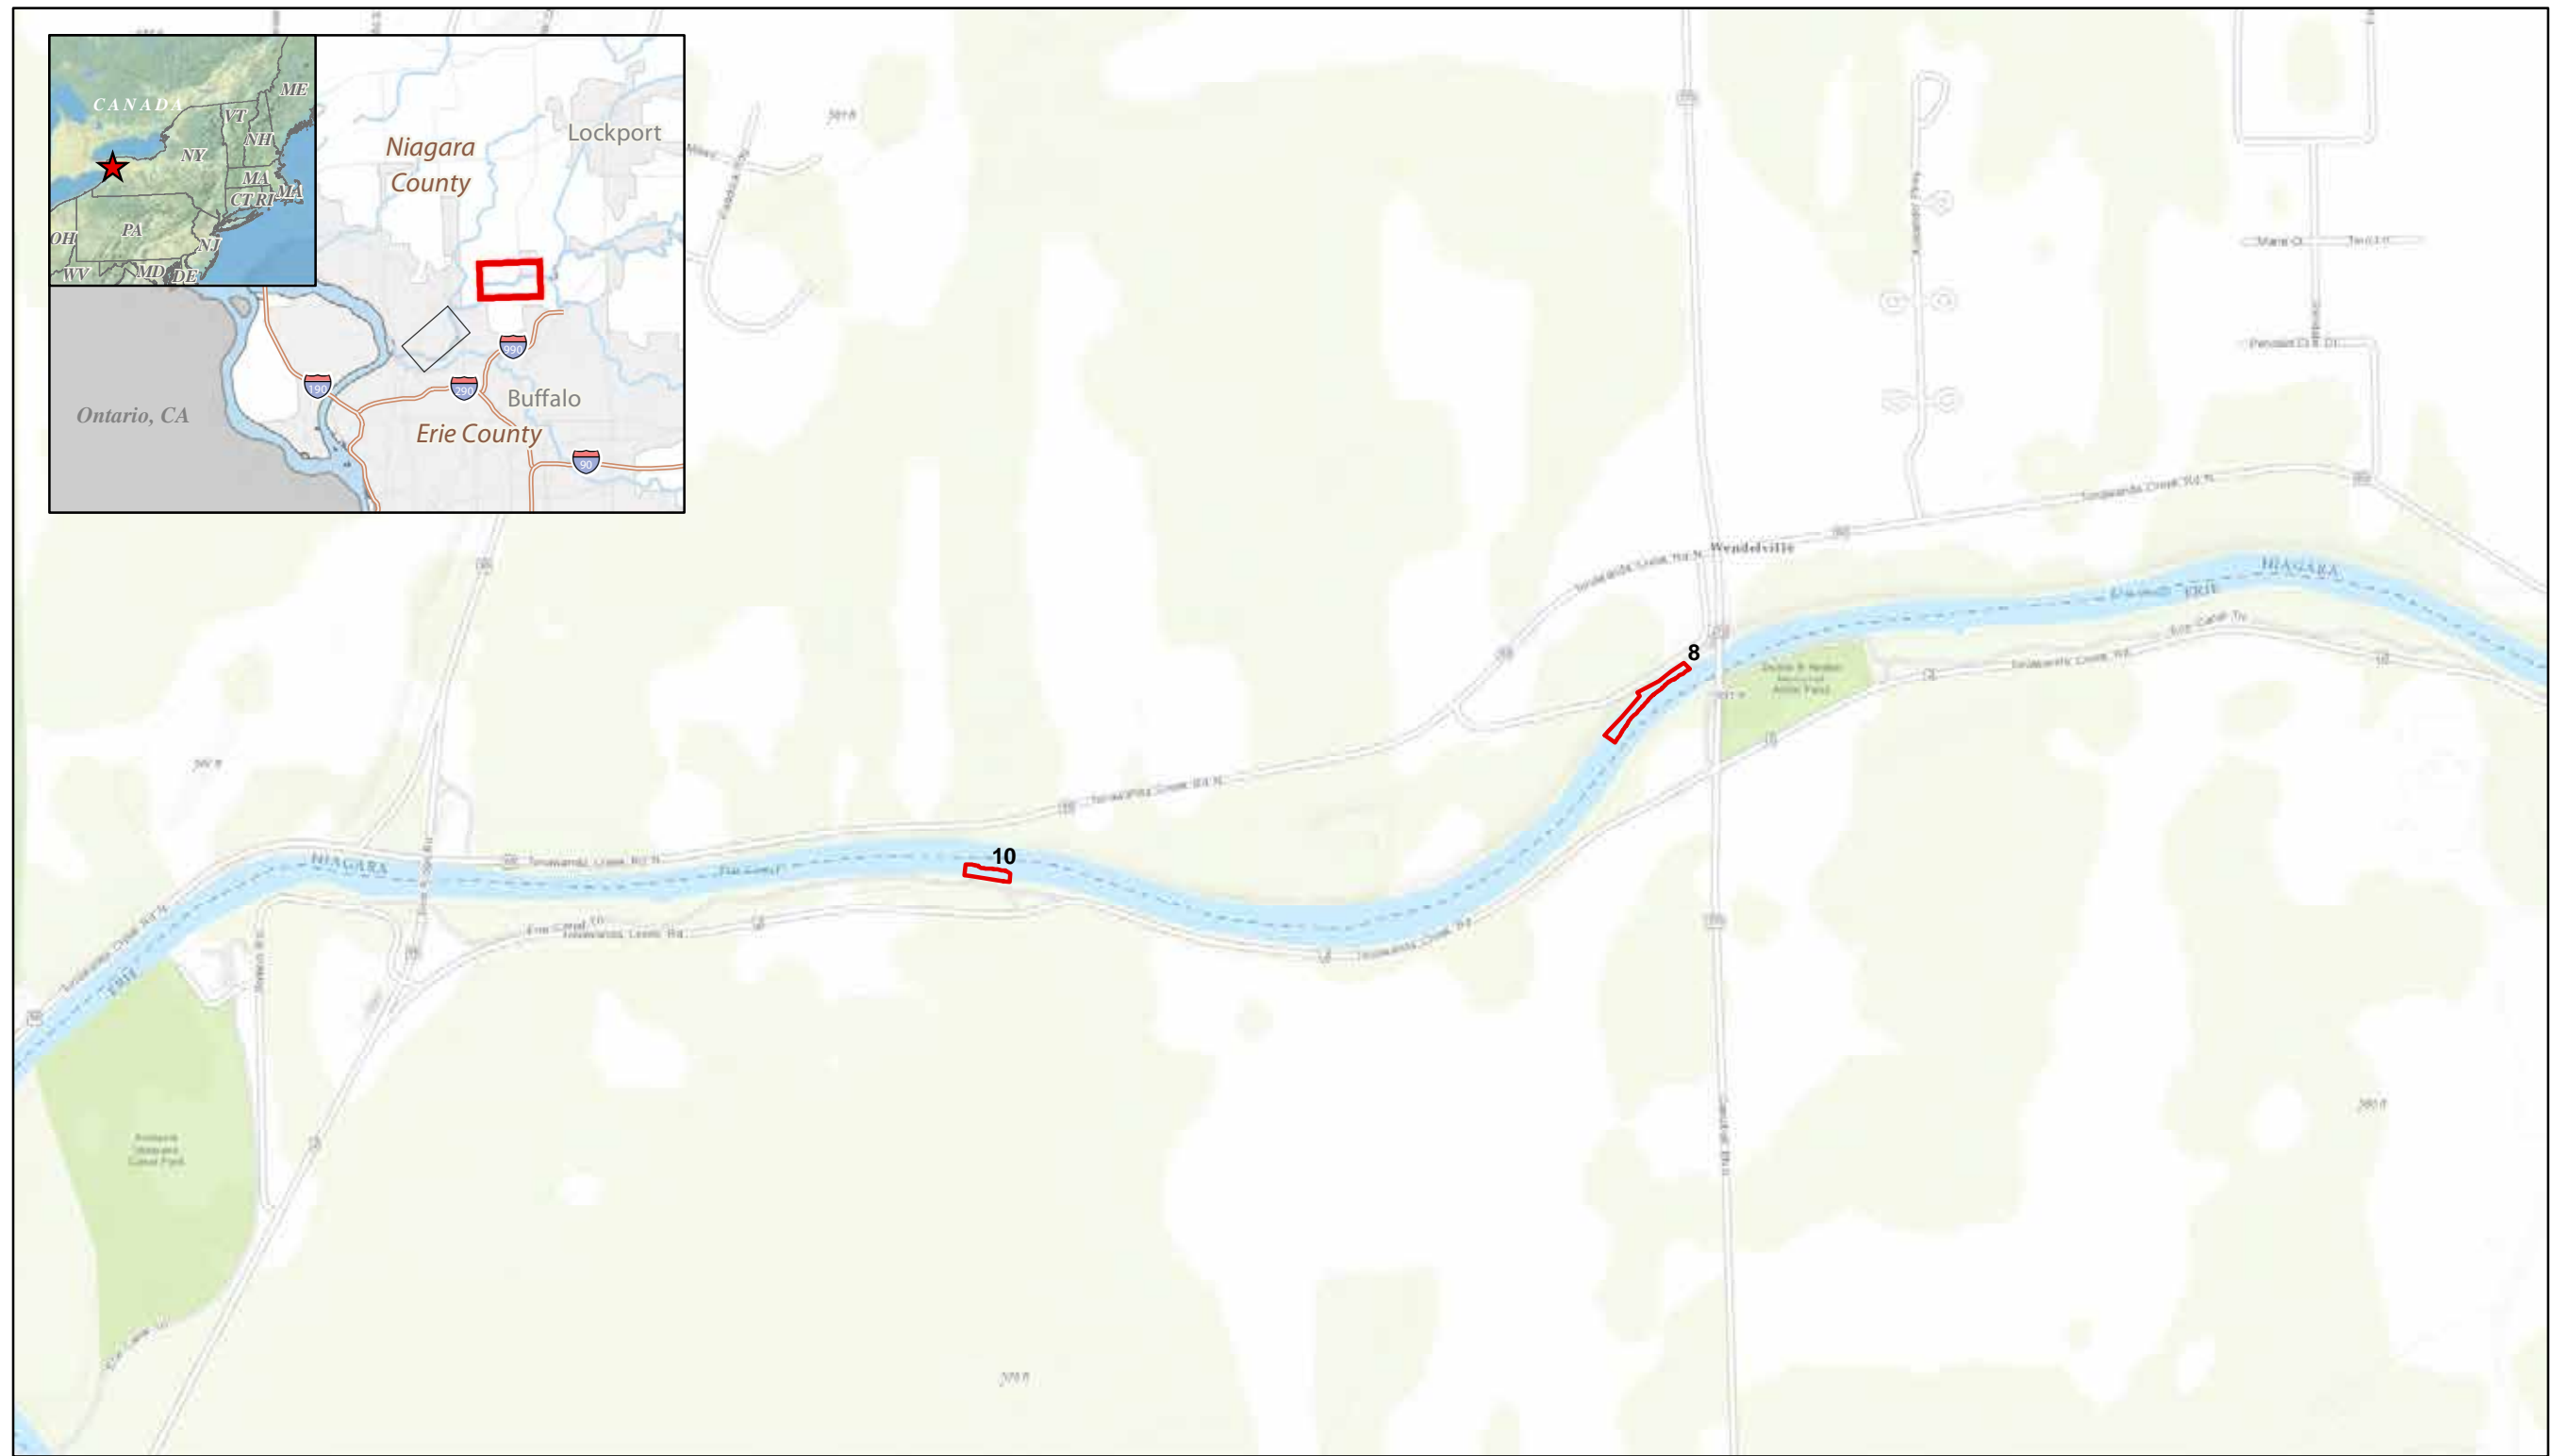
**Figure 2-3b Copper (Harpoon®) Spot Treatment Areas - August 13, 2019**  
Tonawanda Creek/Erie Canal, Erie and Niagara Counties, New York

During the August treatment, smaller plots of endothall – Aquathol® Super K (granular) – were used to the west of West Canal Park. Additionally, a larger plot of copper (Harpoon®) was also treated. In the western portion, no residual monitoring sites achieved the CET needed to effectively treat Hydrilla. The only area where monitoring demonstrated effective CET was the larger site treated with Aquathol® K near the West Canal Park boat ramp. All areas treated with Aquathol® Super K and copper (Harpoon®) showed either new growth or regrowth during post-treatment surveys. The reason for the less effective treatment closer to the Niagara River was likely due to the changing hydrologic regimes, small plot sizes, and in-flows from Ellicott Creek.

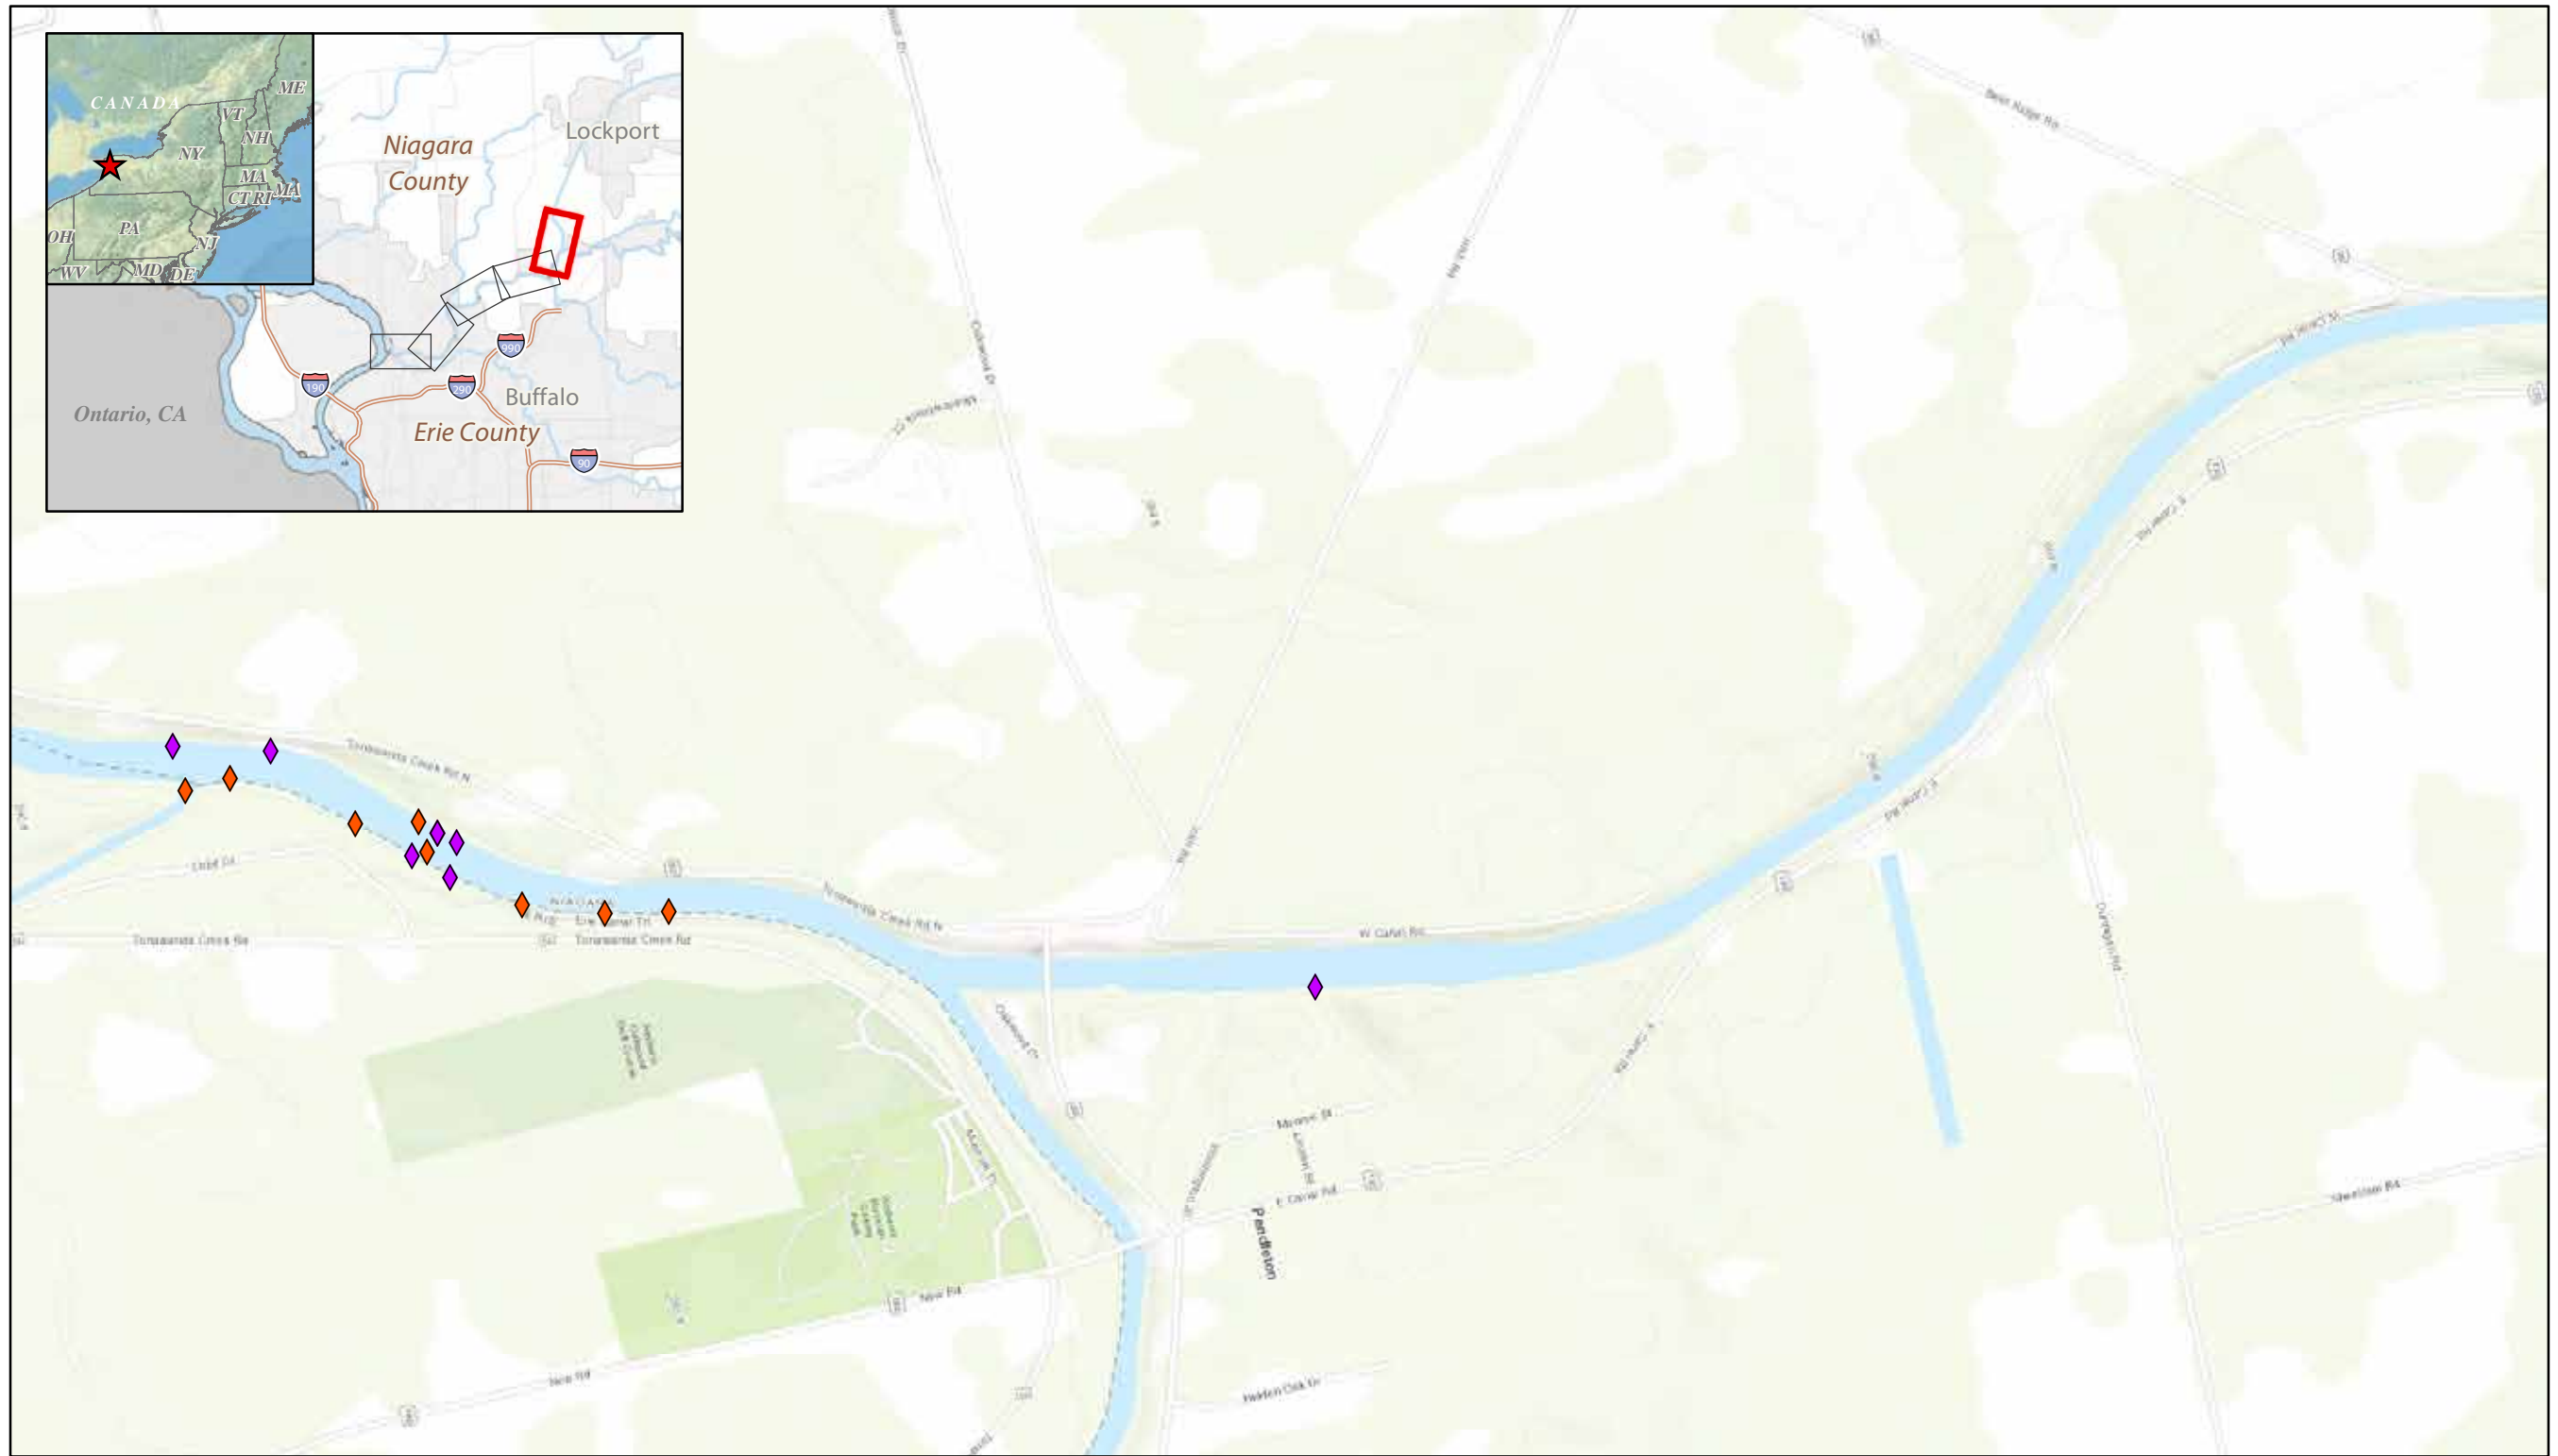
**Figure 2-6e Hydrilla Distribution 2019**  
Tonawanda Creek/Erie Canal, Erie and Niagara Counties, New York

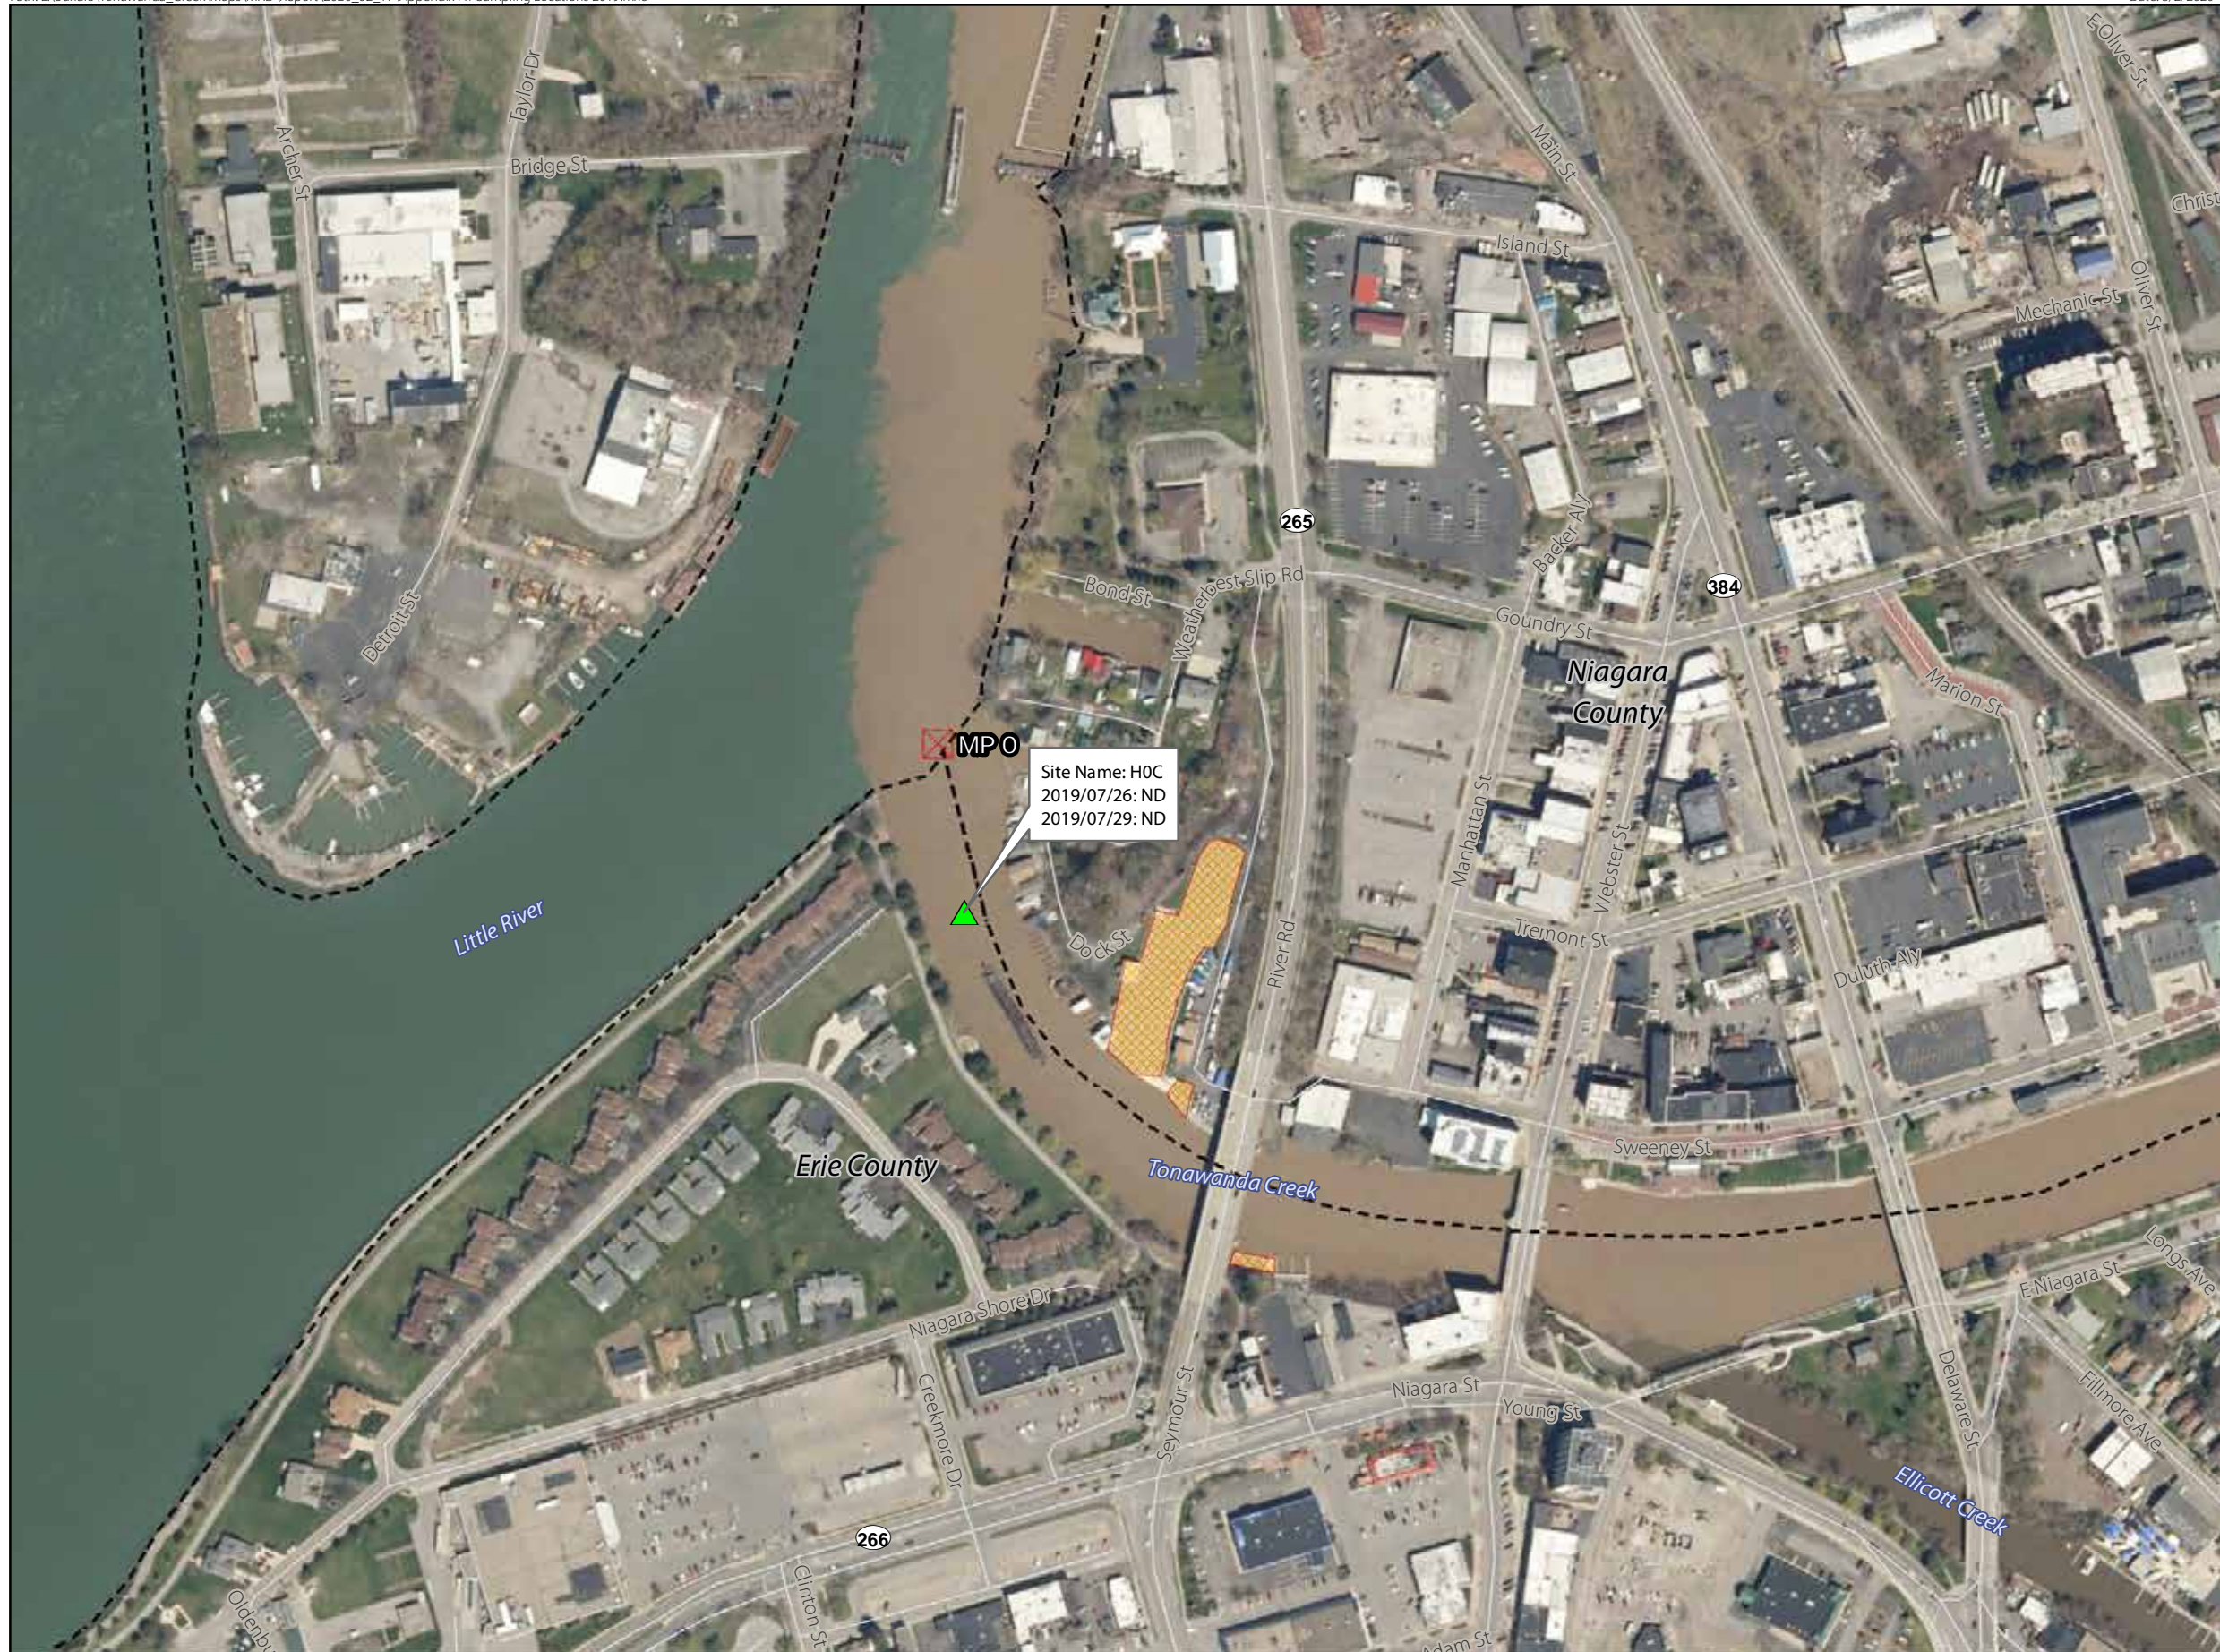
**July Endothall (Aquathol®K) Treatment  
Figure A1-1  
Tonawanda Creek/Erie Canal  
Erie and Niagara Counties, New York**

- ▲ July Sample Locations 2019
- July Endothall (Aquathol®K) Treatment
- Mile Post
- County Boundary
- Roadway

\*Note: All sample locations are approximate  
HAT- Hours After Treatment  
ND- Non-Detect

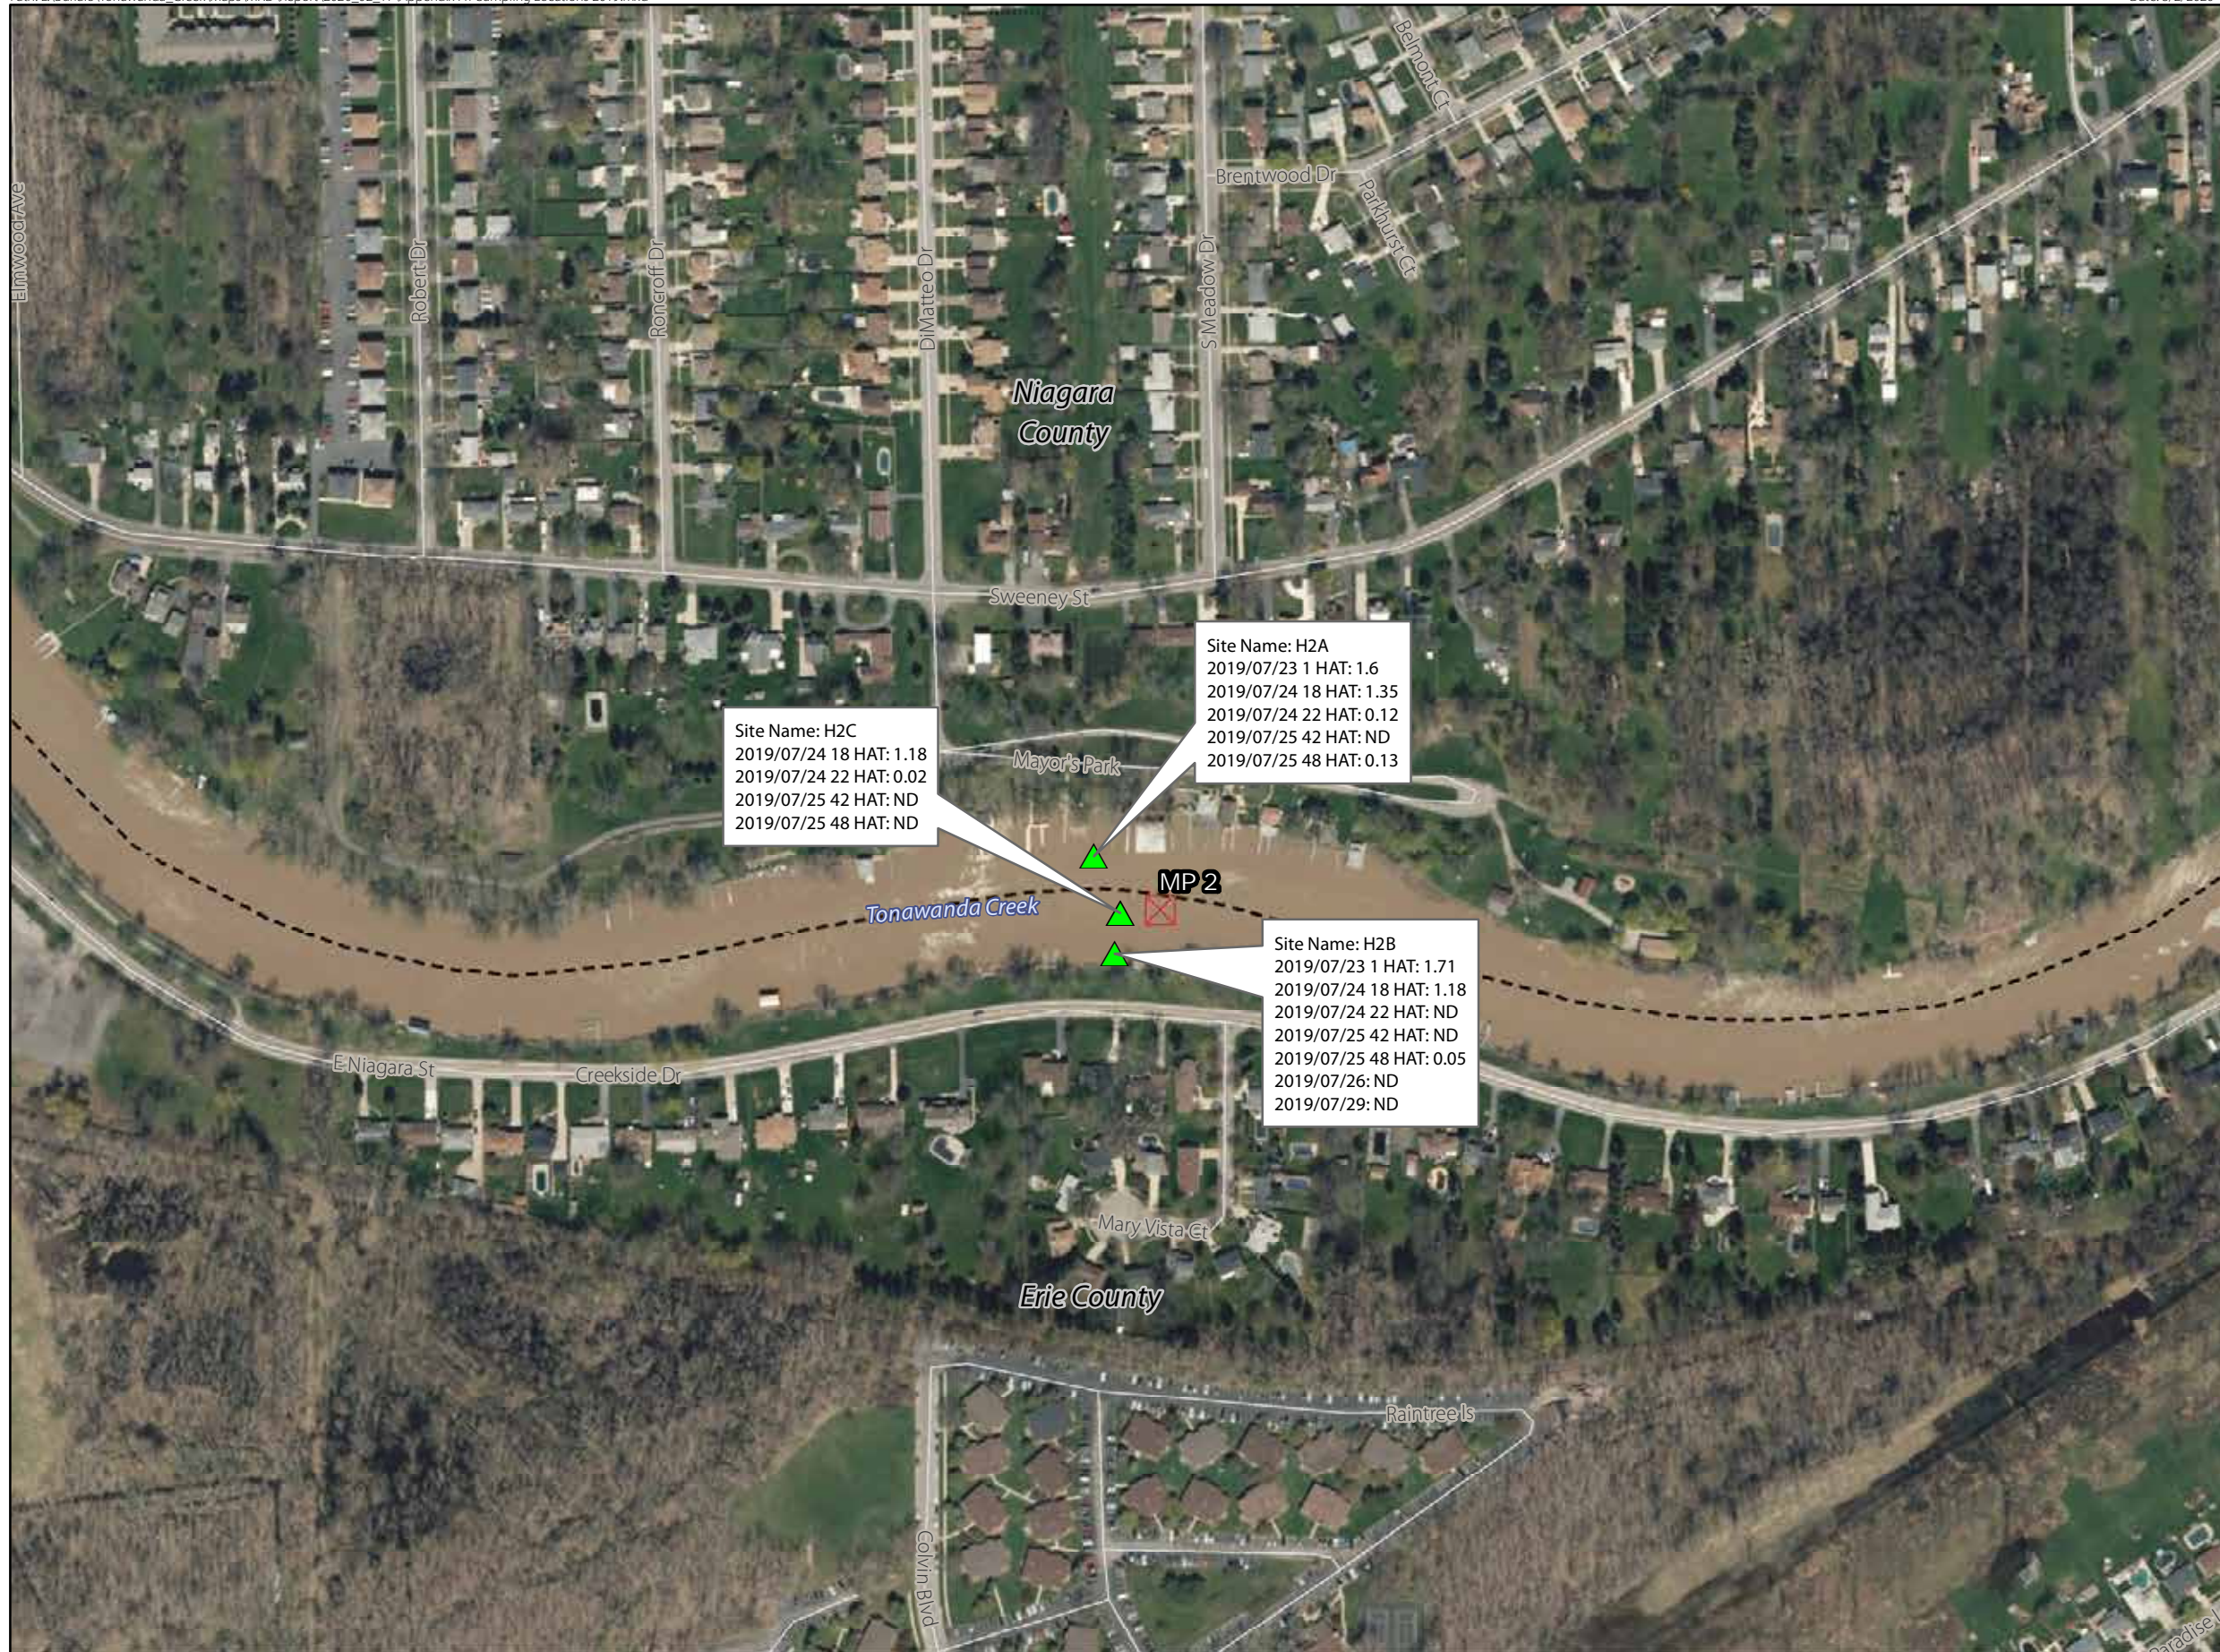
**July Endothall (Aquathol®K) Treatment  
 Figure A1-3  
 Tonawanda Creek/Erie Canal  
 Erie and Niagara Counties, New York**

- July Sample Locations 2019
- Mile Post
- County Boundary
- Roadway

\*Note: All sample locations are approximate  
 HAT- Hours After Treatment  
 ND- Non-Detect
