**Final Post-Treatment Assessment  
for Aquatic Plant Control  
ERDC Demonstration Project  
Tonawanda Creek/Erie Canal  
2019**

**Contract No. W912P4-16-D-0002**

**May 2020**

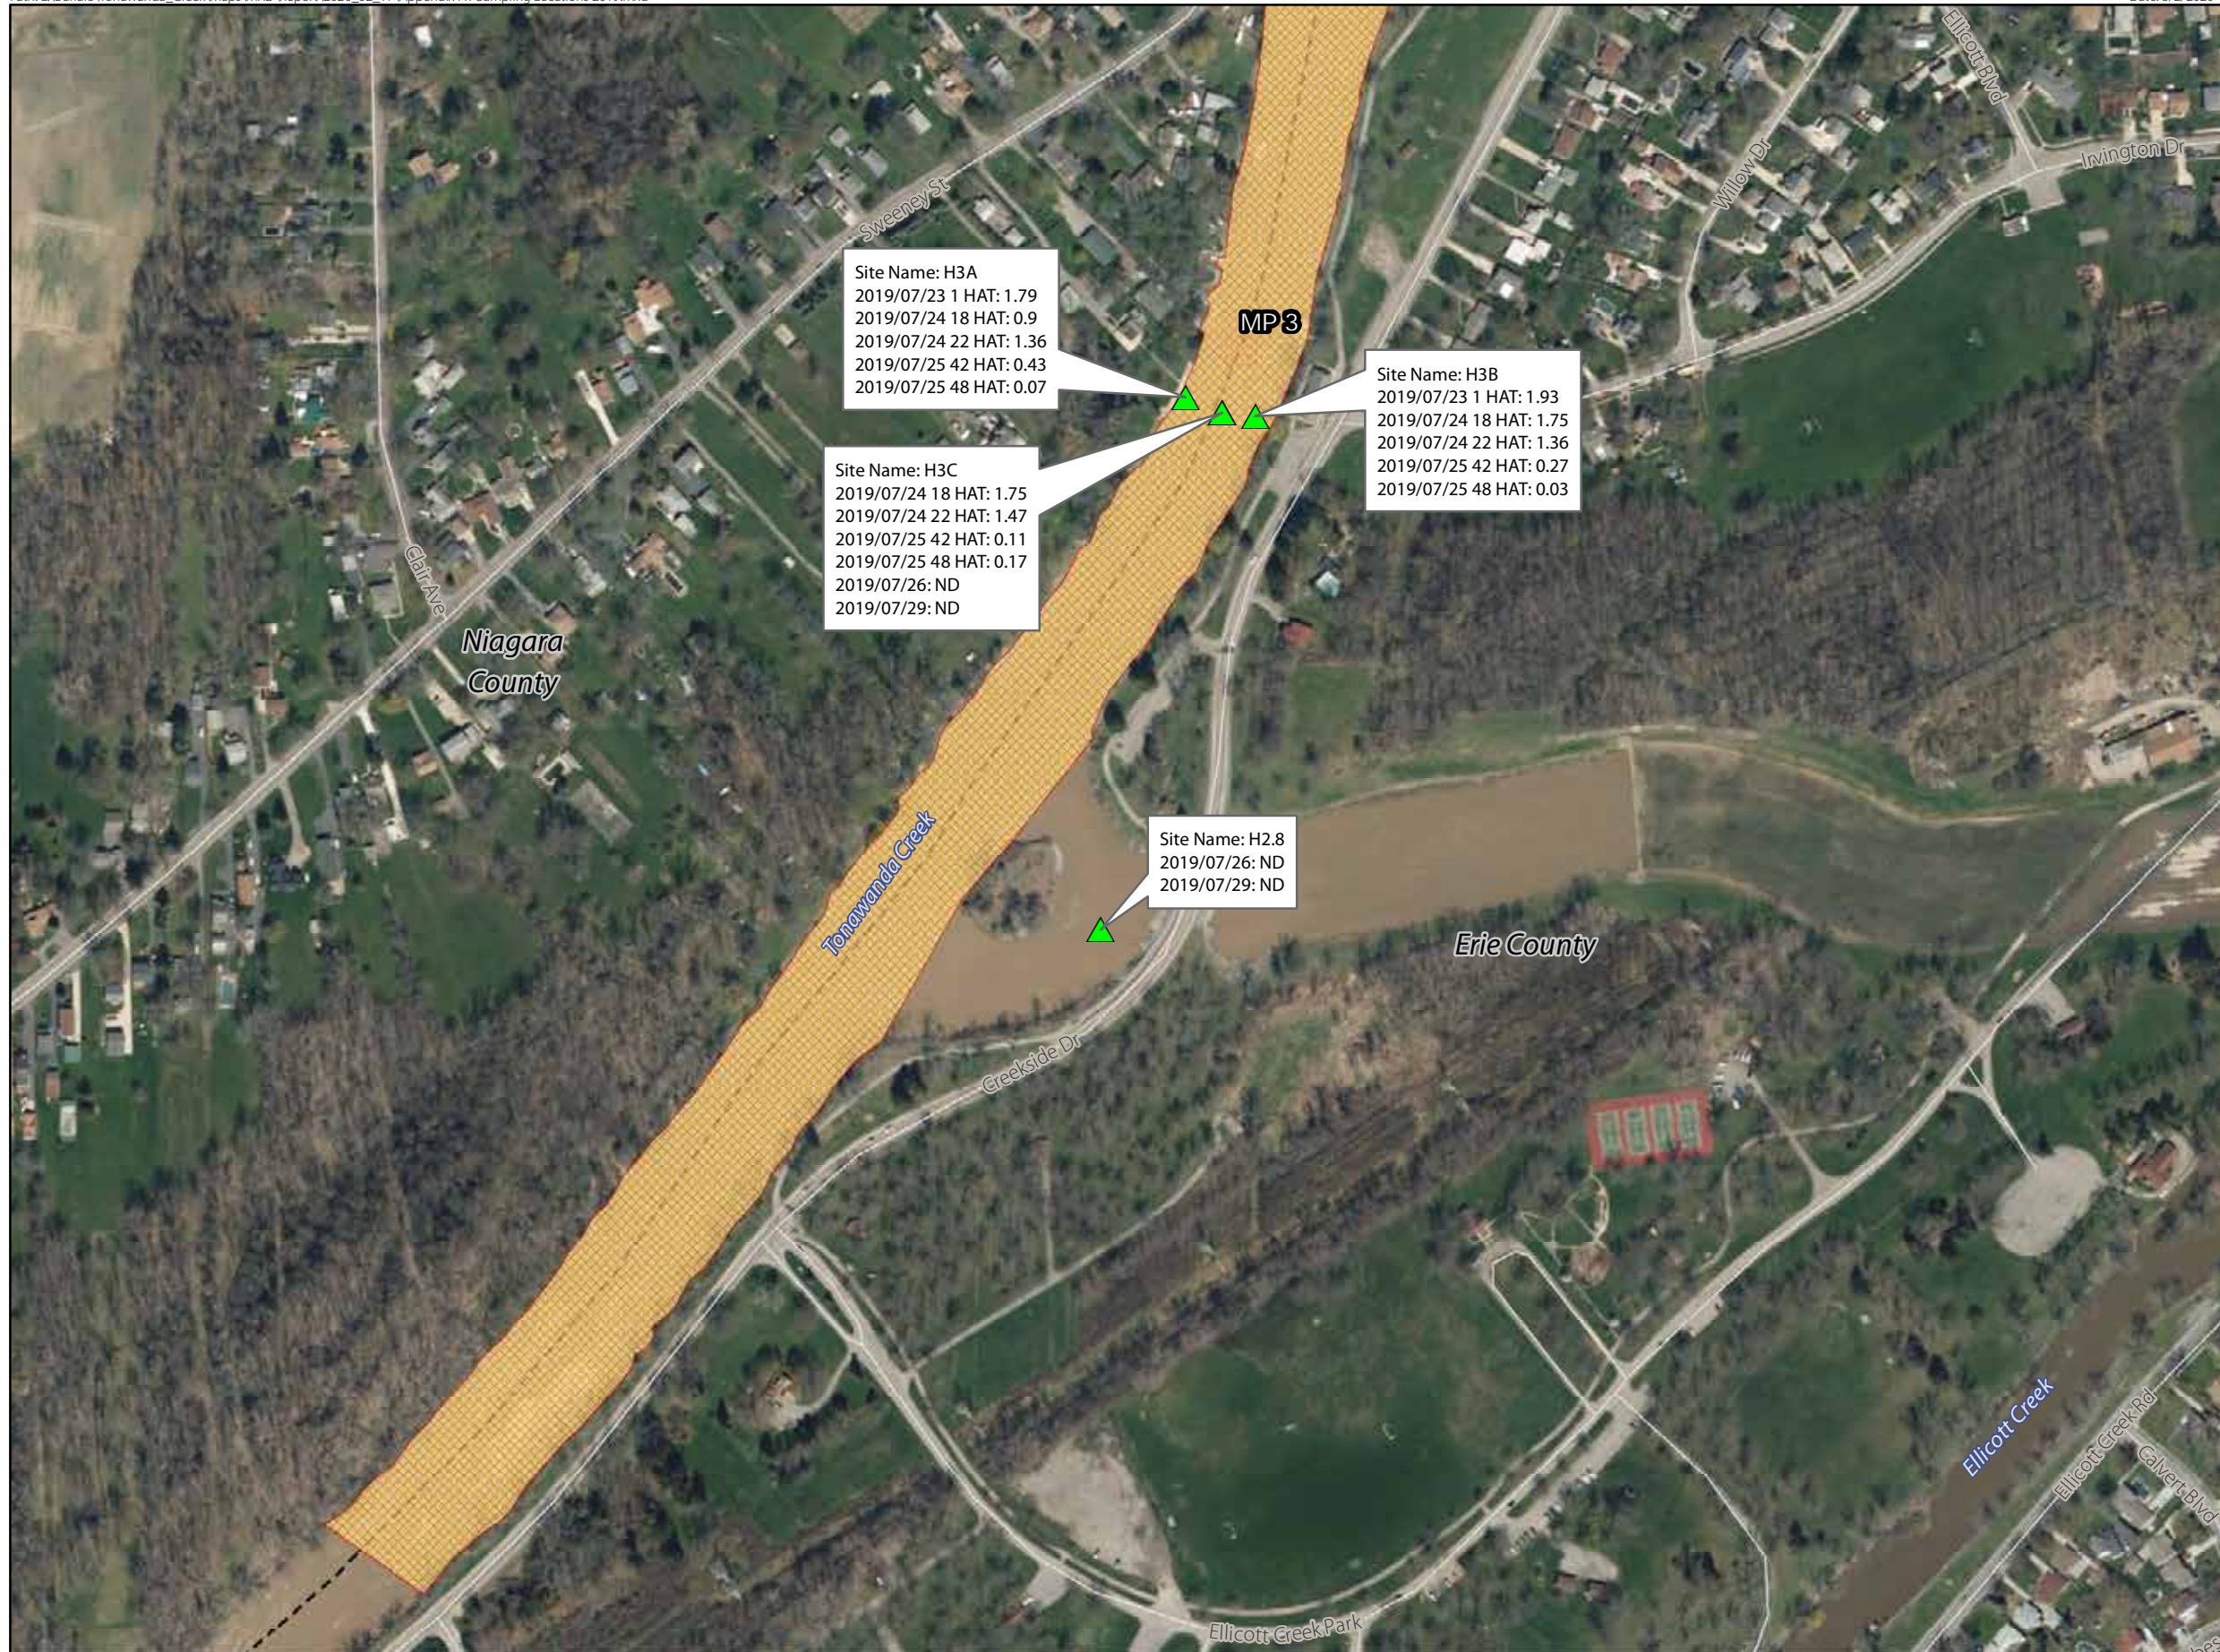
**July Endothall (Aquathol®K) Treatment  
 Figure A1-4  
 Tonawanda Creek/Erie Canal  
 Erie and Niagara Counties, New York**

- July Sample Locations 2019
- July Endothall (Aquathol®K) Treatment
- Mile Post
- County Boundary
- Roadway

\*Note: All sample locations are approximate  
 HAT- Hours After Treatment  
 ND- Non-Detect

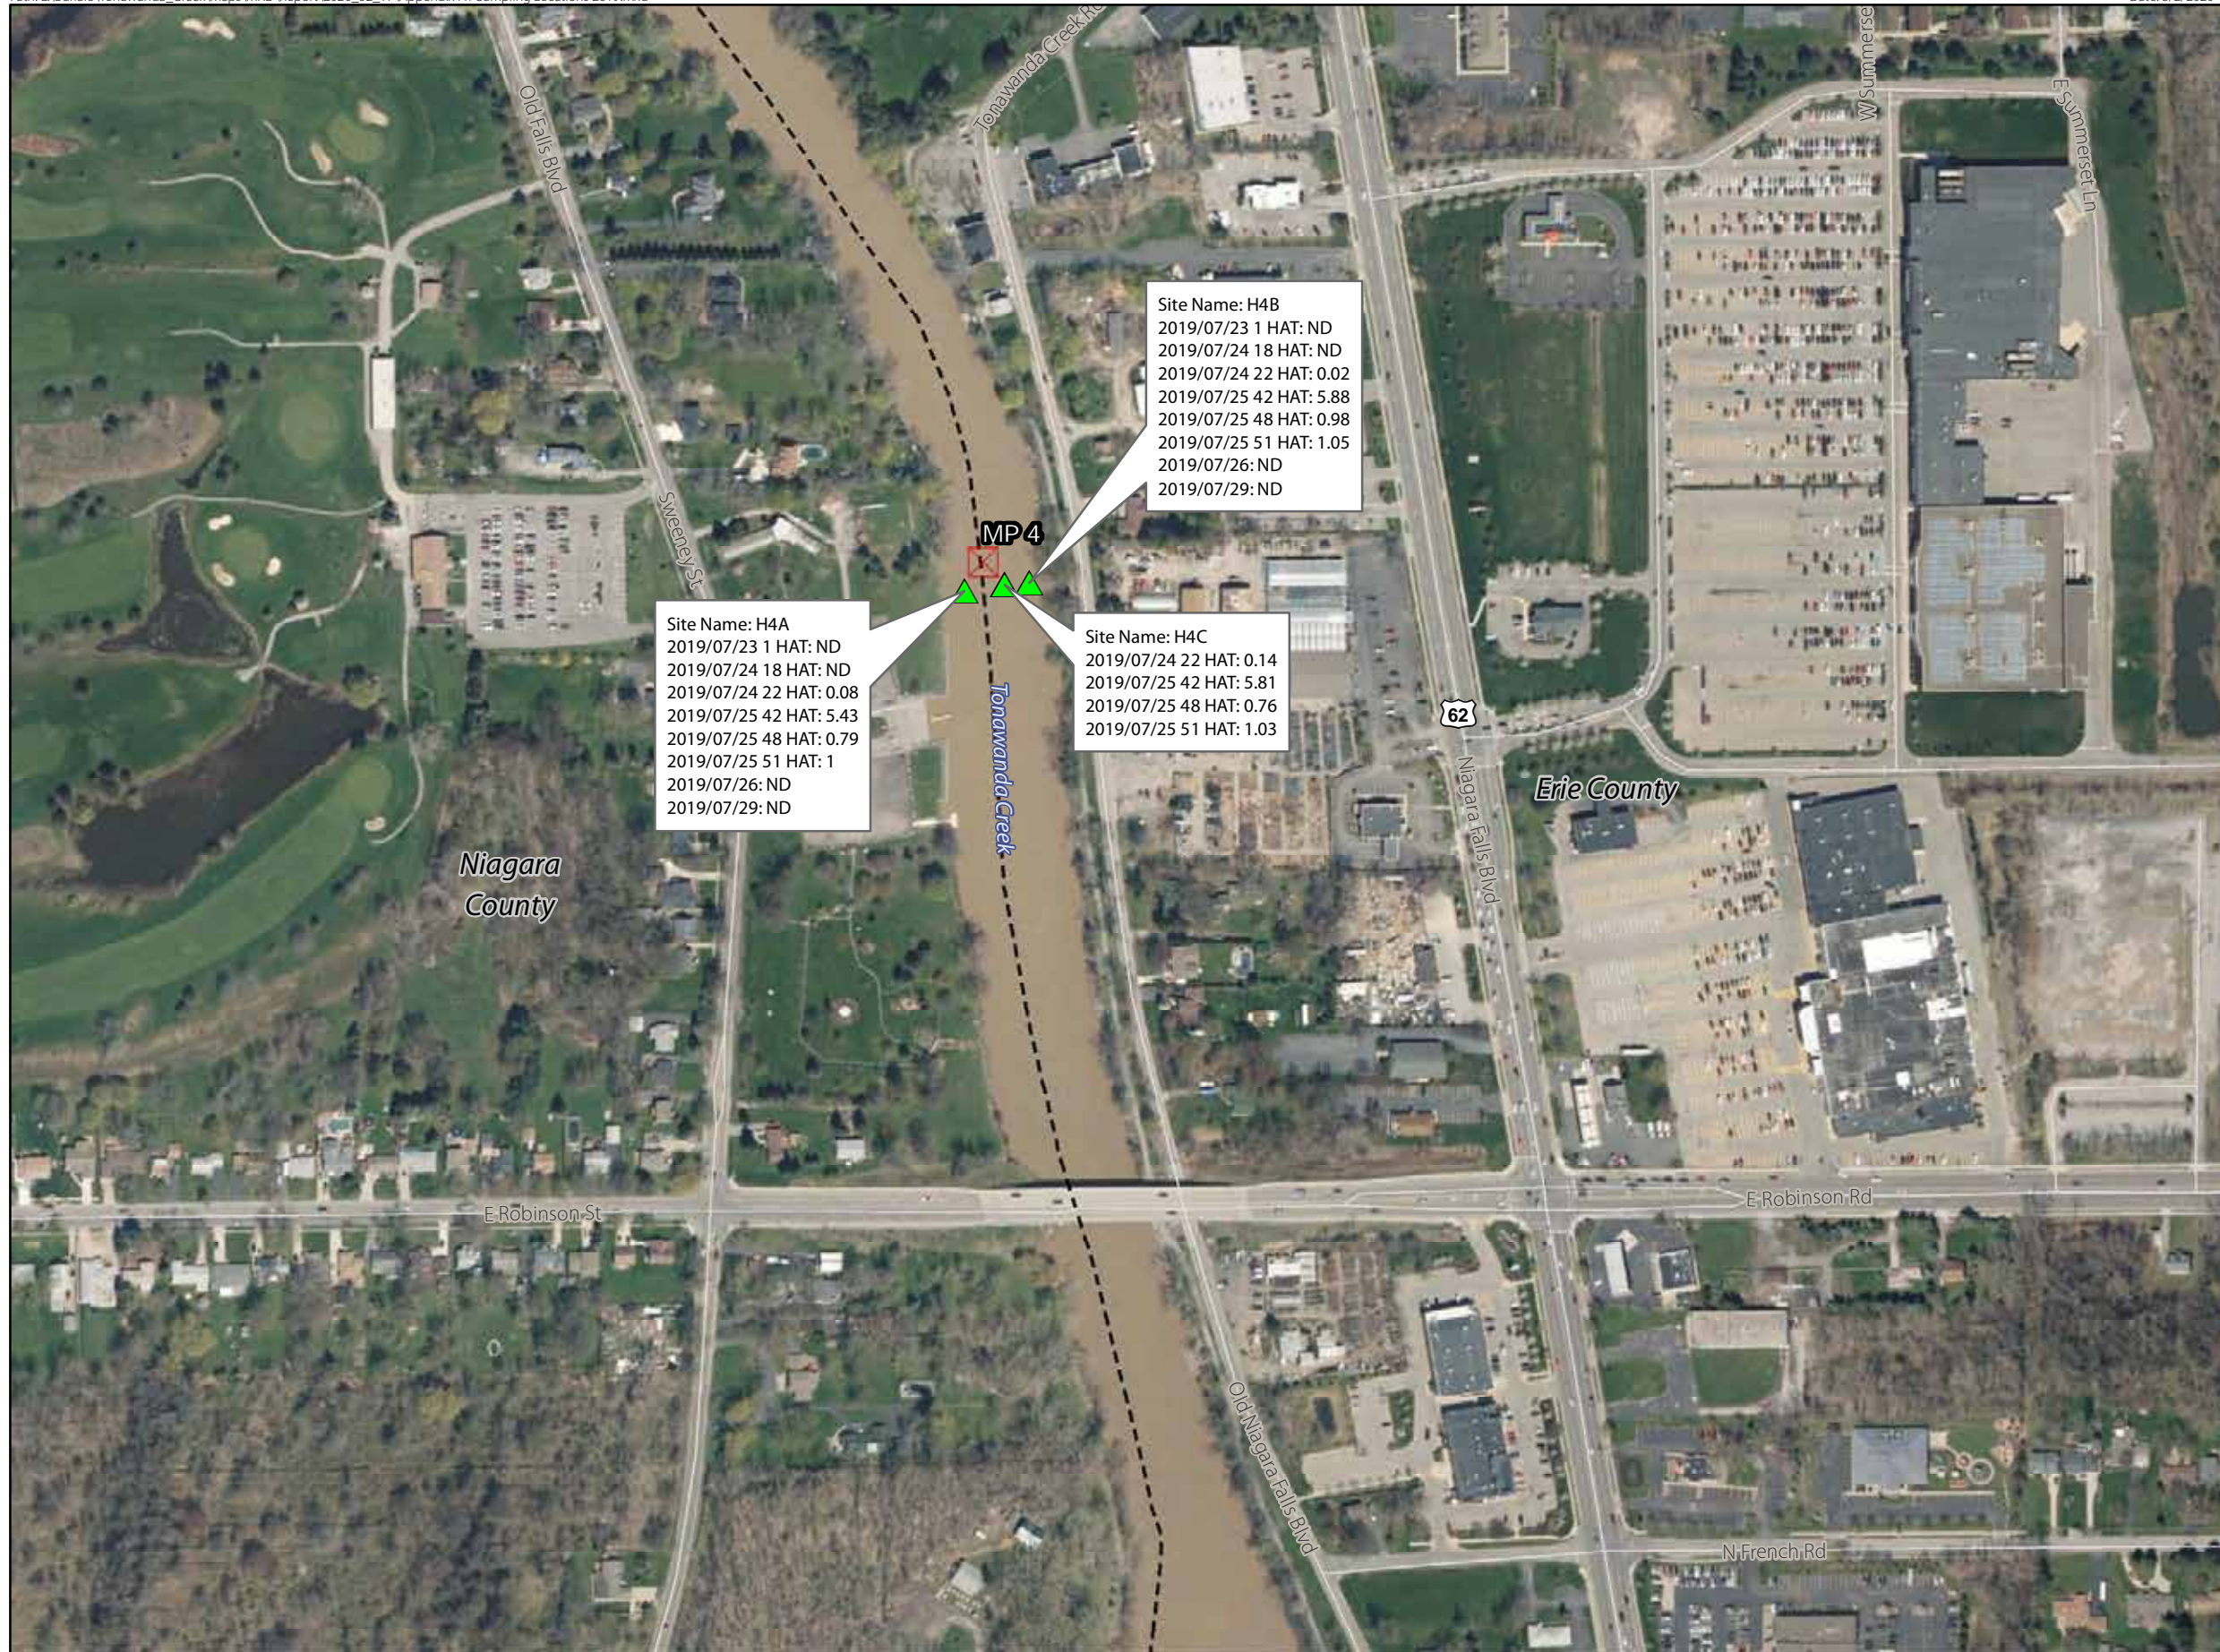
**July Endothall (Aquathol®K) Treatment  
 Figure A1-6  
 Tonawanda Creek/Erie Canal  
 Erie and Niagara Counties, New York**

- ▲ July Sample Locations 2019
- X Mile Post
- County Boundary
- Roadway

\*Note: All sample locations are approximate  
 HAT- Hours After Treatment  
 ND- Non-Detect

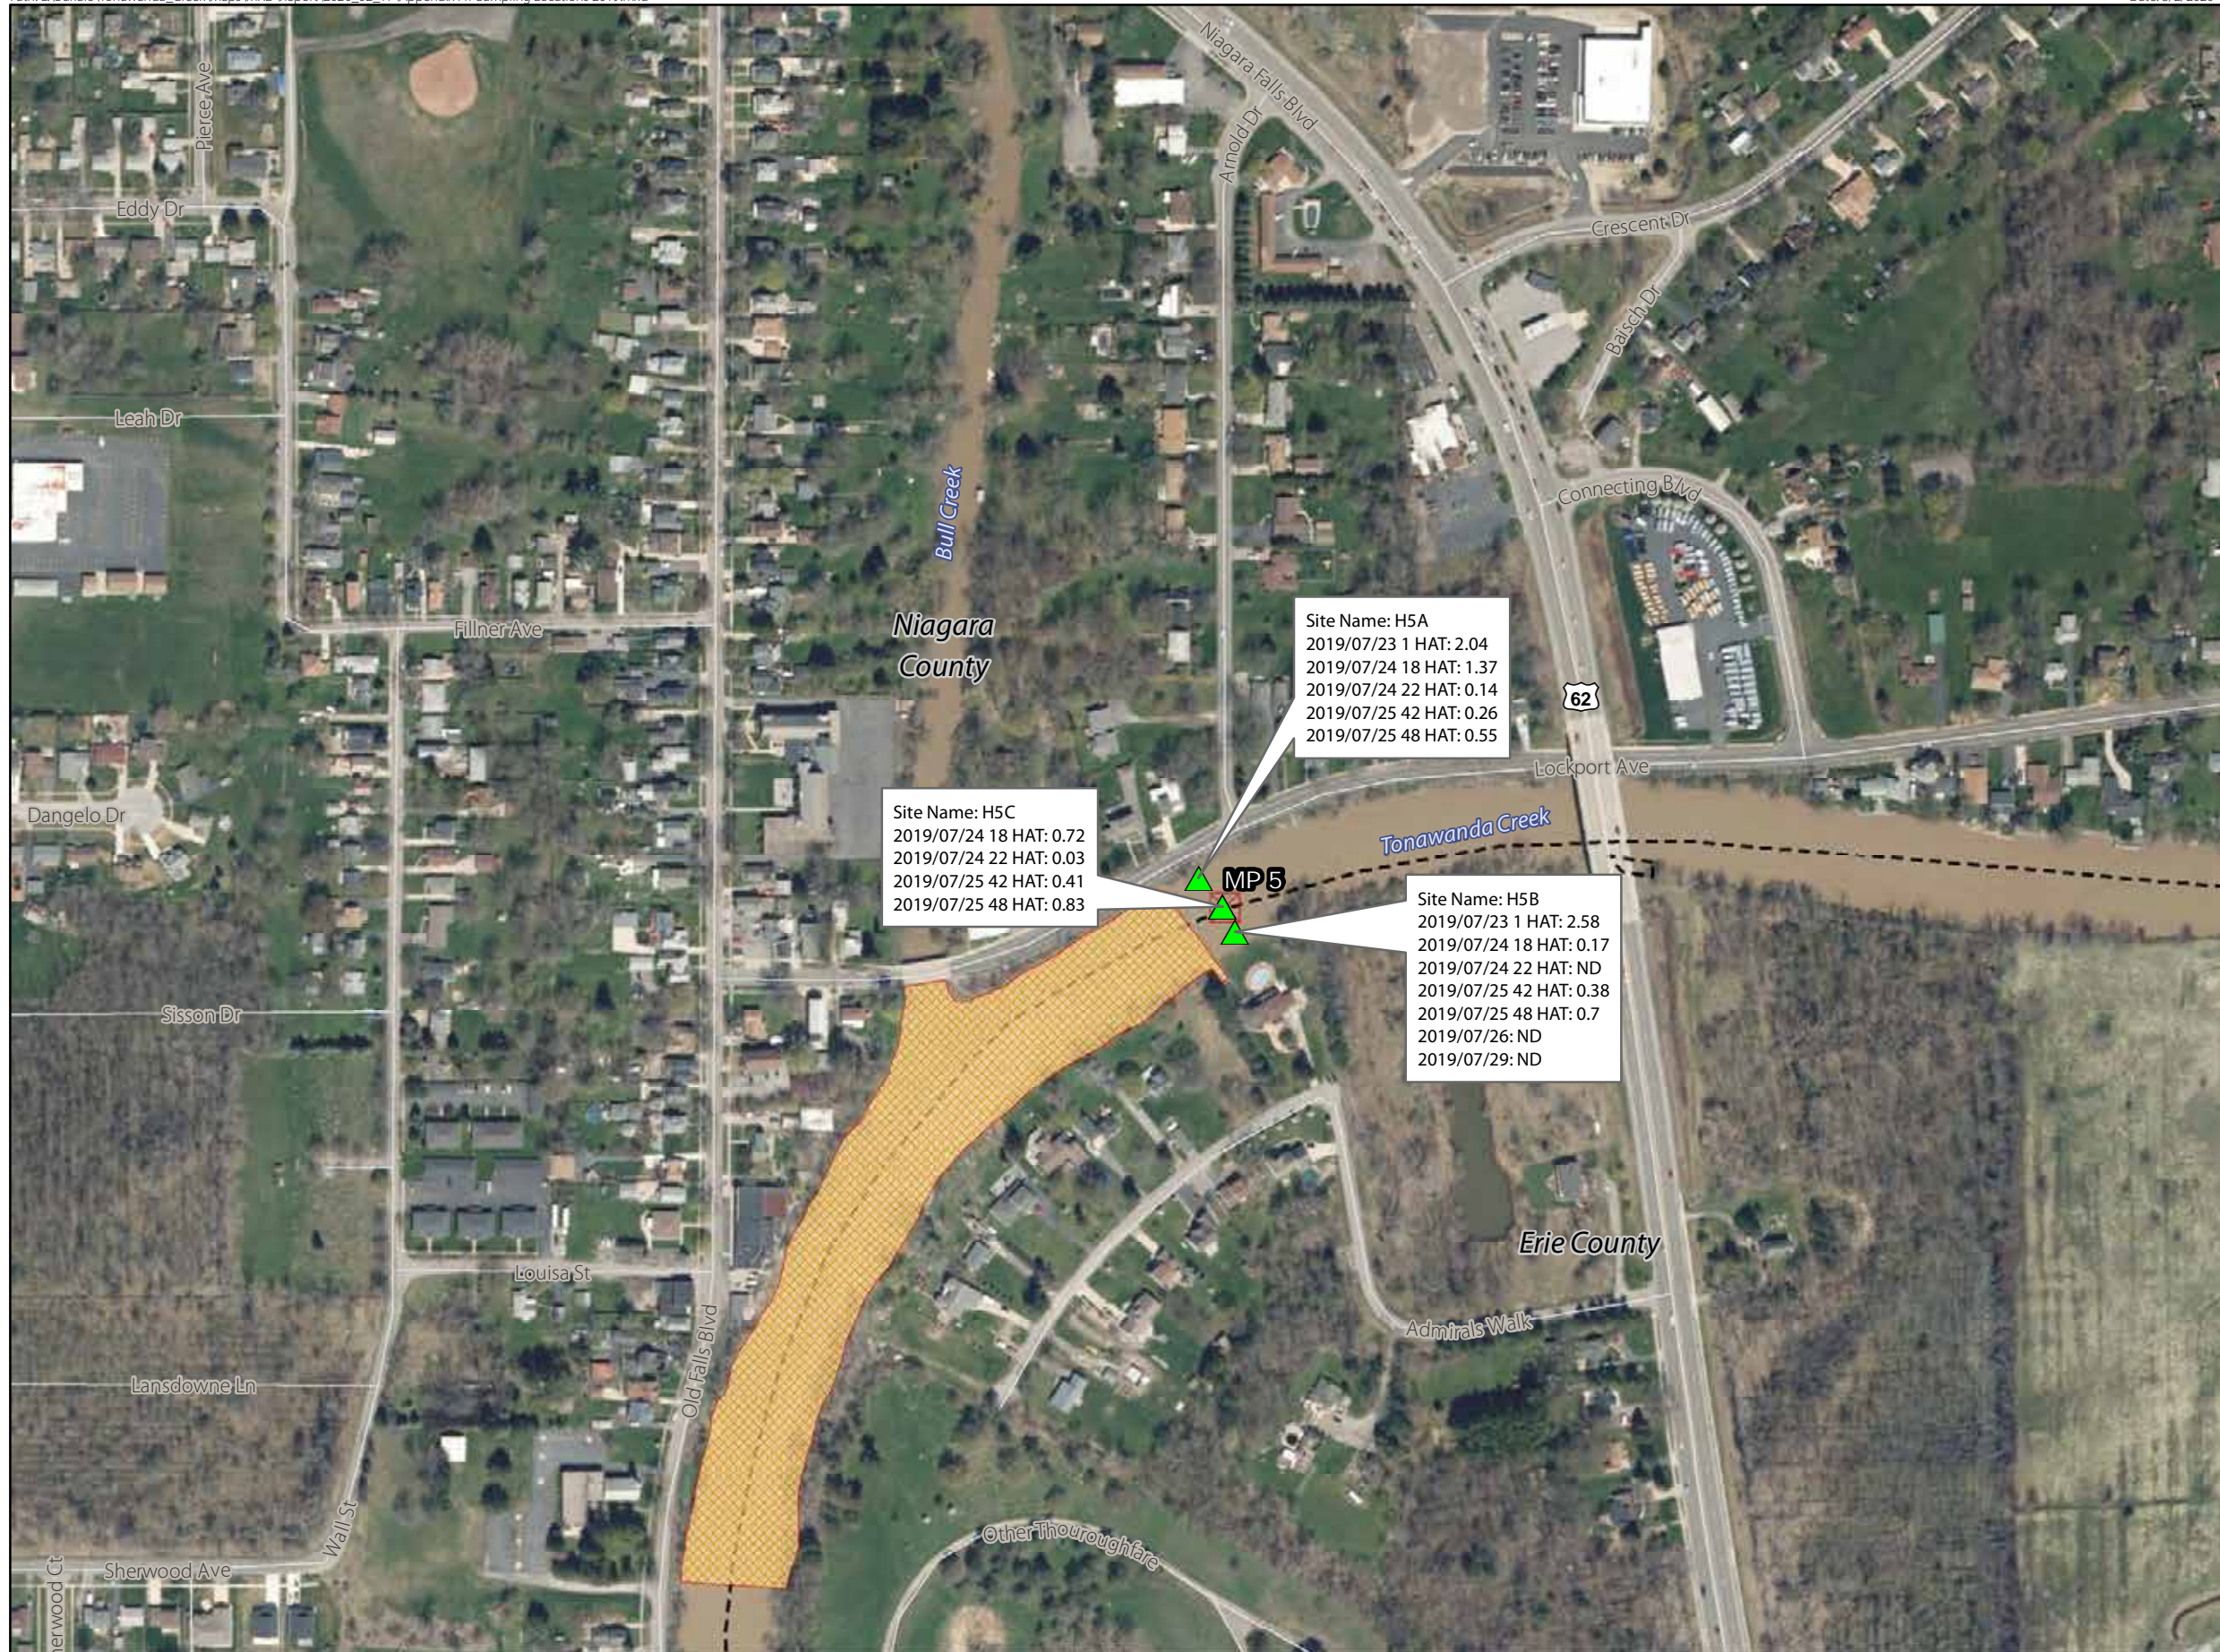
**July Endothall (Aquathol®K) Treatment  
Figure A1-7  
Tonawanda Creek/Erie Canal  
Erie and Niagara Counties, New York**

Site Name: H5C  
2019/07/24 18 HAT: 0.72  
2019/07/24 22 HAT: 0.03  
2019/07/25 42 HAT: 0.41  
2019/07/25 48 HAT: 0.83

Site Name: H5B  
2019/07/23 1 HAT: 2.58  
2019/07/24 18 HAT: 0.17  
2019/07/24 22 HAT: ND  
2019/07/25 42 HAT: 0.38  
2019/07/25 48 HAT: 0.7  
2019/07/26: ND  
2019/07/29: ND

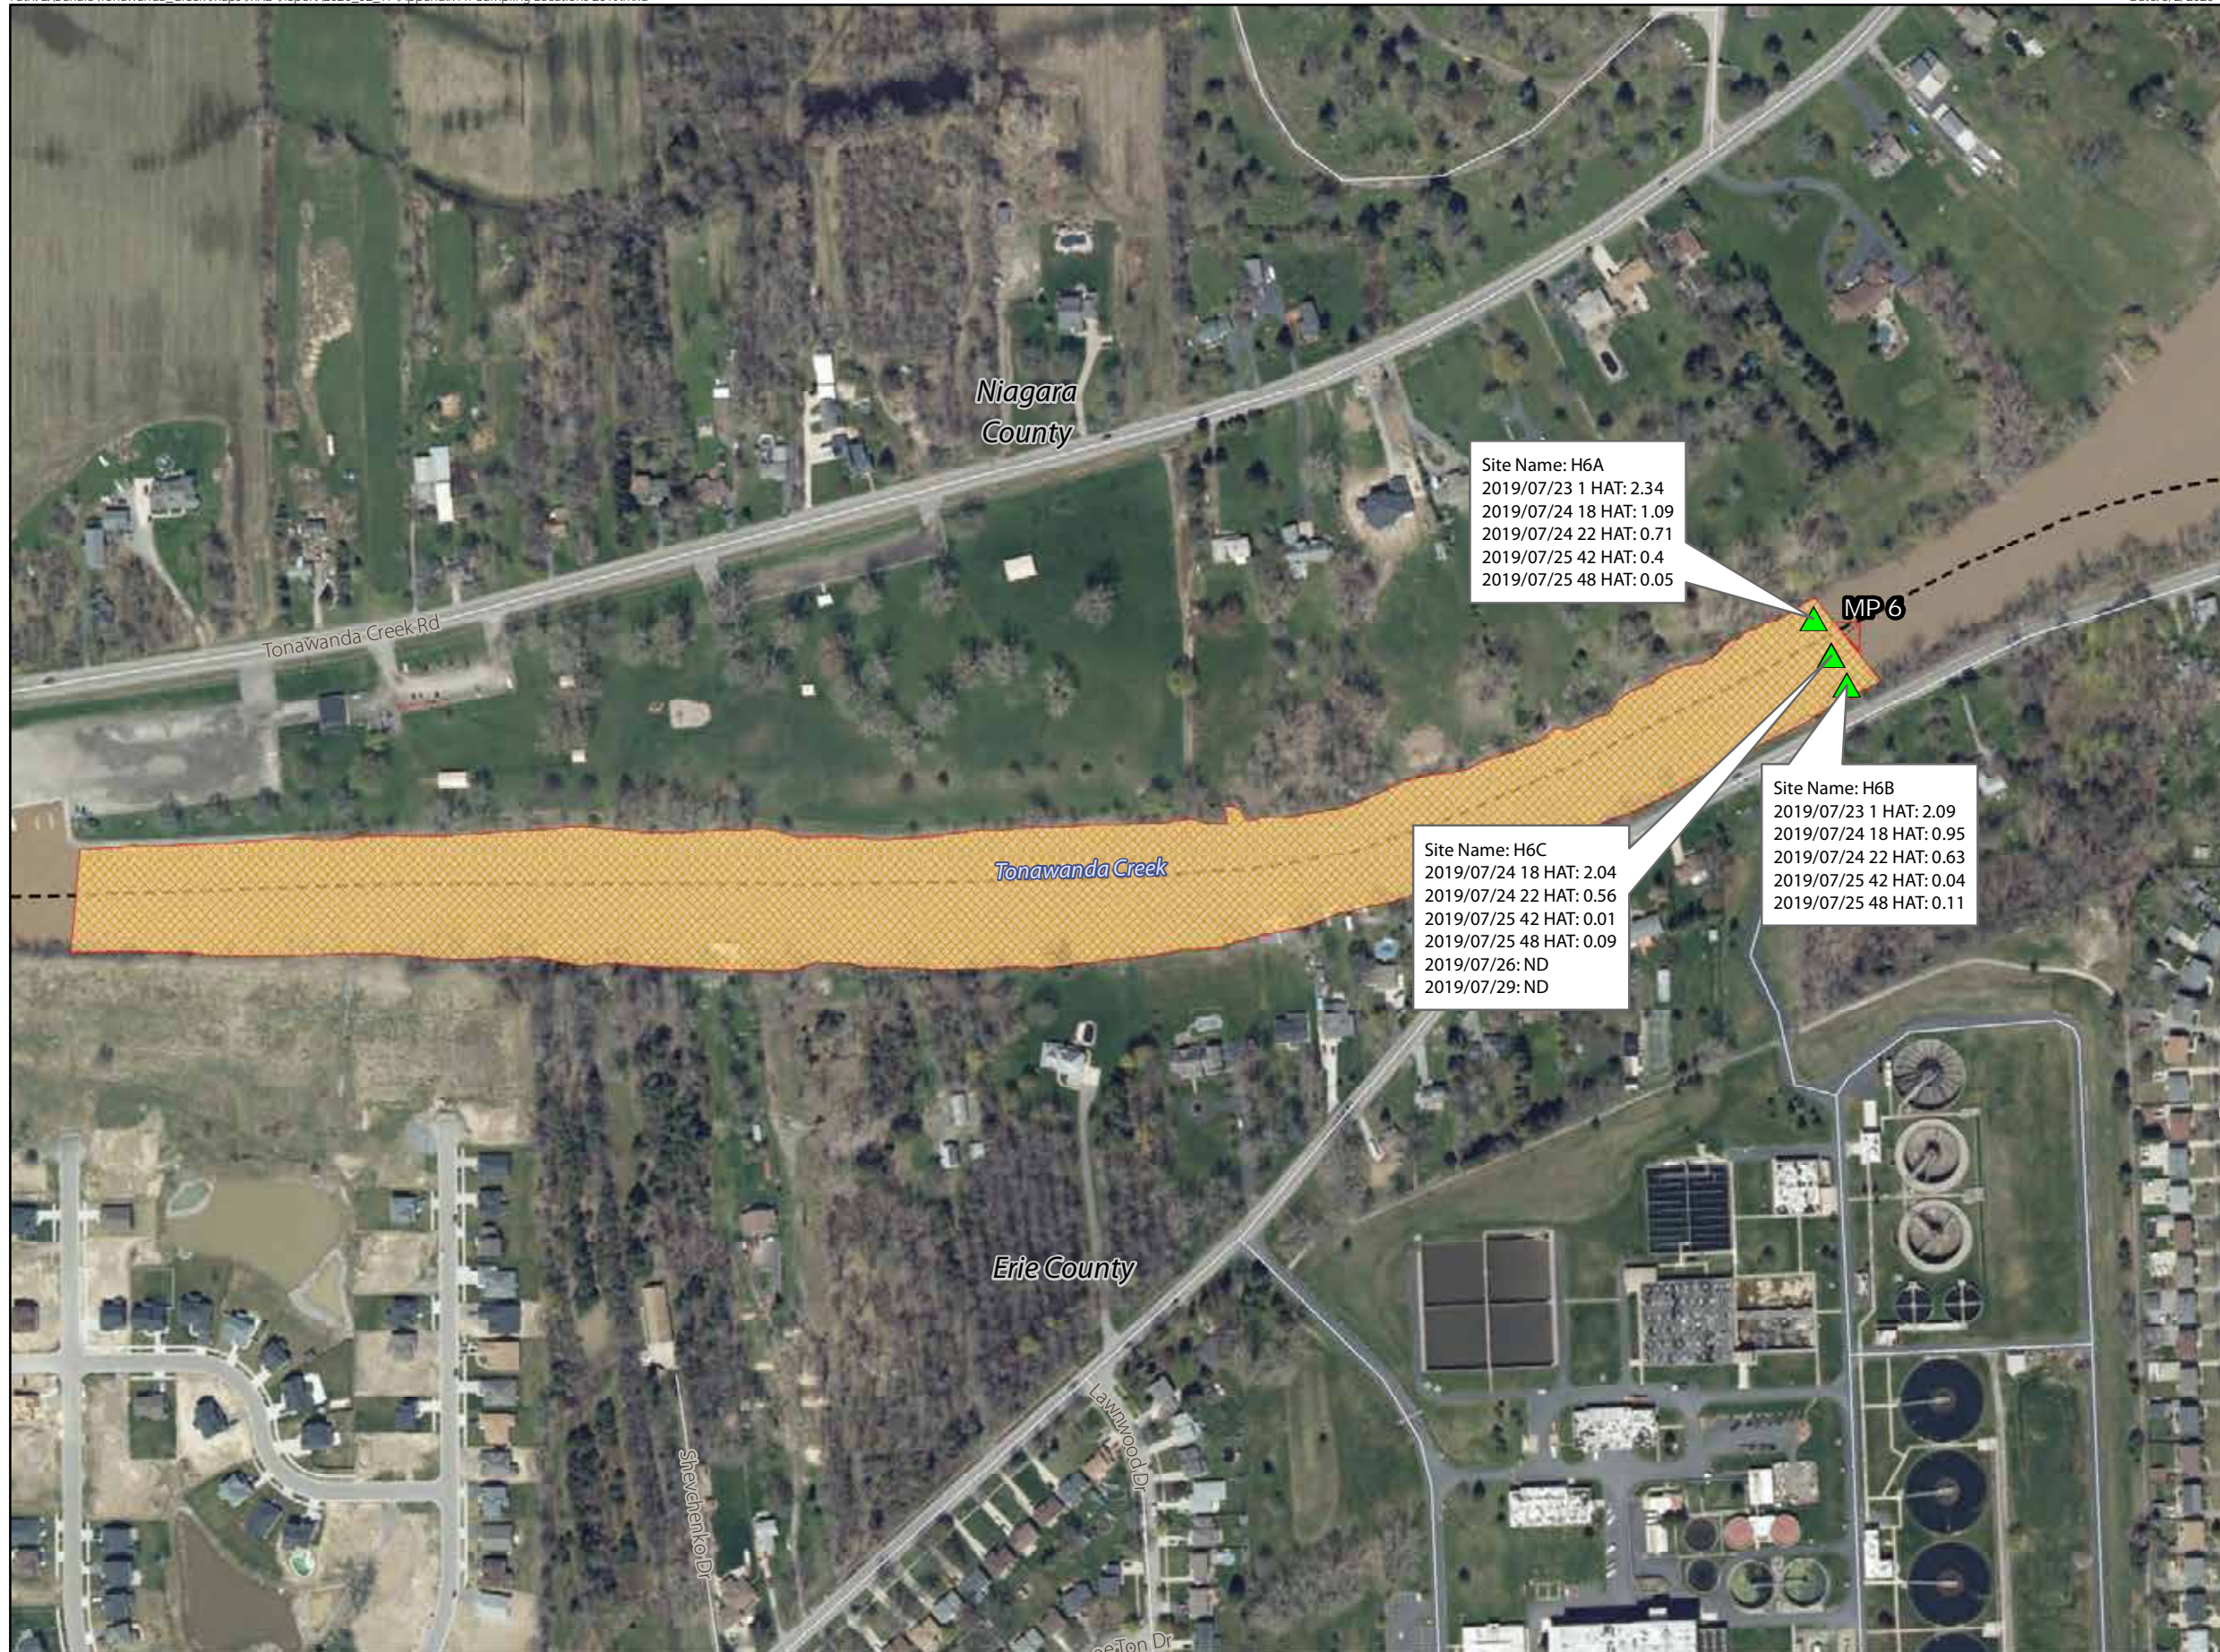
Site Name: H6A  
 2019/07/23 1 HAT: 2.34  
 2019/07/24 18 HAT: 1.09  
 2019/07/24 22 HAT: 0.71  
 2019/07/25 42 HAT: 0.4  
 2019/07/25 48 HAT: 0.05

Site Name: H6C  
 2019/07/24 18 HAT: 2.04  
 2019/07/24 22 HAT: 0.56  
 2019/07/25 42 HAT: 0.01  
 2019/07/25 48 HAT: 0.09  
 2019/07/26: ND  
 2019/07/29: ND

- July Sample Locations 2019
- July Endothall (Aquathol®K) Treatment
- Mile Post
- County Boundary
- Roadway

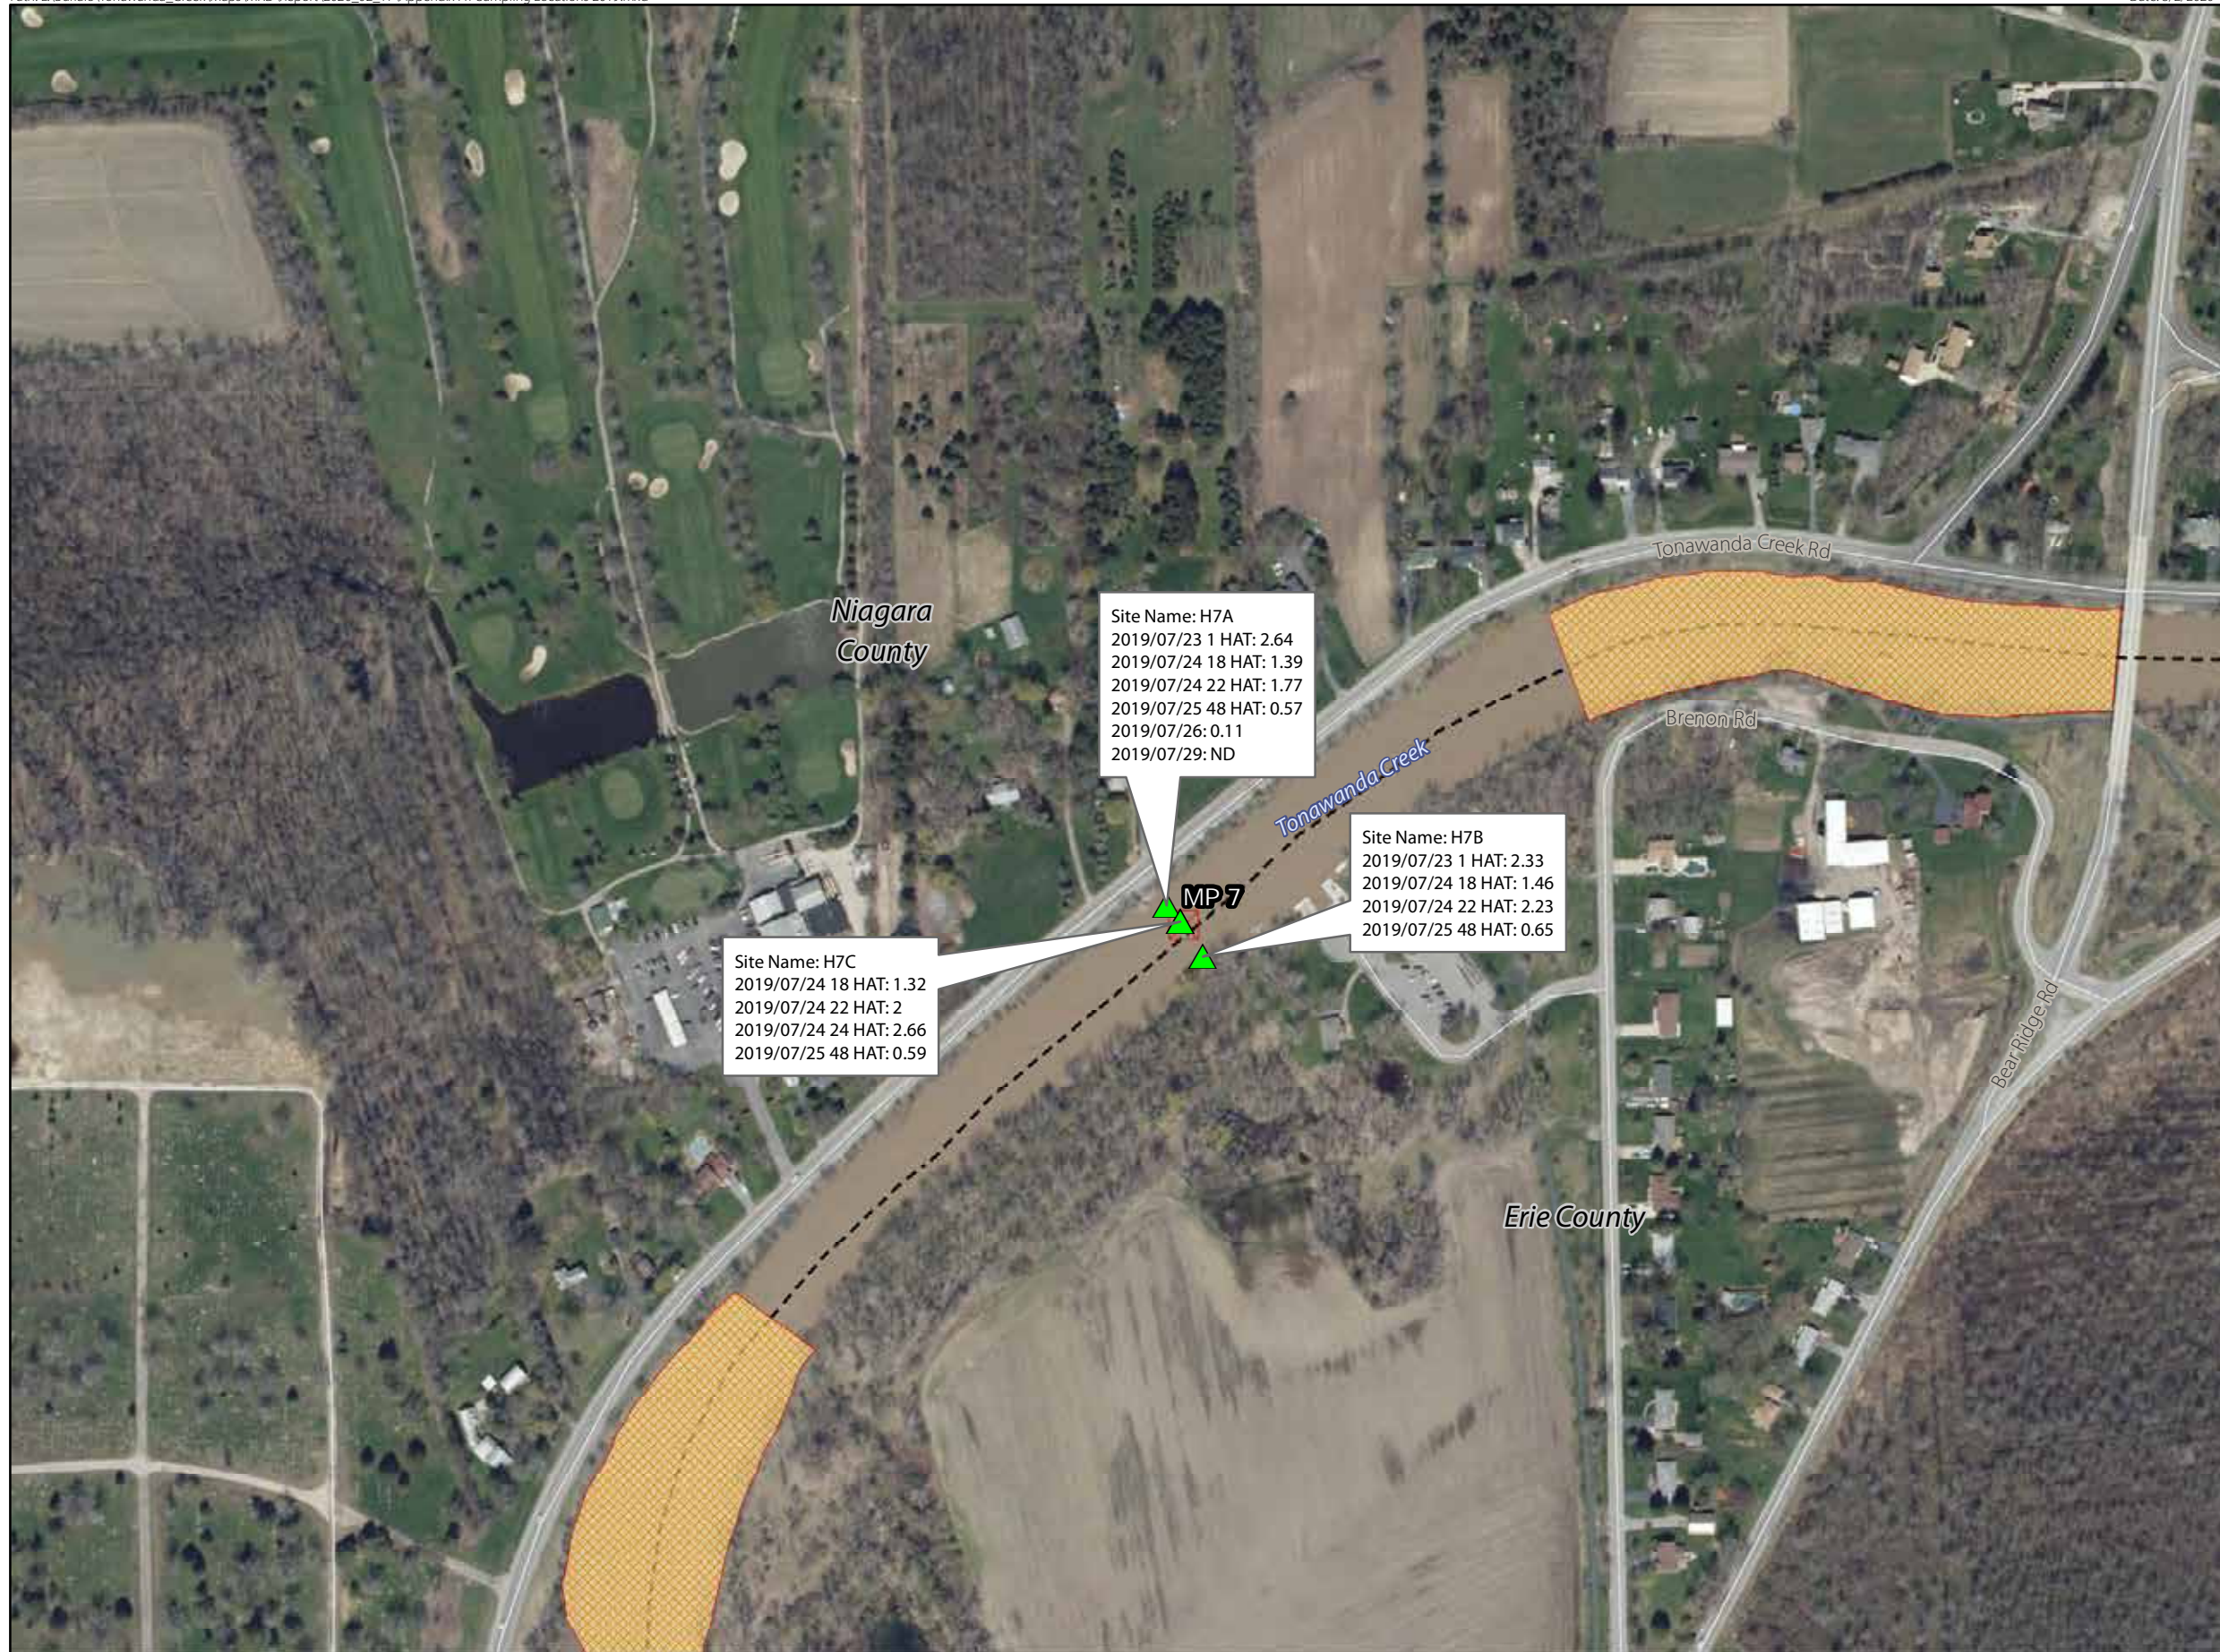
**July Endothall (Aquatho®K) Treatment  
 Figure A1-10  
 Tonawanda Creek/Erie Canal  
 Erie and Niagara Counties, New York**

- July Sample Locations 2019
- July Endothall (Aquatho®K) Treatment
- Mile Post
- County Boundary
- Roadway

\*Note: All sample locations are approximate  
 HAT- Hours After Treatment  
 ND- Non-Detect

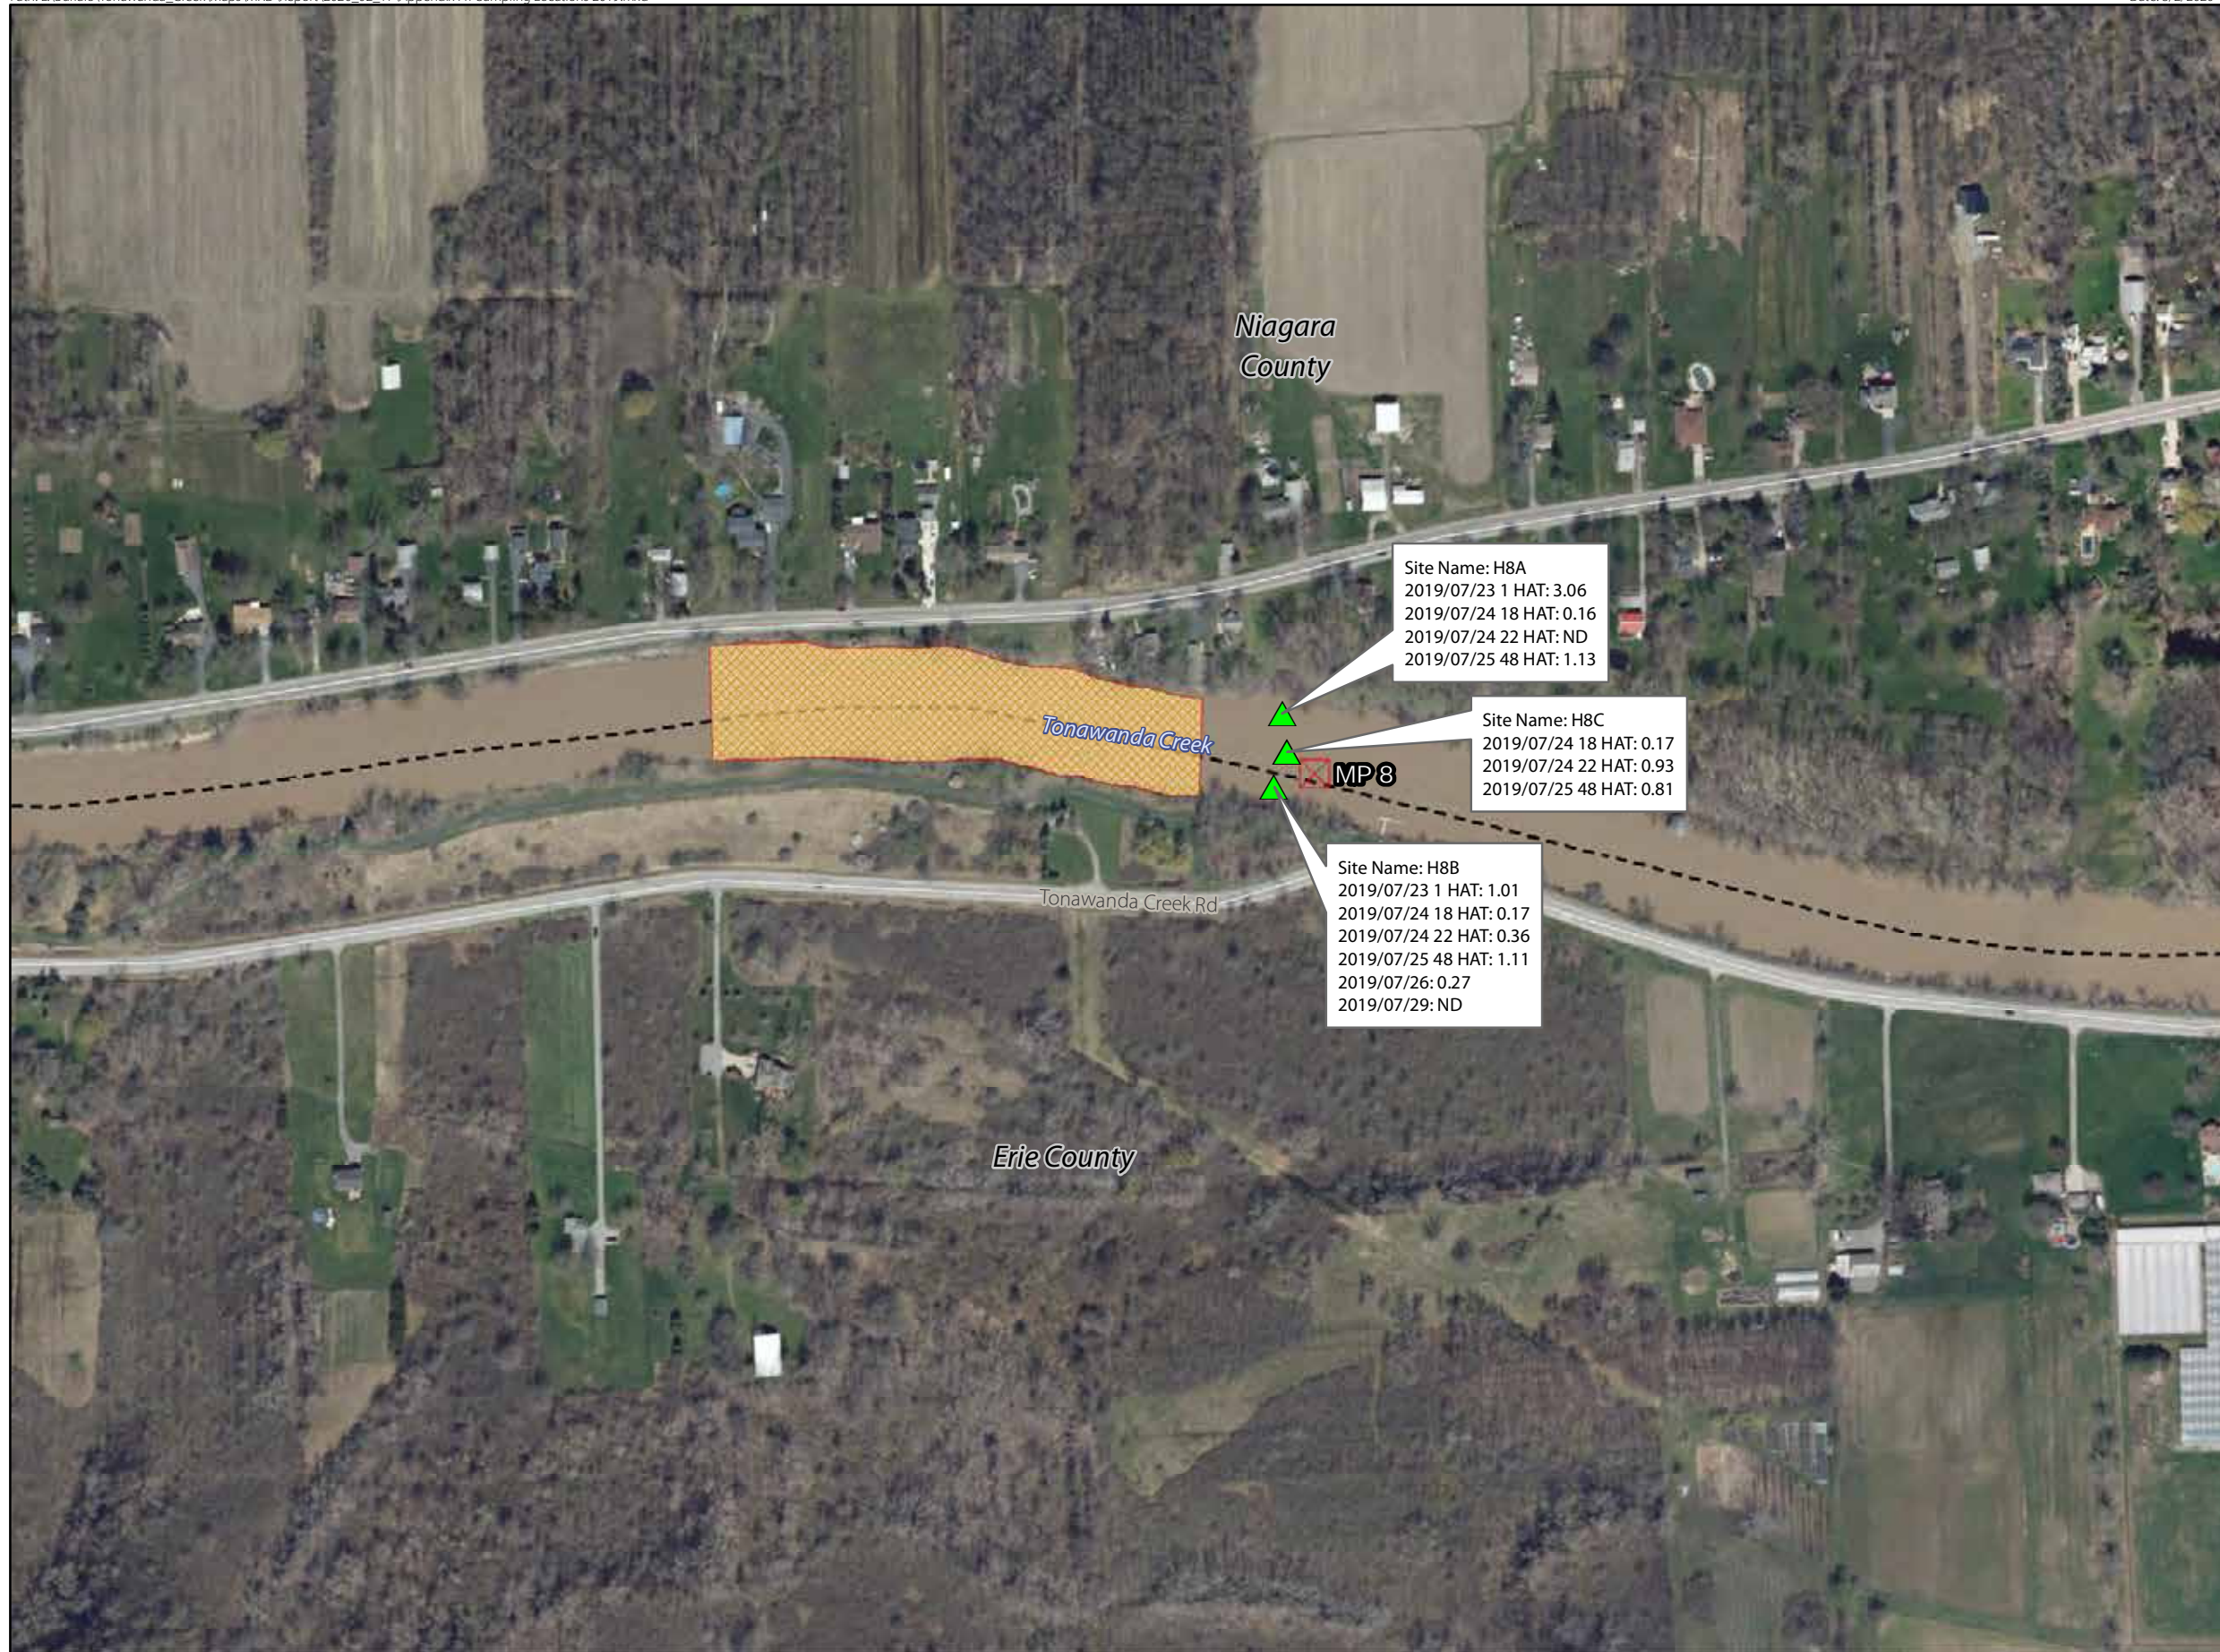
**July Endothall (Aquathol®K) Treatment  
 Figure A1-11  
 Tonawanda Creek/Erie Canal  
 Erie and Niagara Counties, New York**

- July Sample Locations 2019
- July Endothall (Aquathol®K) Treatment
- Mile Post
- County Boundary
- Roadway

\*Note: All sample locations are approximate  
 HAT- Hours After Treatment  
 ND- Non-Detect
