**Final Post-Treatment Assessment  
for Aquatic Plant Control  
ERDC Demonstration Project  
Tonawanda Creek/Erie Canal  
2019**

**Contract No. W912P4-16-D-0002**

**May 2020**

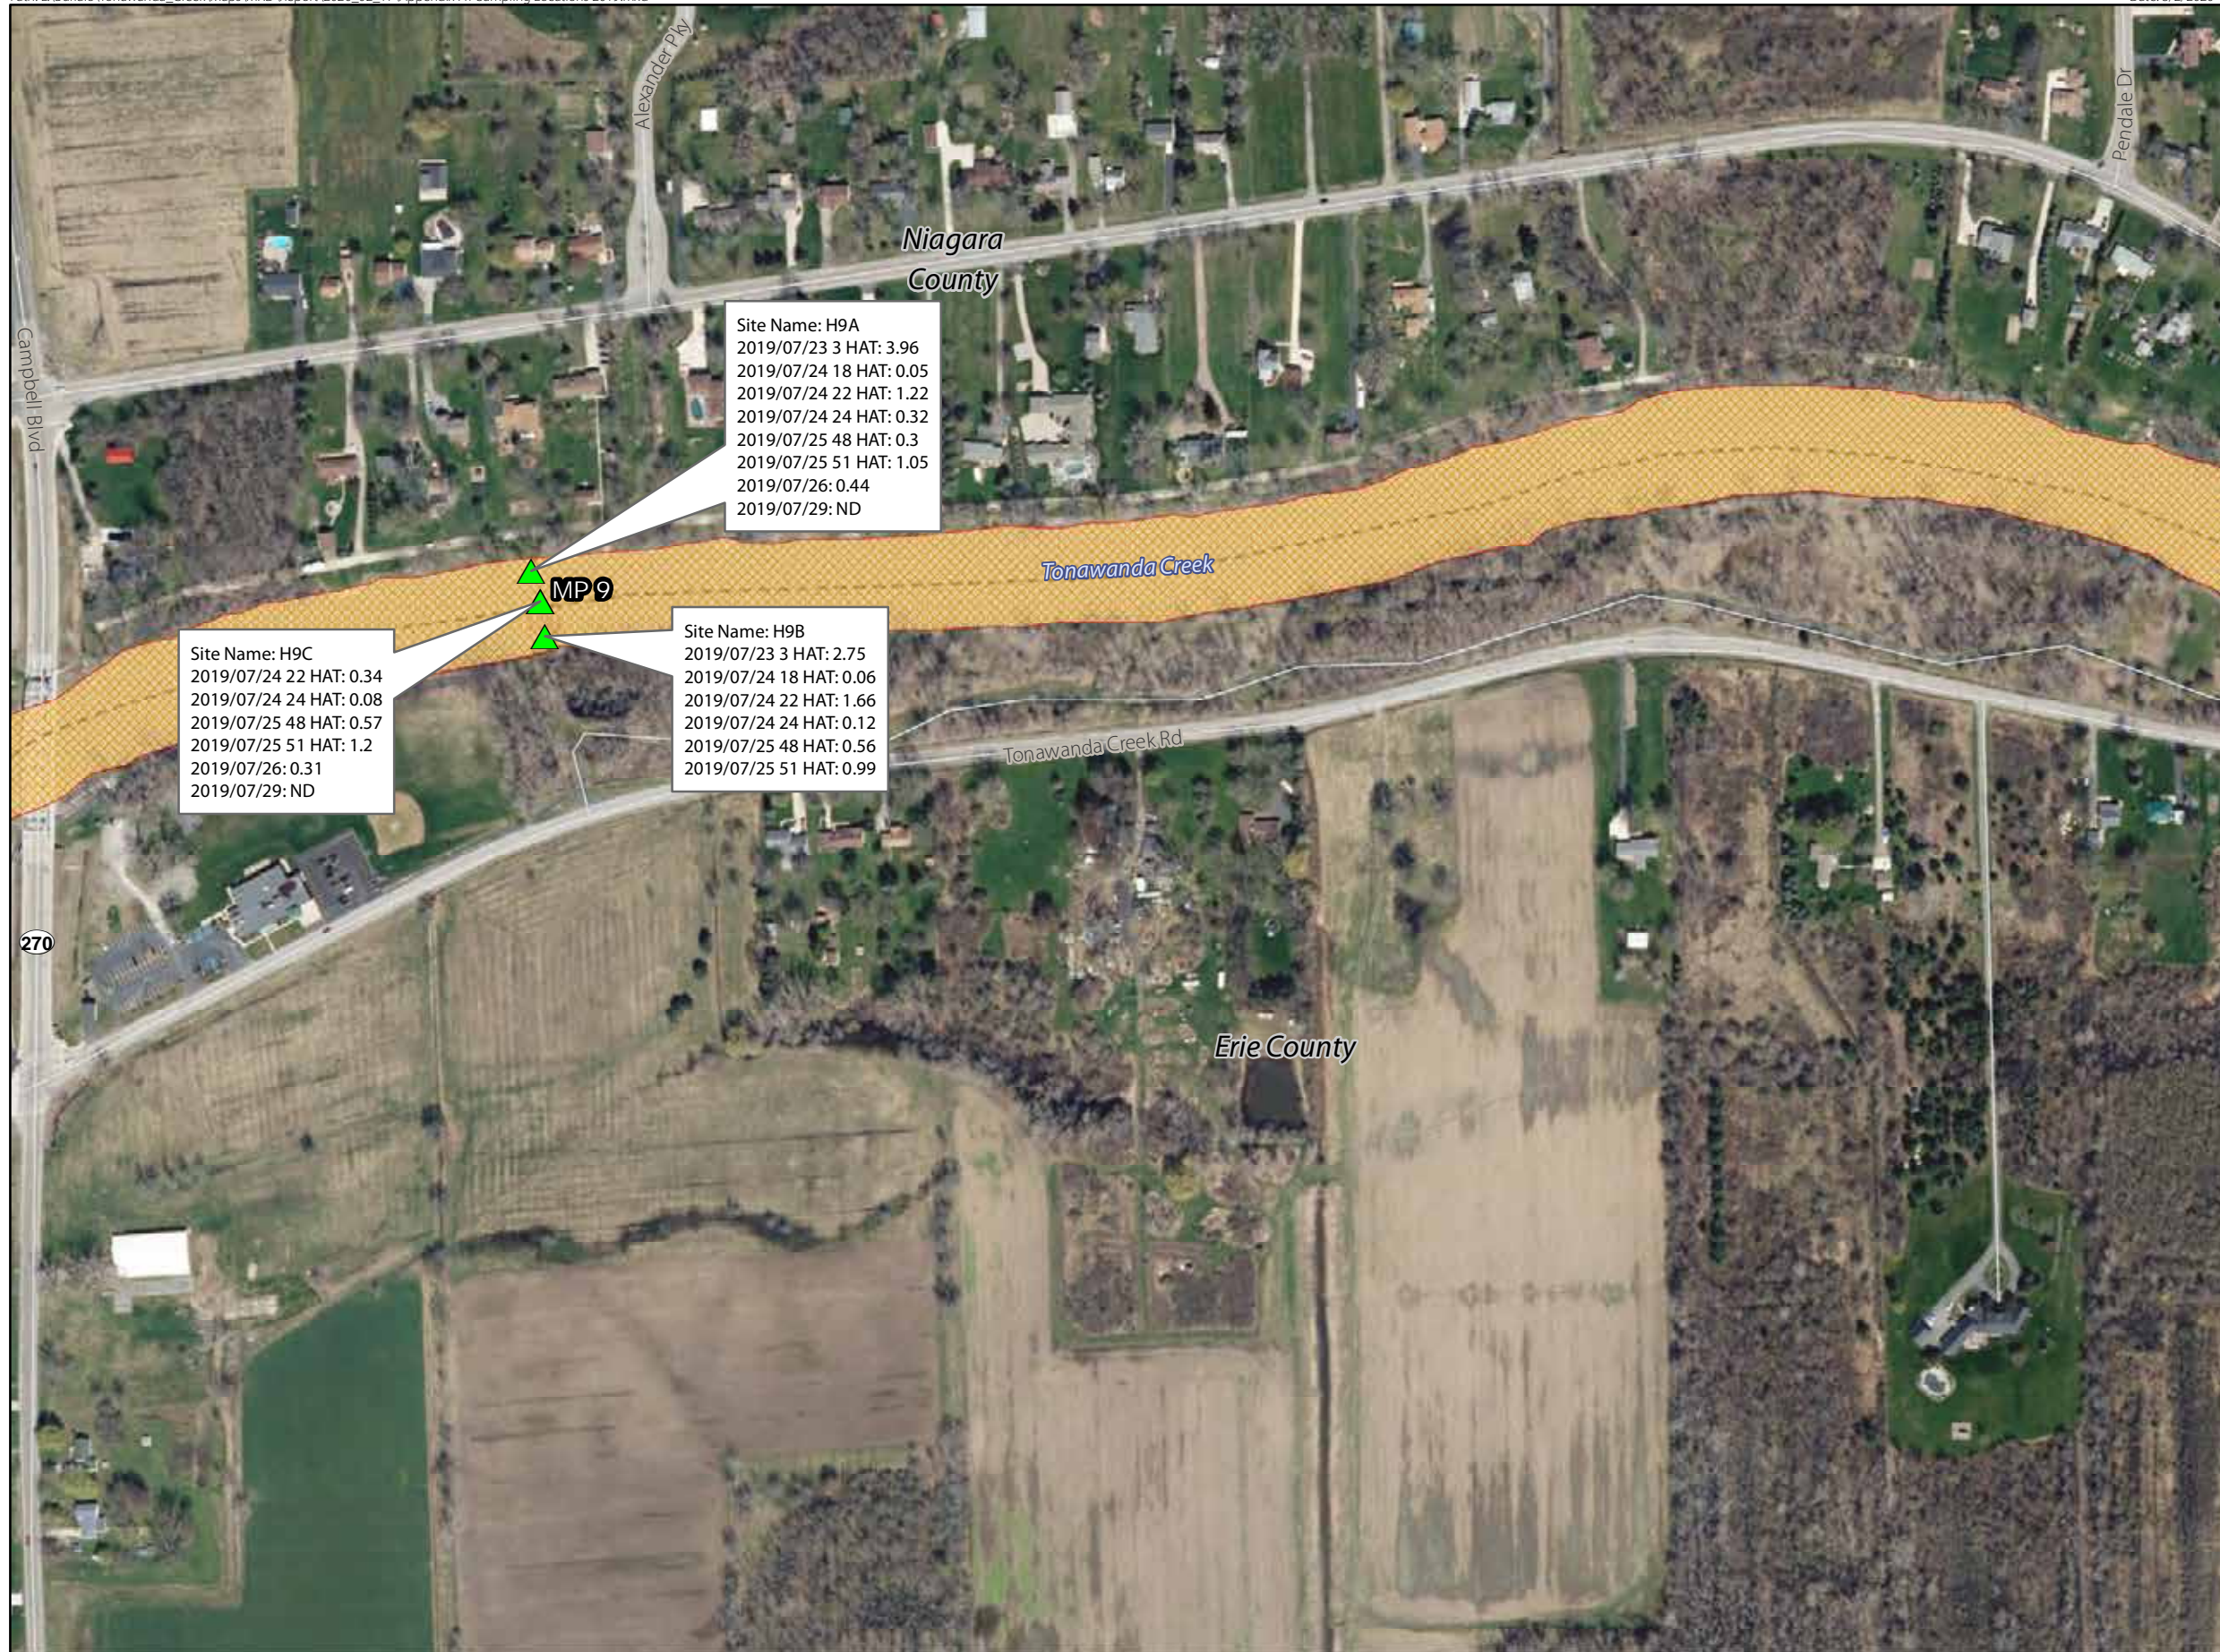
**July Endothall (Aquathol®K) Treatment  
 Figure A1-12  
 Tonawanda Creek/Erie Canal  
 Erie and Niagara Counties, New York**

- July Sample Locations 2019
- July Endothall (Aquathol®K) Treatment
- Mile Post
- County Boundary
- Roadway

\*Note: All sample locations are approximate  
 HAT- Hours After Treatment  
 ND- Non-Detect

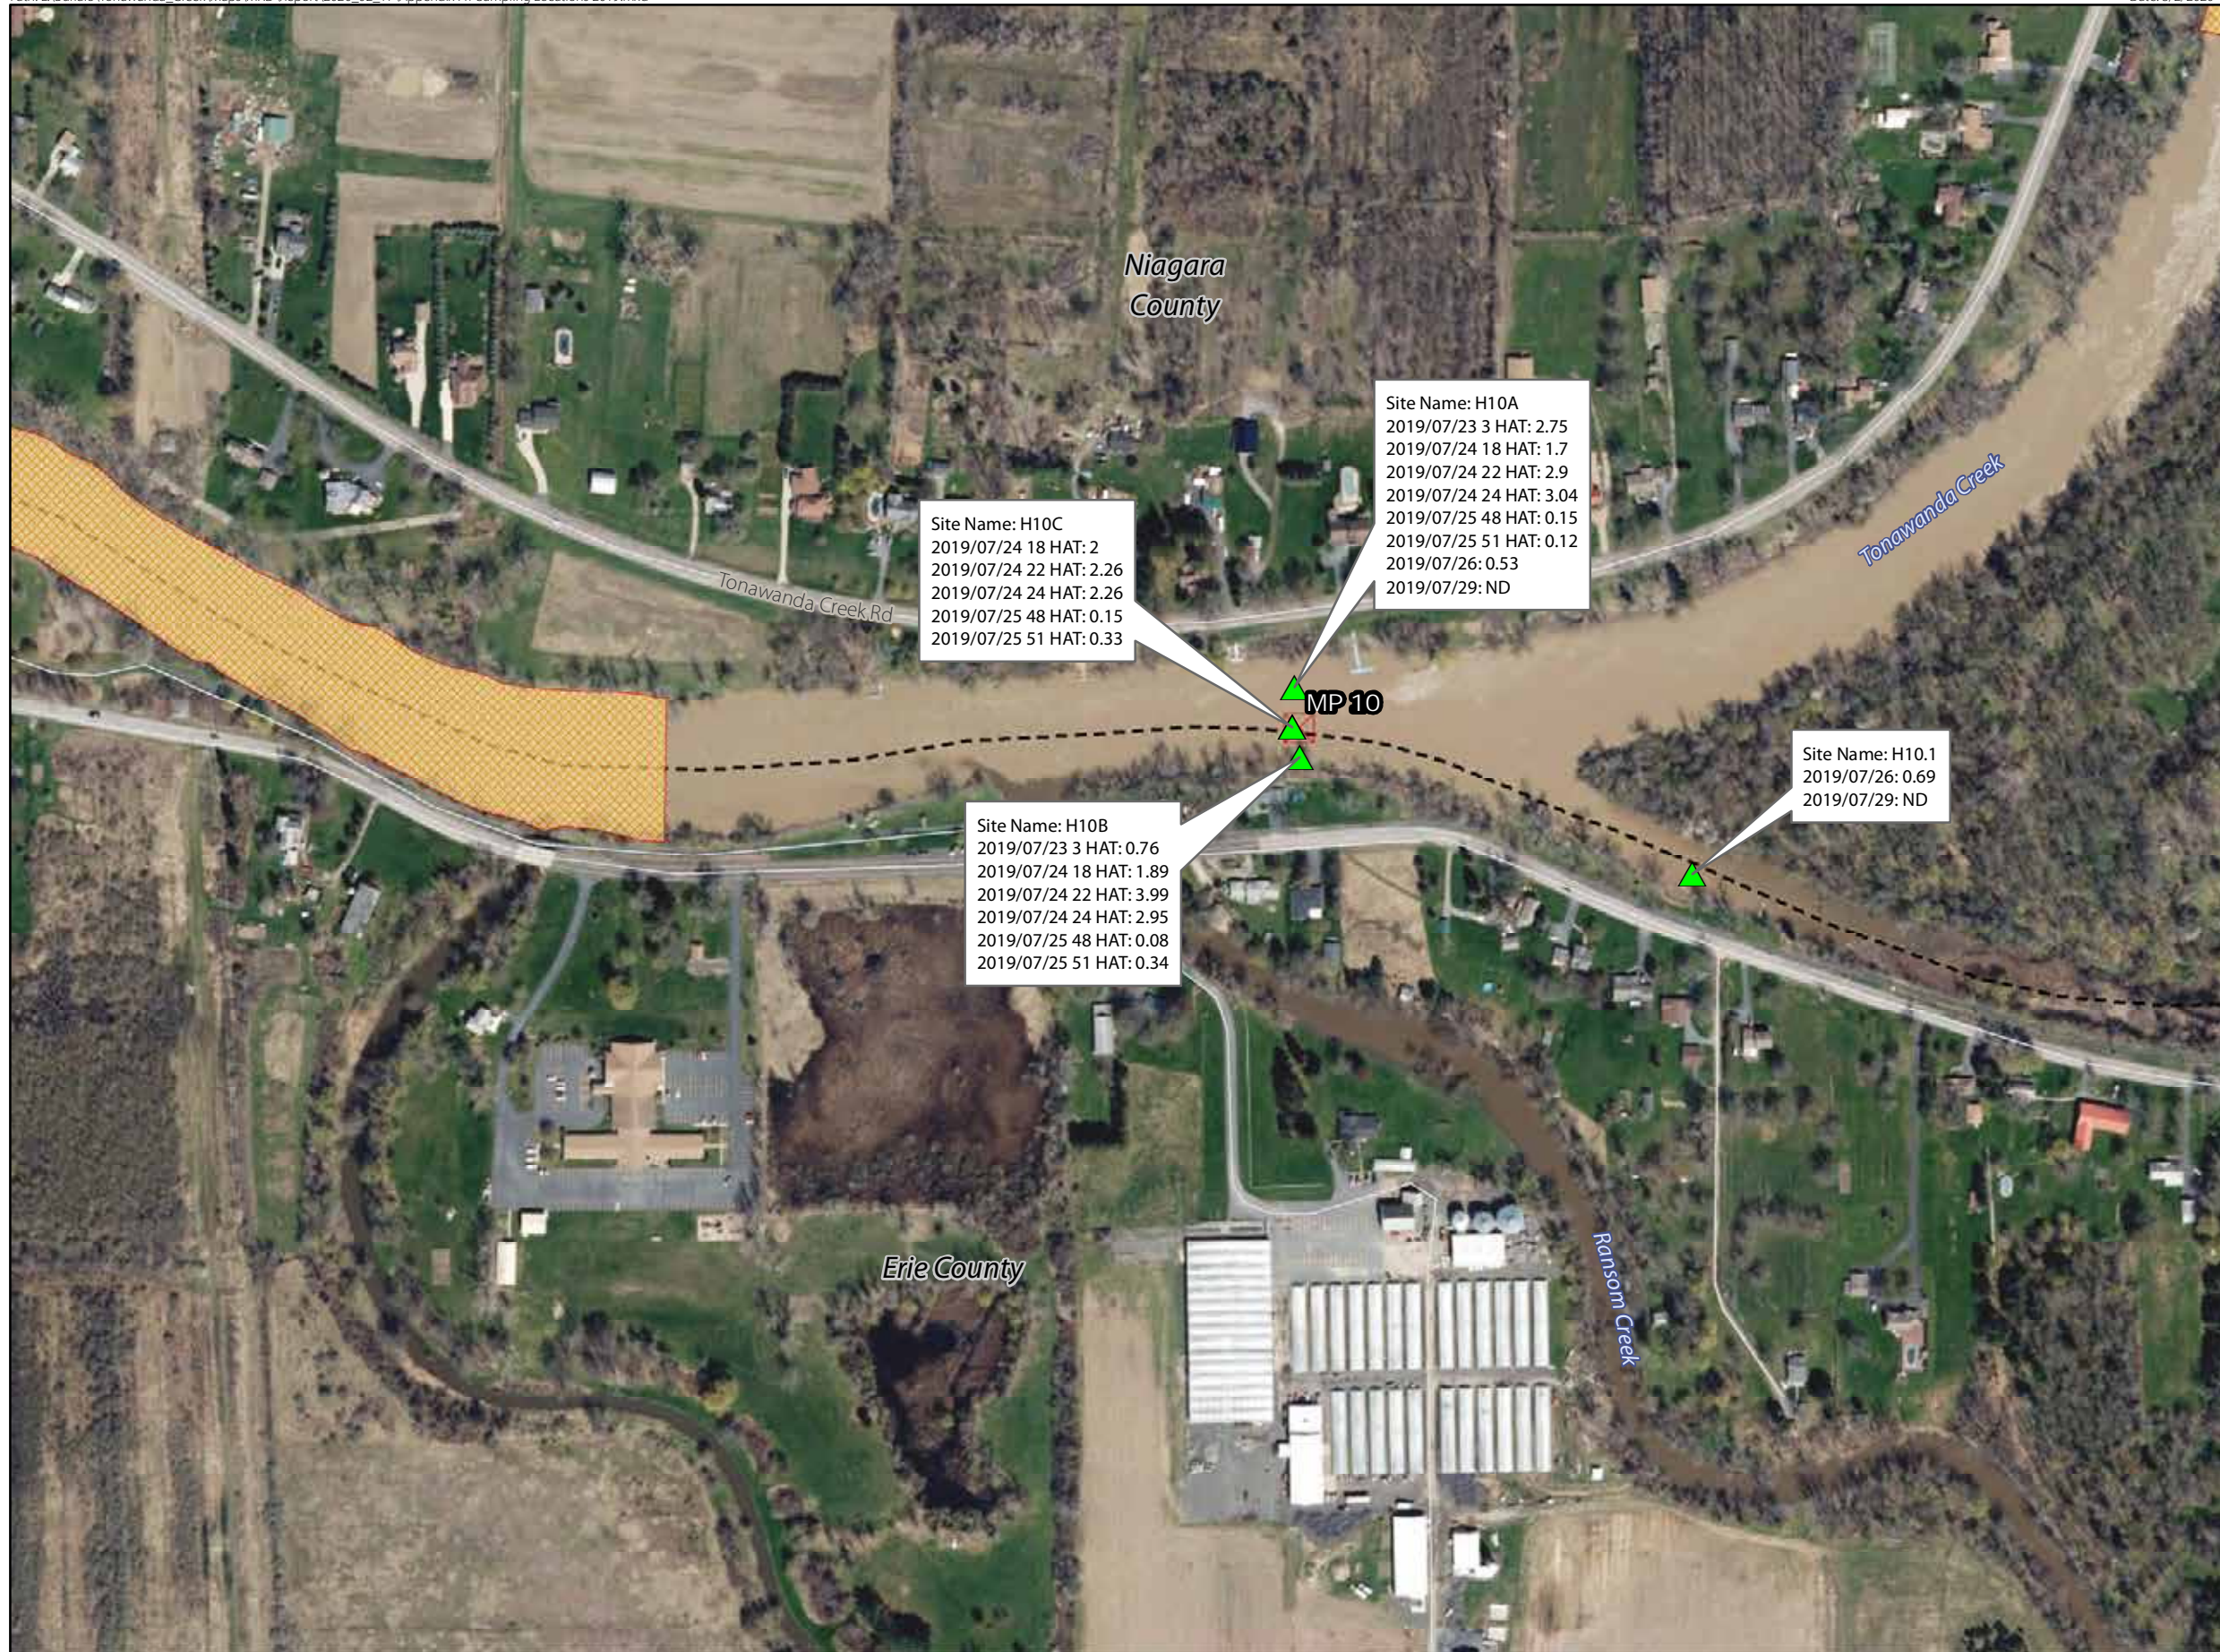
**July Endothall (Aquathol®K) Treatment  
Figure A1-13  
Tonawanda Creek/Erie Canal  
Erie and Niagara Counties, New York**

- July Sample Locations 2019
- July Endothall (Aquathol®K) Treatment
- Mile Post
- County Boundary
- Roadway

\*Note: All sample locations are approximate  
HAT- Hours After Treatment  
ND- Non-Detect

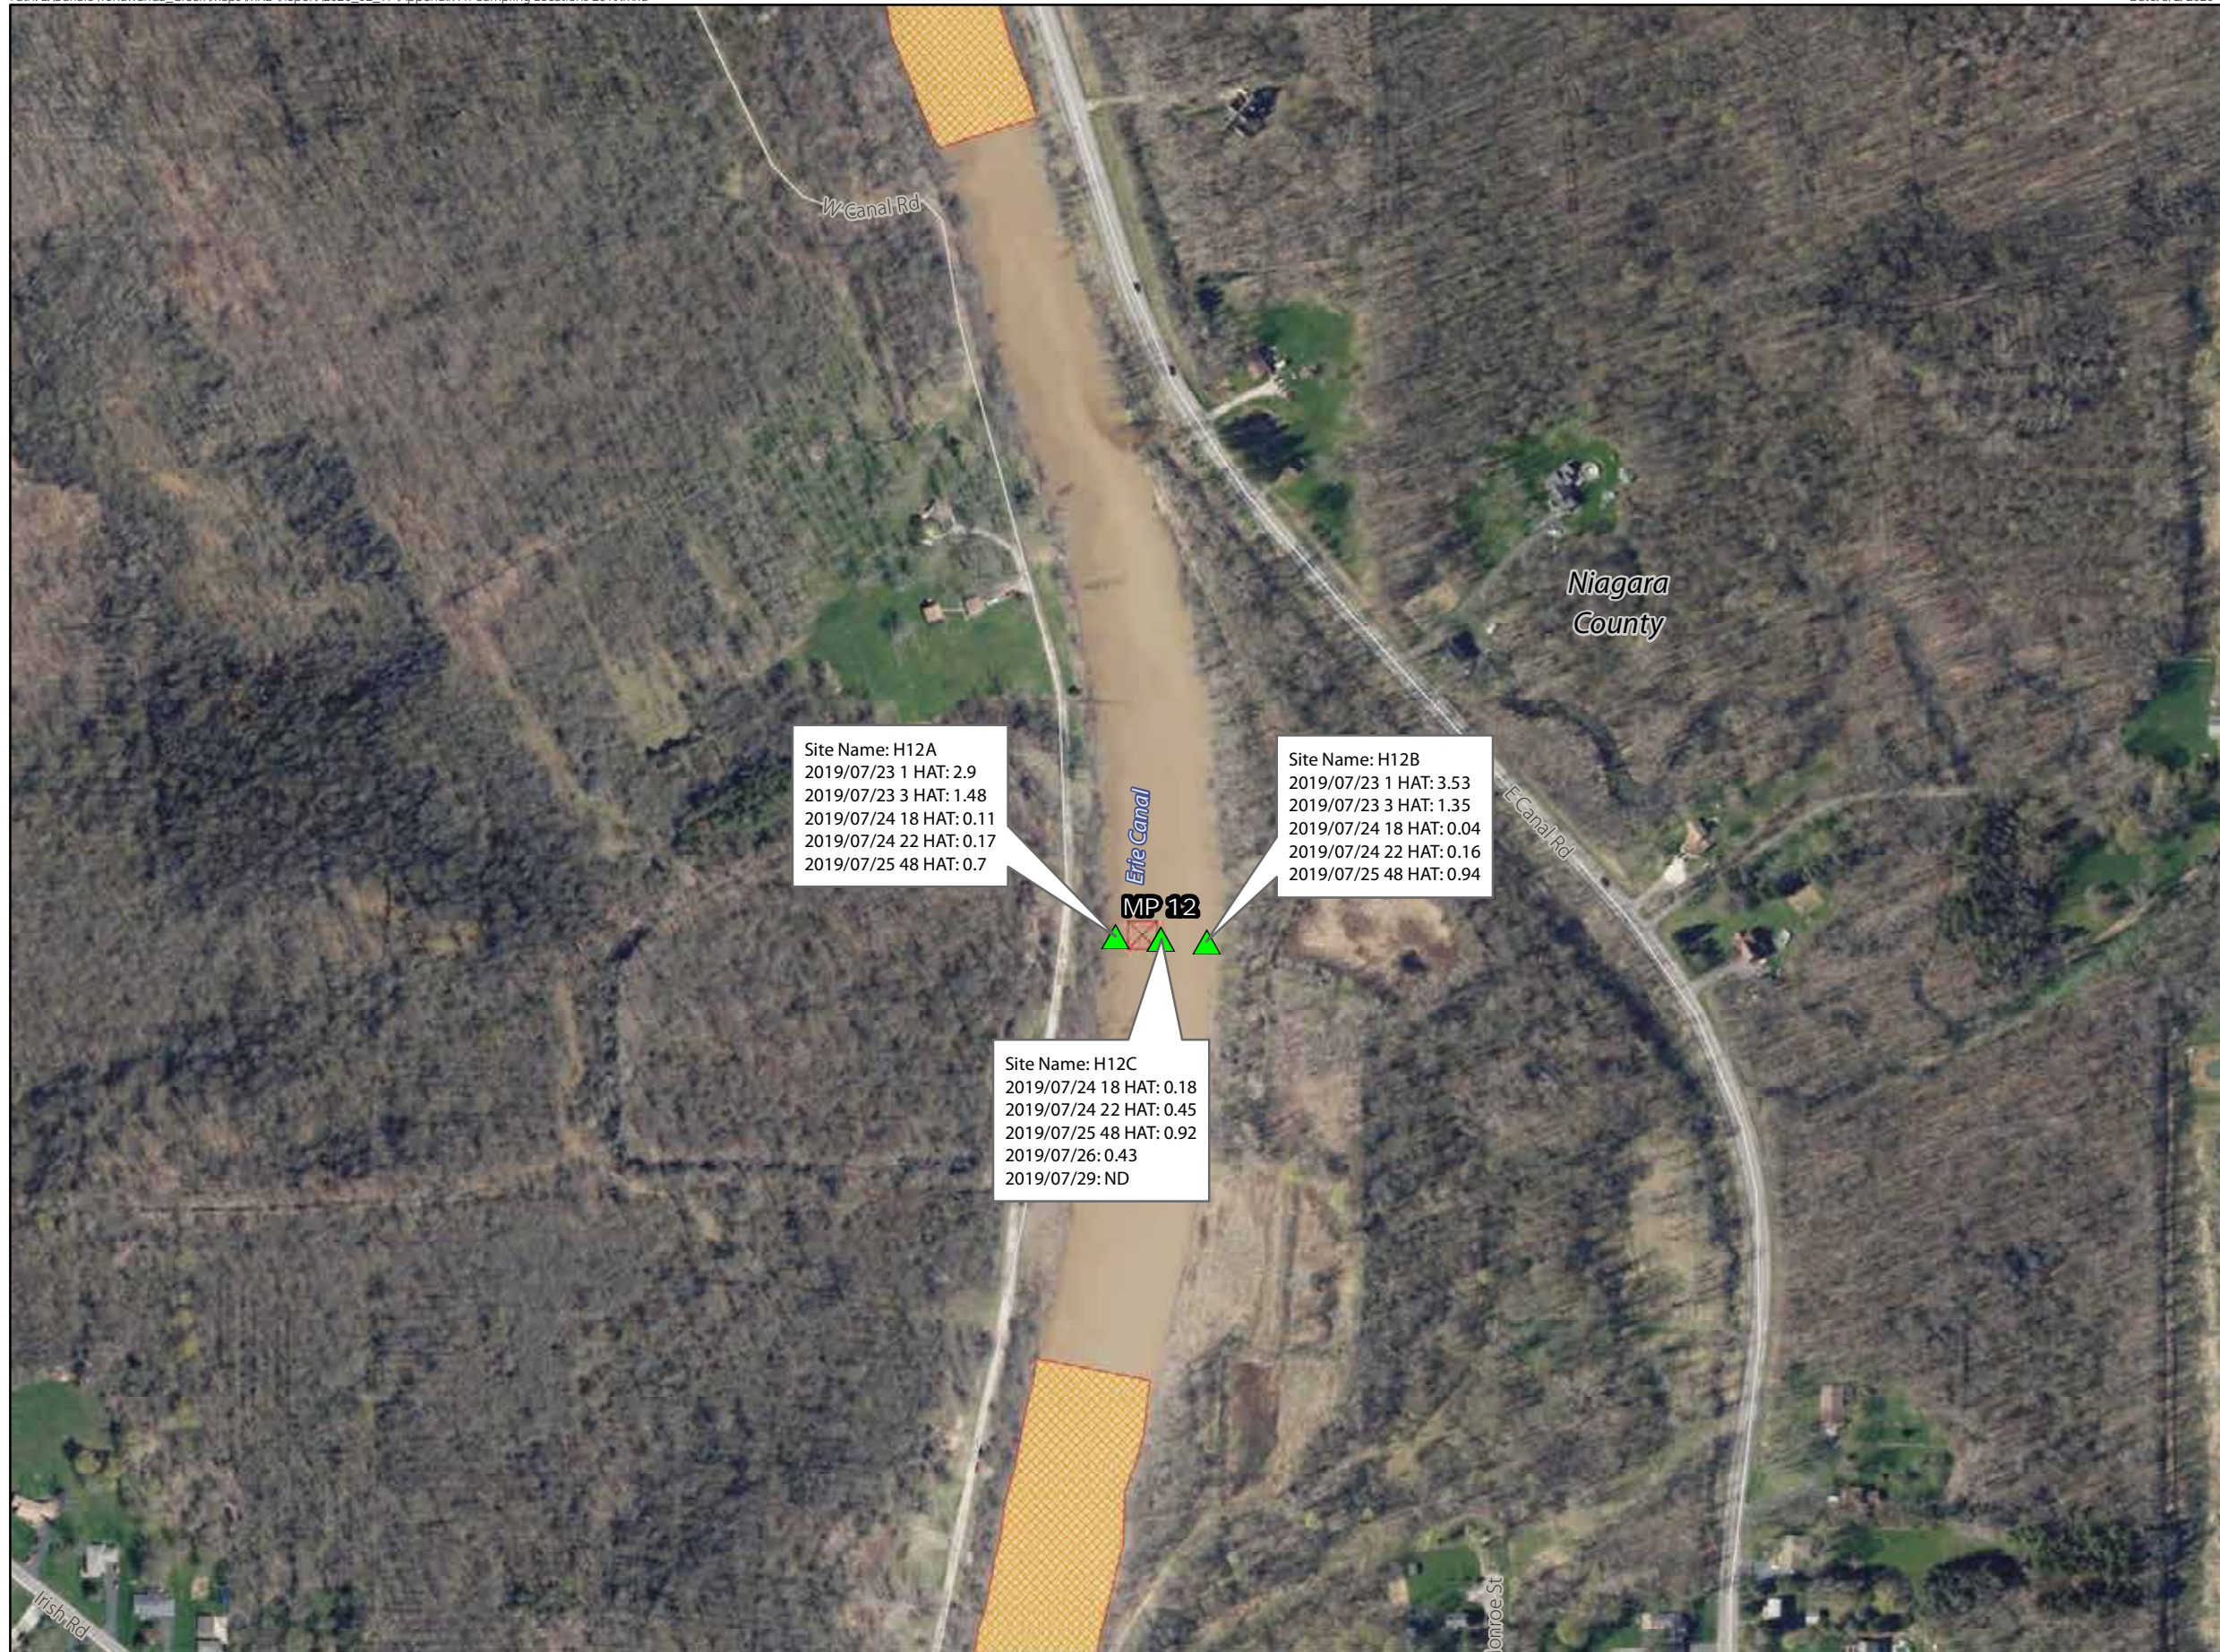
**July Endothall (Aquathol®K) Treatment  
 Figure A1-15  
 Tonawanda Creek/Erie Canal  
 Erie and Niagara Counties, New York**

- July Sample Locations 2019
- July Endothall (Aquathol®K) Treatment
- Mile Post
- Roadway

\*Note: All sample locations are approximate  
 HAT- Hours After Treatment  
 ND- Non-Detect

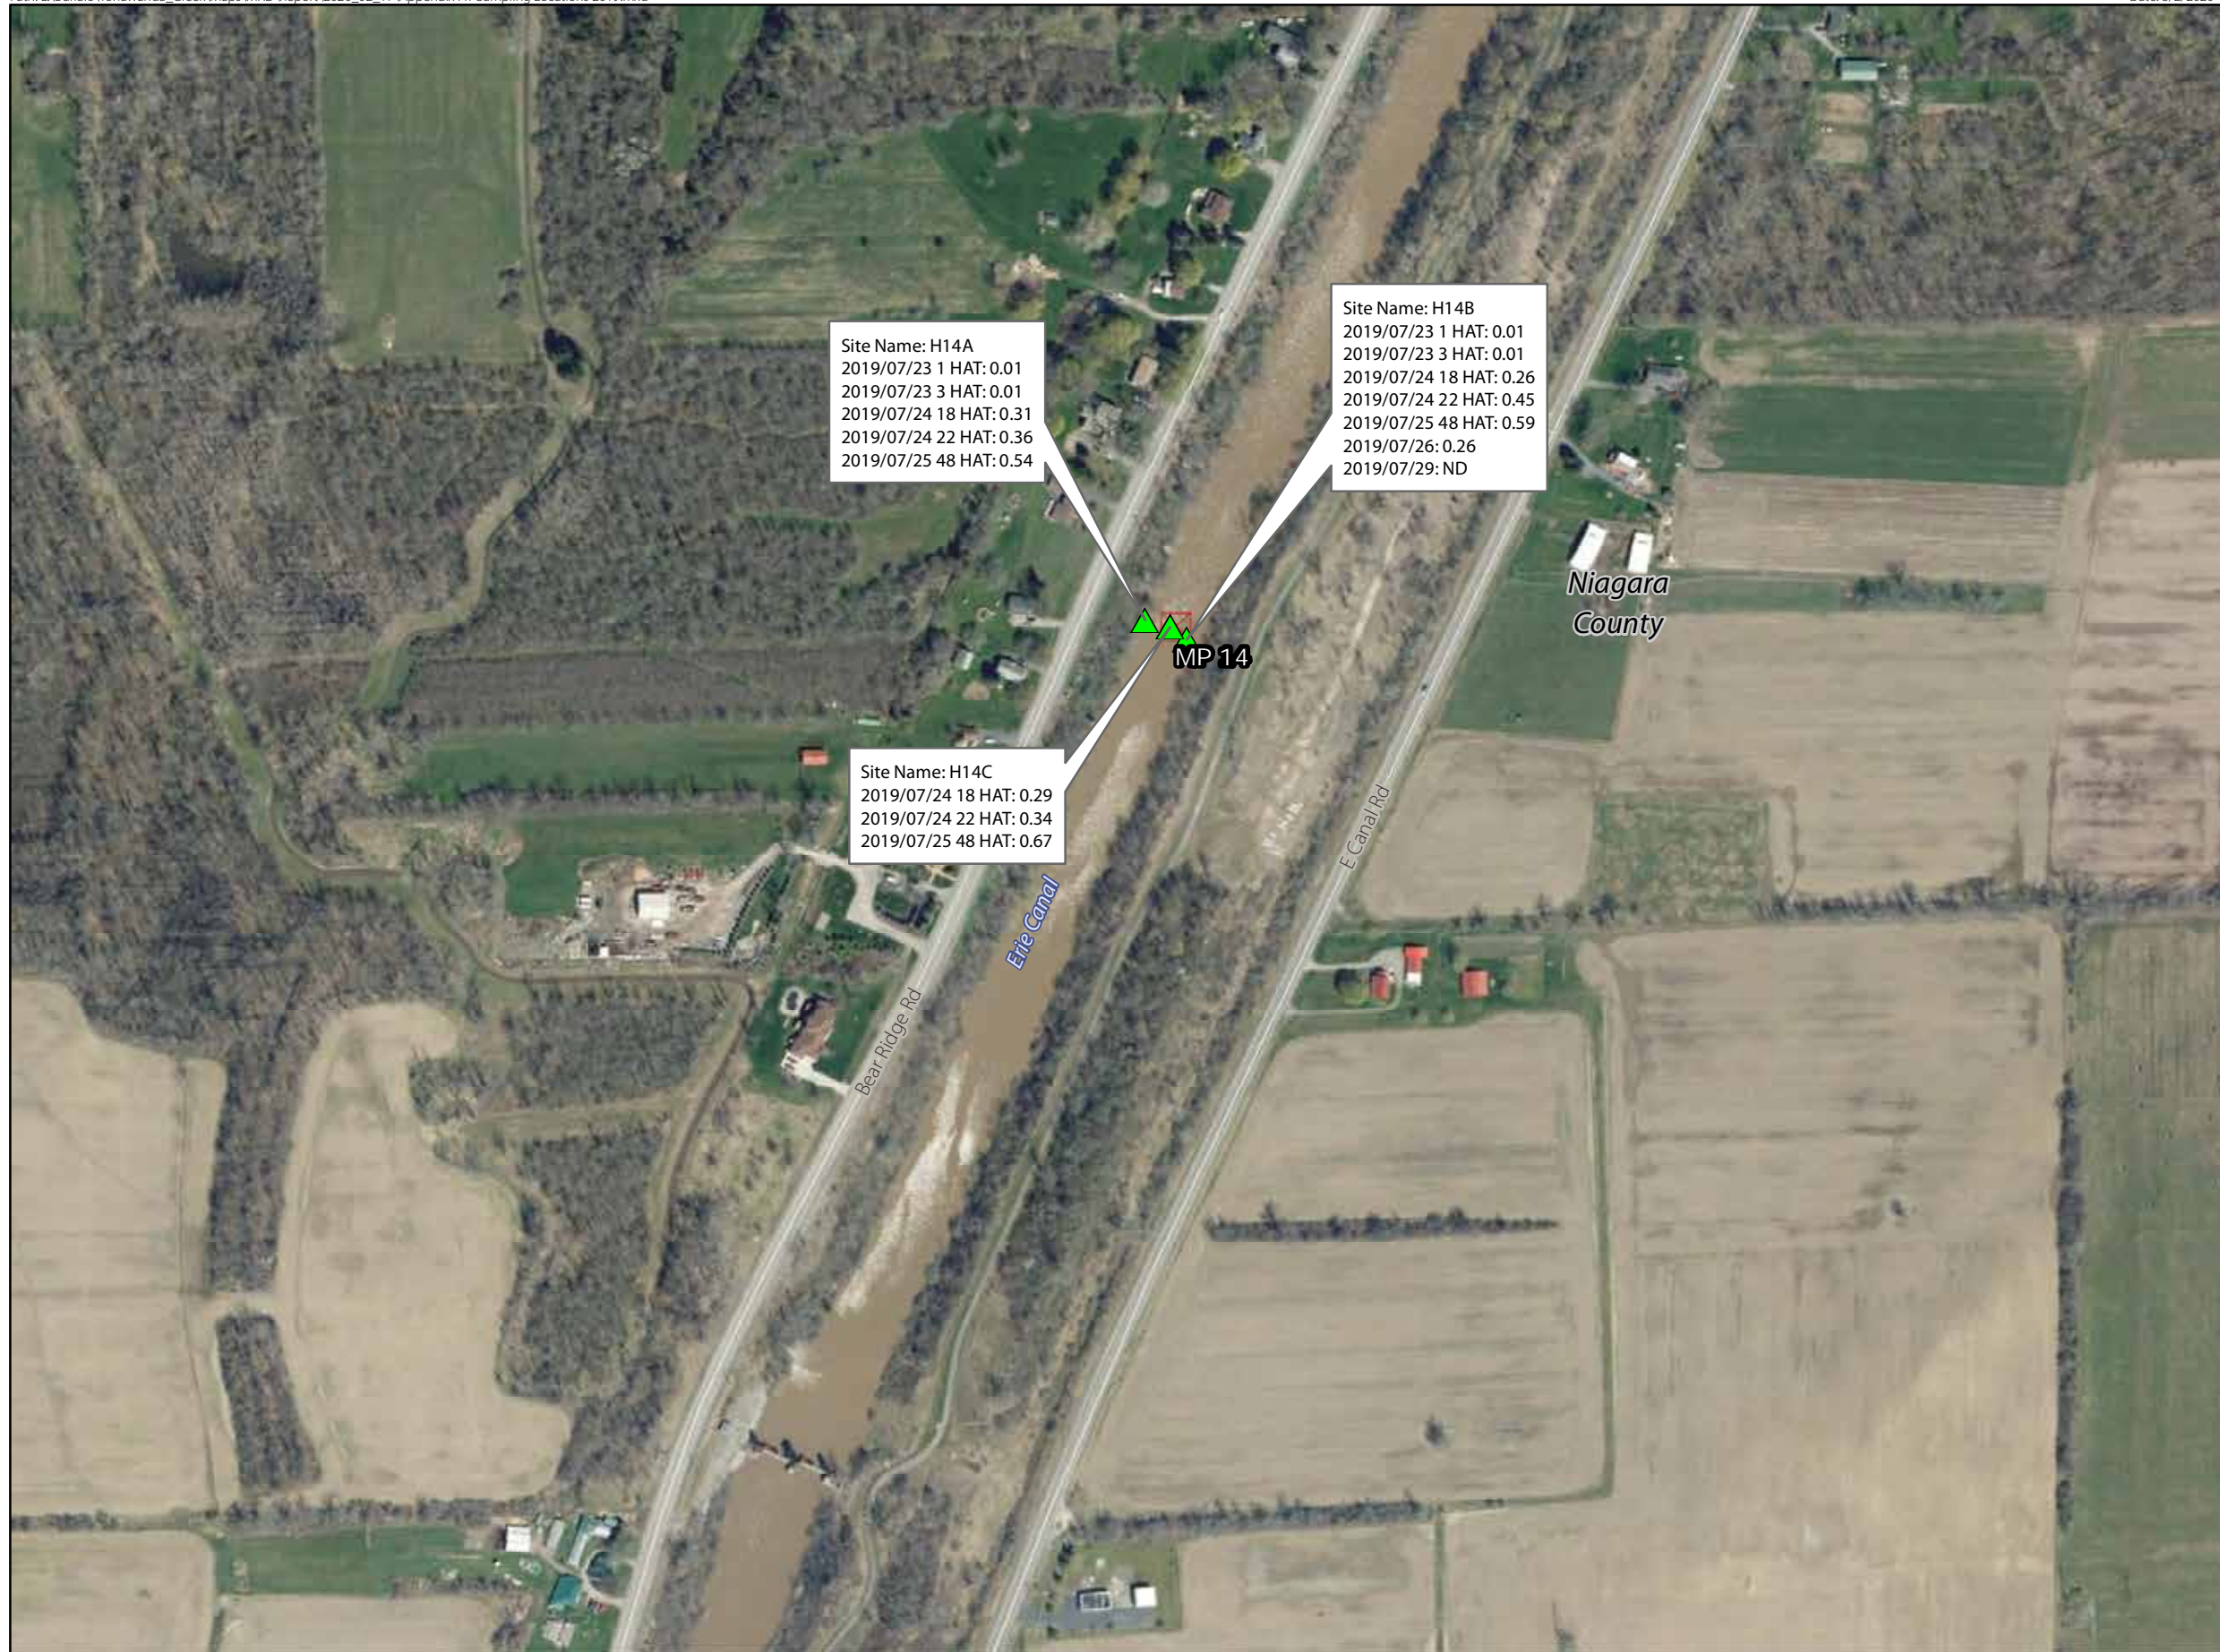
Site Name: H14A  
 2019/07/23 1 HAT: 0.01  
 2019/07/23 3 HAT: 0.01  
 2019/07/24 18 HAT: 0.31  
 2019/07/24 22 HAT: 0.36  
 2019/07/25 48 HAT: 0.54

Site Name: H14B  
 2019/07/23 1 HAT: 0.01  
 2019/07/23 3 HAT: 0.01  
 2019/07/24 18 HAT: 0.26  
 2019/07/24 22 HAT: 0.45  
 2019/07/25 48 HAT: 0.59  
 2019/07/26: 0.26  
 2019/07/29: ND

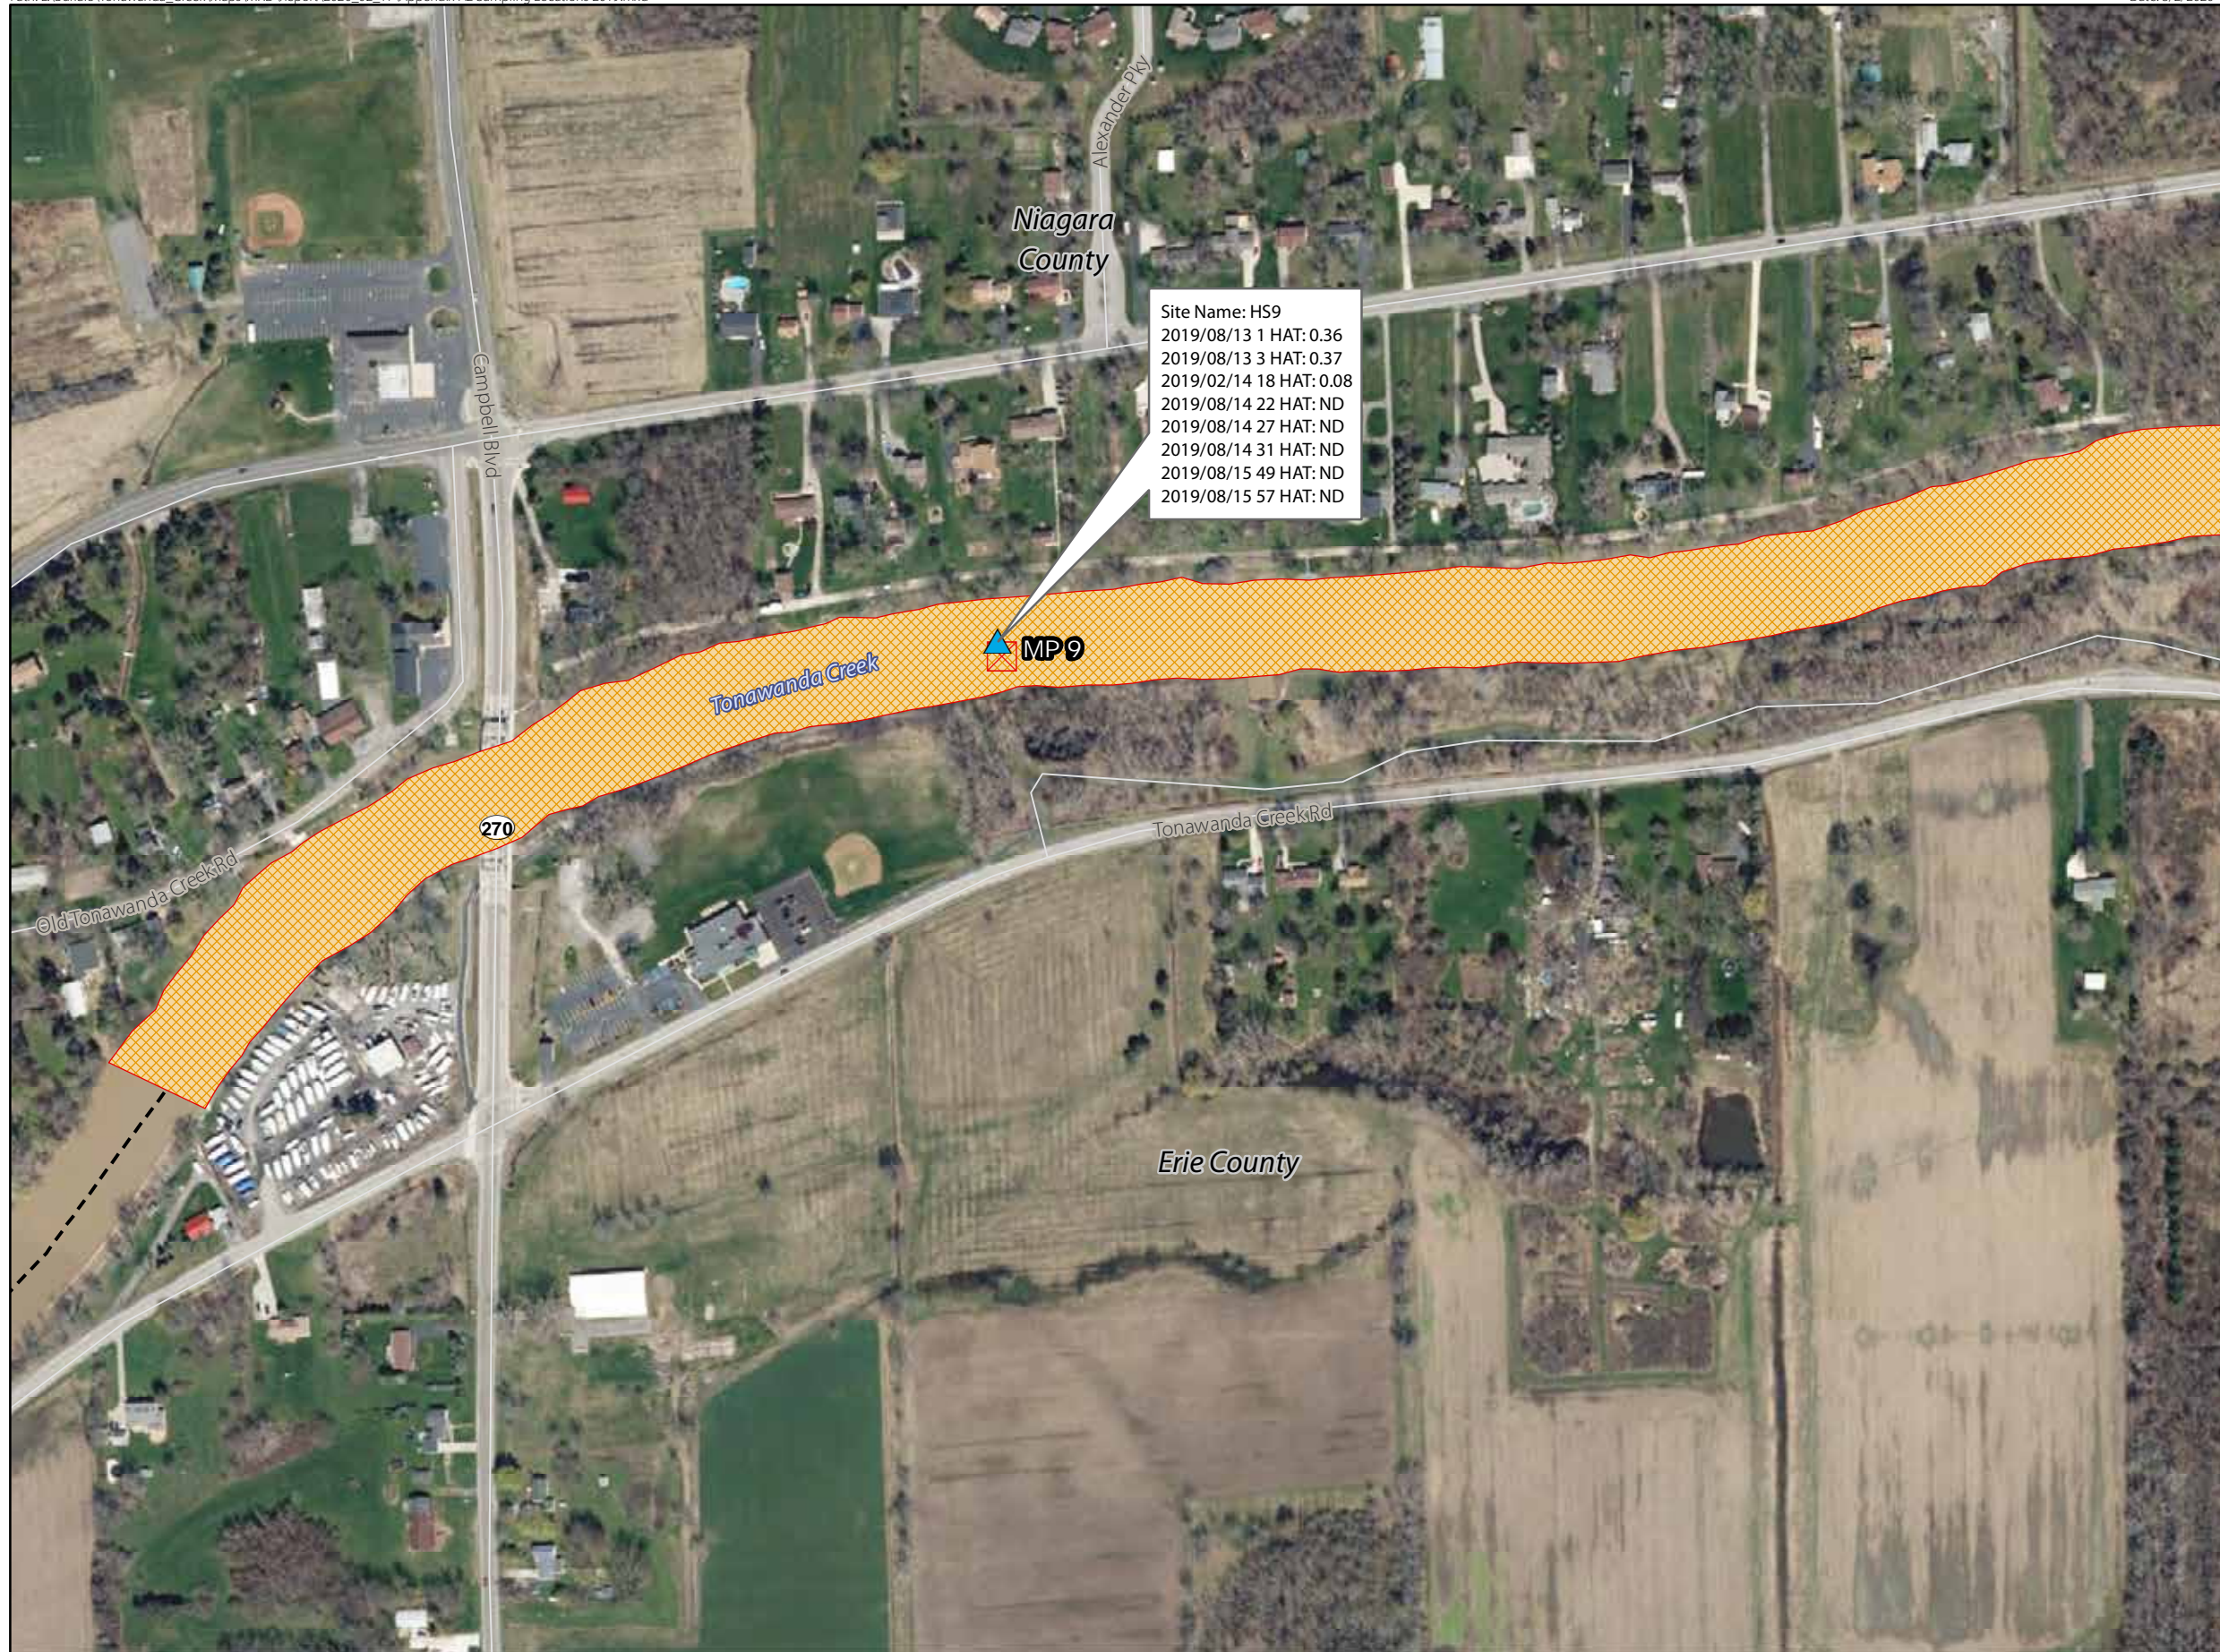
**August Endothall (Aquathol®K) Spot Treatment**  
**Figure A2- 9**  
**Tonawanda Creek/Erie Canal**  
**Erie and Niagara Counties, New York**

Site Name: HS9  
 2019/08/13 1 HAT: 0.36  
 2019/08/13 3 HAT: 0.37  
 2019/02/14 18 HAT: 0.08  
 2019/08/14 22 HAT: ND  
 2019/08/14 27 HAT: ND  
 2019/08/14 31 HAT: ND  
 2019/08/15 49 HAT: ND  
 2019/08/15 57 HAT: ND
