**Post-Treatment Assessment
for Aquatic Plant Control
ERDC Demonstration Project
Tonawanda Creek/Erie Canal
2017**

Contract No. W912P4-16-D-0002

February 2018

**US Army Corps
of Engineers®**
Buffalo District
BUILDING STRONG®

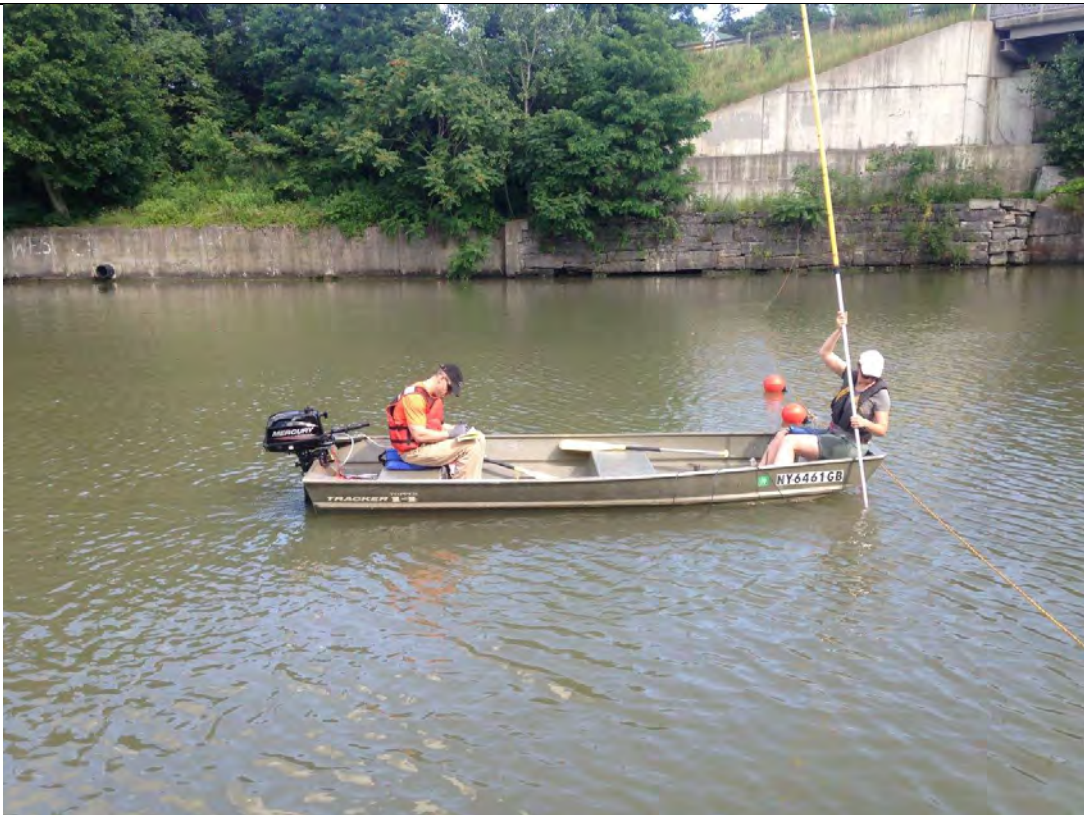
Description: E&E employees measuring velocity at 6 inches, 25%, 50% and 75% of creek/canal depth to determine the velocity profile at Stevens Street Bridge flow monitoring location.

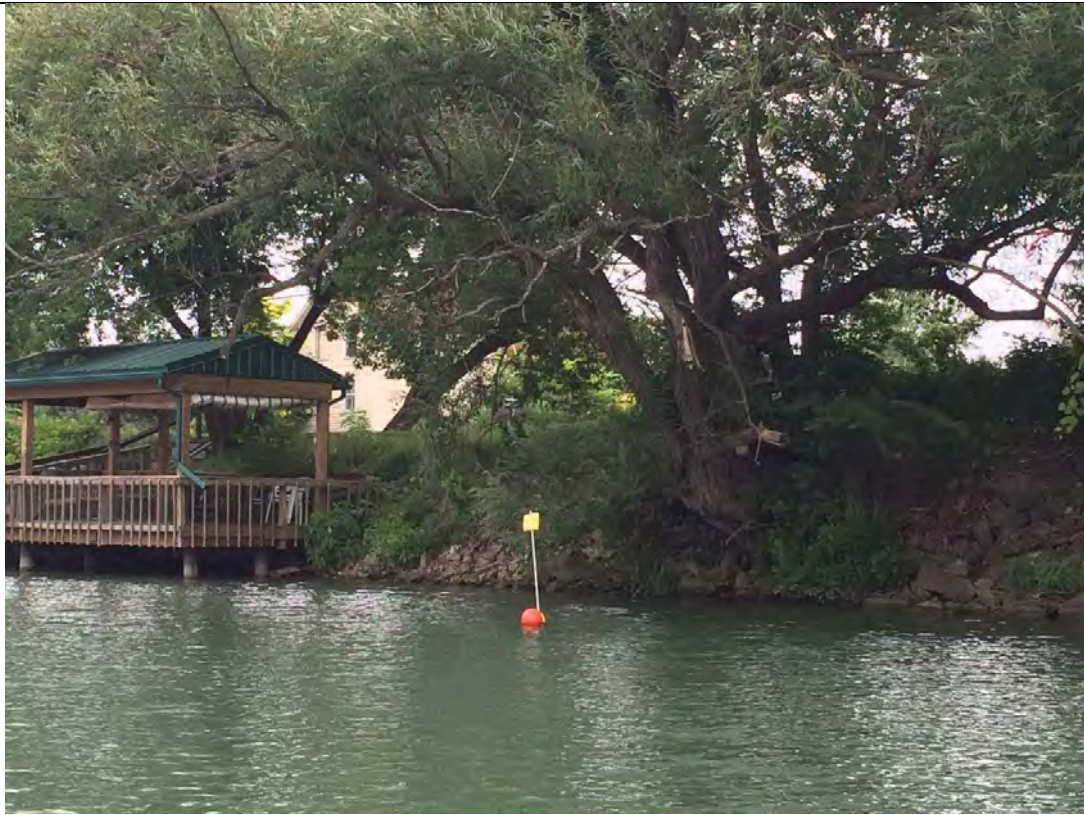
Date: 08/11/2017 **Direction of View:** SE from N side of creek
Subject: Botanical Gardens meter location
Description: Two buoys mark the new location of the flow meter at the Botanical Gardens in North Tonawanda, NY

In 2016, the flow meter at Mayor's Park was difficult to put in place before treatment and difficult to remove when sampling was completed. In 2017, a location on the south shore of the creek/canal near the Botanical Gardens ramp was chosen for the meter placement. No issues with meter tipping were noted and access to the location was easy from both boat and shoreline, making this location a better alternative for the former Mayor's Park meter location.

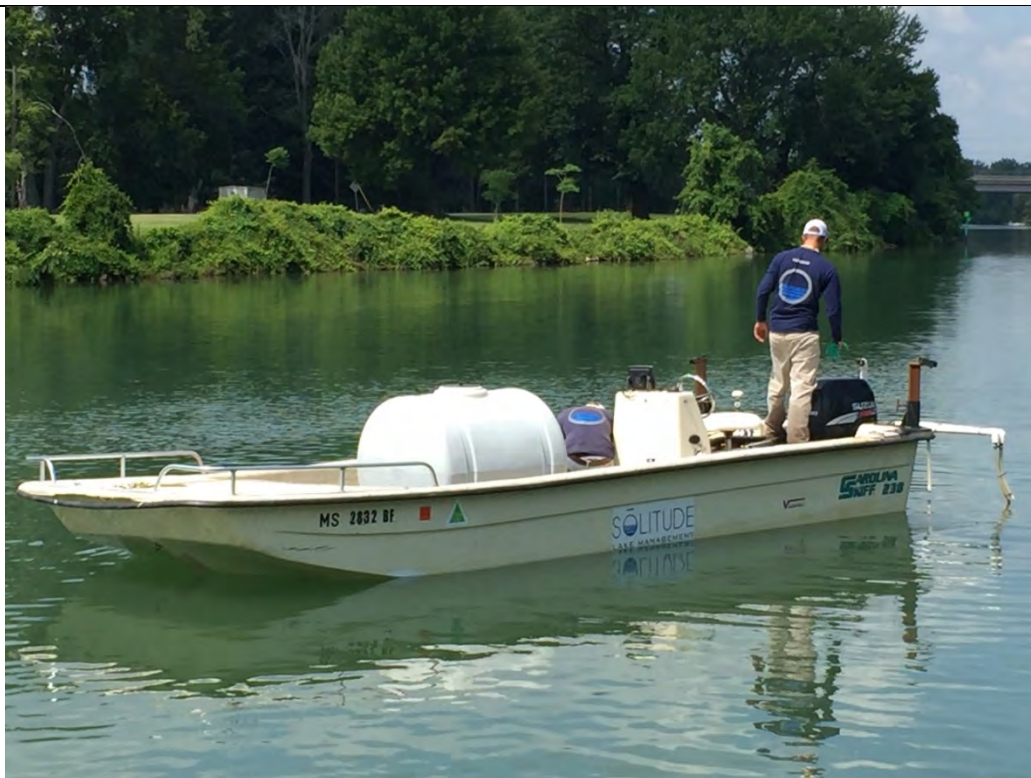
Date: 08/01/2017 **Direction of View:** West from North shore of creek
Subject: SOLitude endothall application boat
Description: Endothall was placed in the tank and dispensed into the creek/canal through PVC pipes off of boat stern.

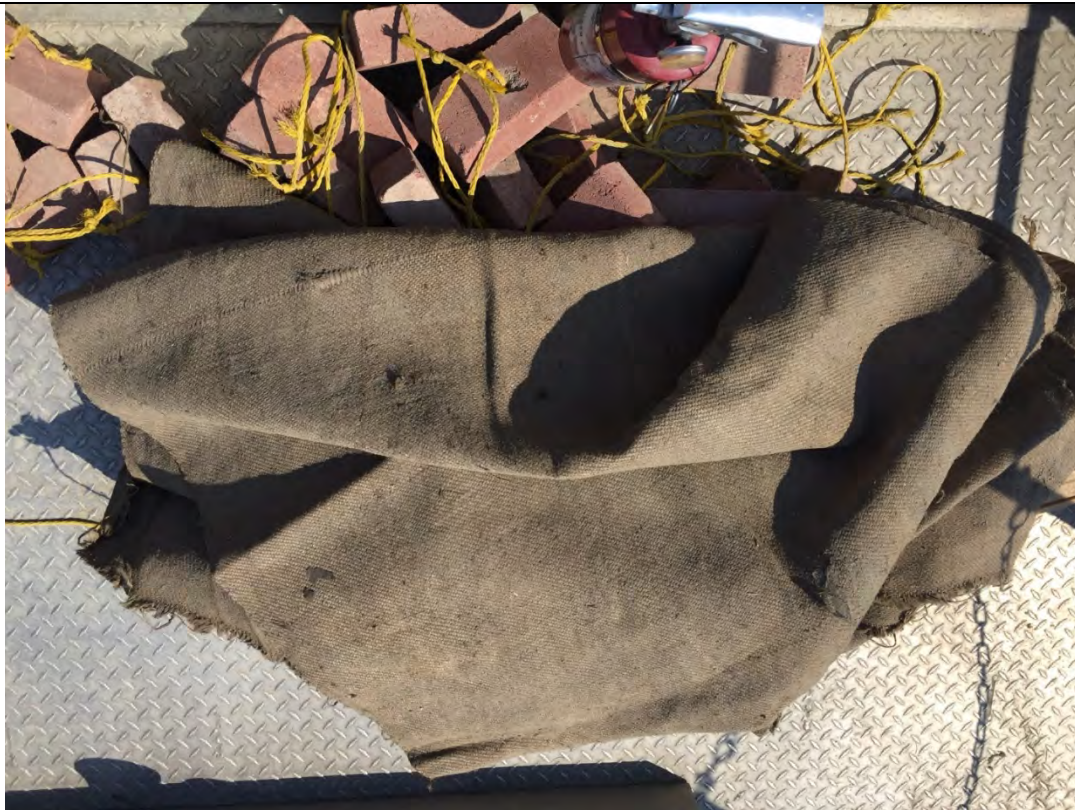
Date:	08/02/2017	Direction of View:	NA
Subject:	Benthic mat		
Description:	Burlap benthic mat and associated brick weights.

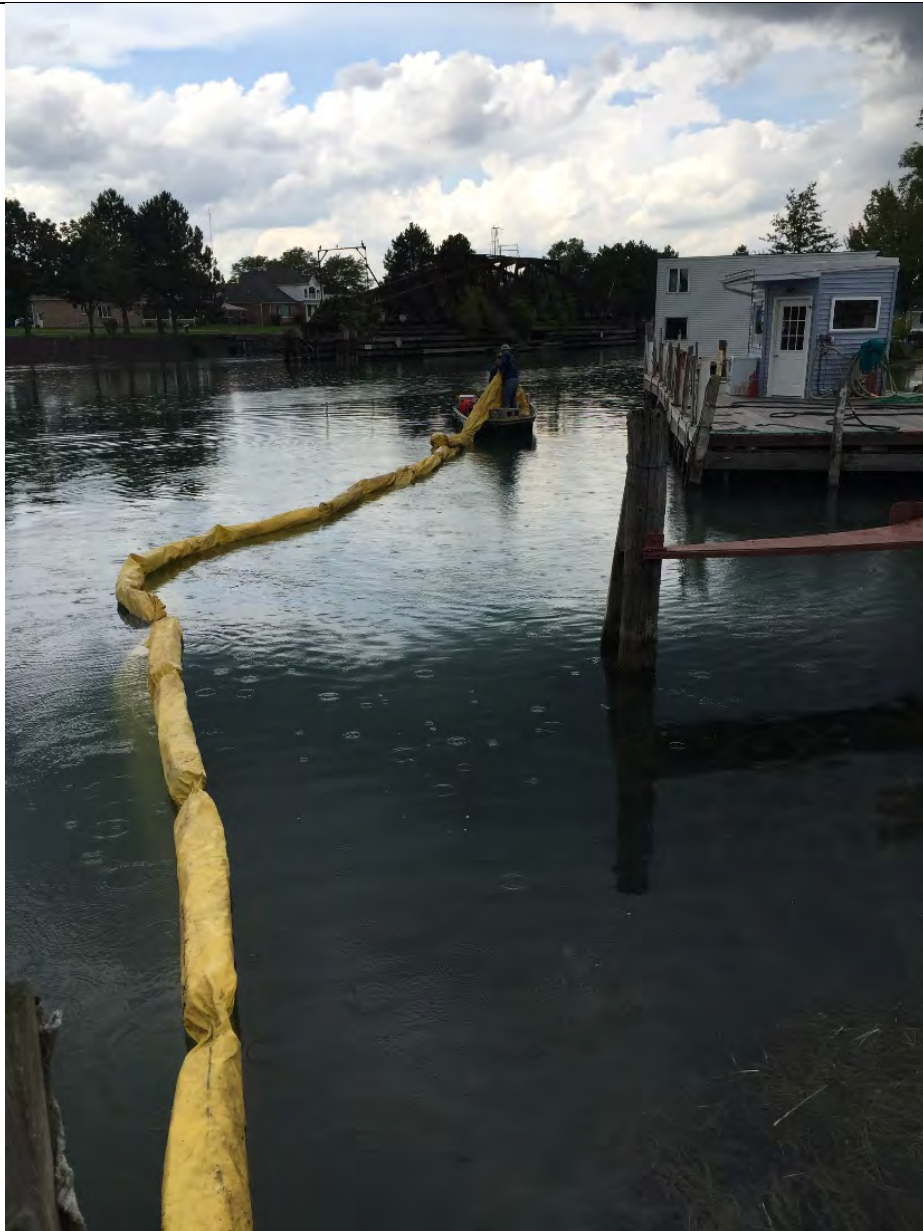
Date:	09/06/2017	Direction of View:	West from North shore of creek
Subject:	Limnocorral at Wardell Boat Yard Marina		
Description:	Installation of limnocorral at Wardell Boat Yard marina for isolated spraying of endothall from shore by backpack and from boat.

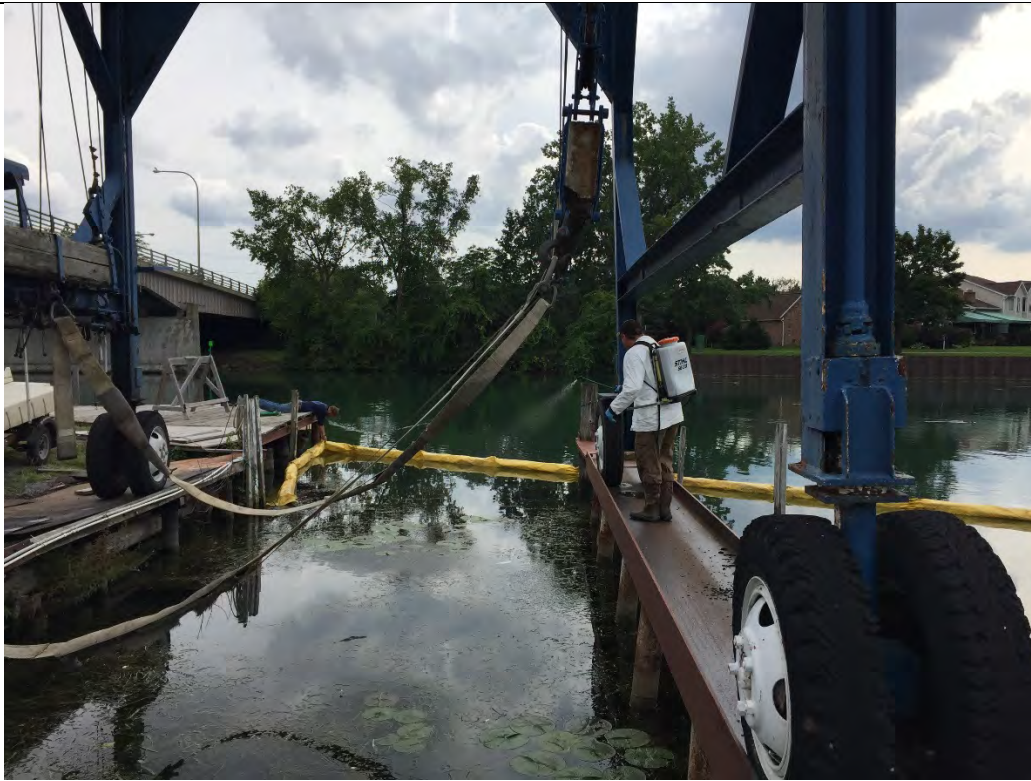
Date:	09/06/2017	Direction of View:	West from North shore of creek
Subject:	SOLitude endothall sprayer application at Wardell Boat Yard Marina		
Description:	Endothall was placed in the backpack tank and sprayed into the area around the marina by hand.

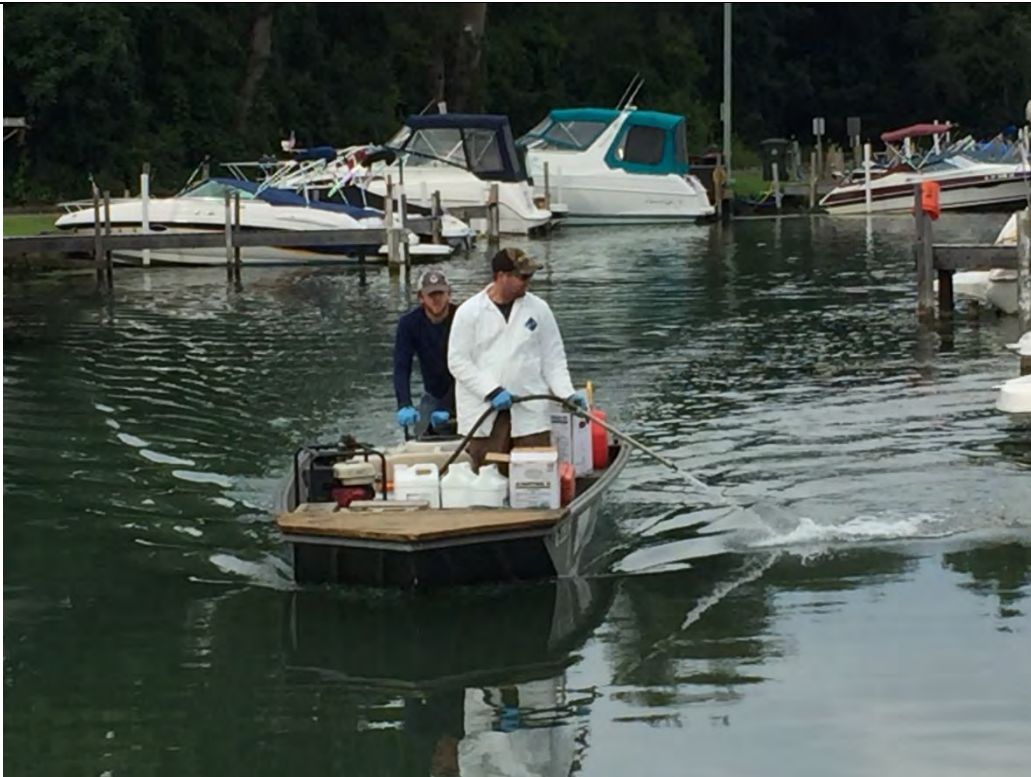
Date:	09/06/2017	Direction of View:	North from North shore of creek
Subject:	Wardell Boat Yard Marina		
Description:	Endothall application.
