Cleveland Metroparks

A Hydrilla project in Ohio's Lake Erie Basin

Detection, Control, and
Prevention

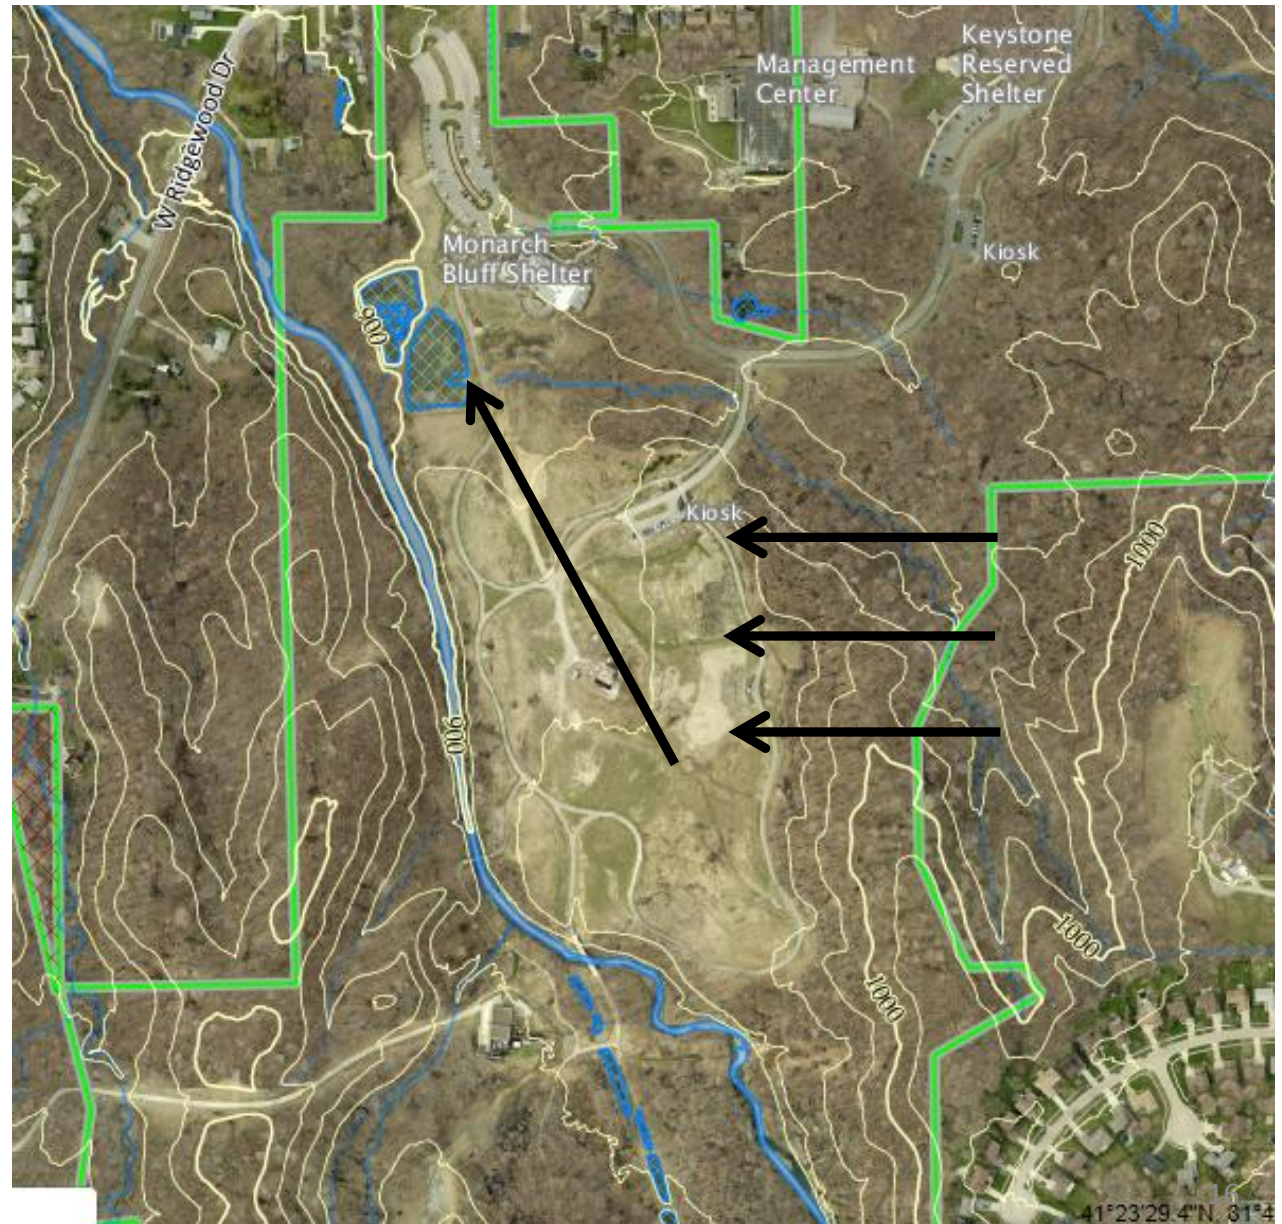
Greathouse Wetlands

2 - 4 feet deep

Hydrologically dynamic
accept runoff from a
capped landfill

Flood in spring
Dry in the summer

Challenge to maintain
fluridone concentrations

Now use Sonar H4C,
results encouraging

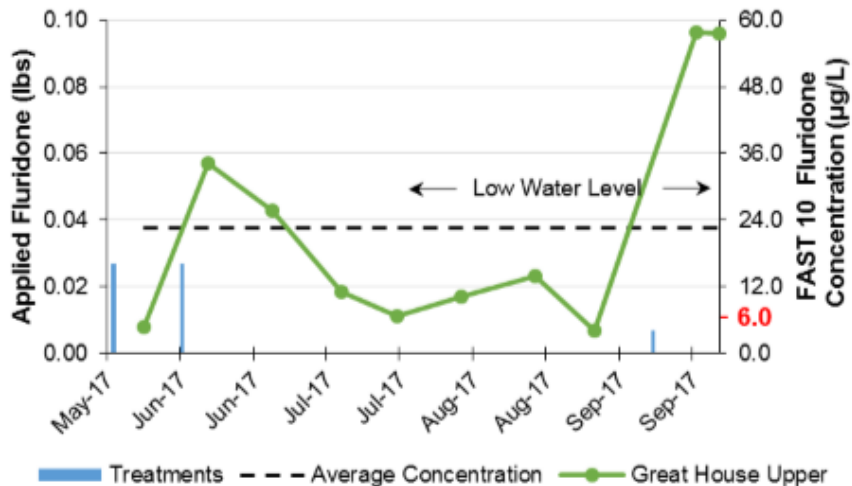
Greathouse Wetlands Sonar H4C

May – October
 Fluidone 6ppb, target
 FasTESTs every ~ two weeks

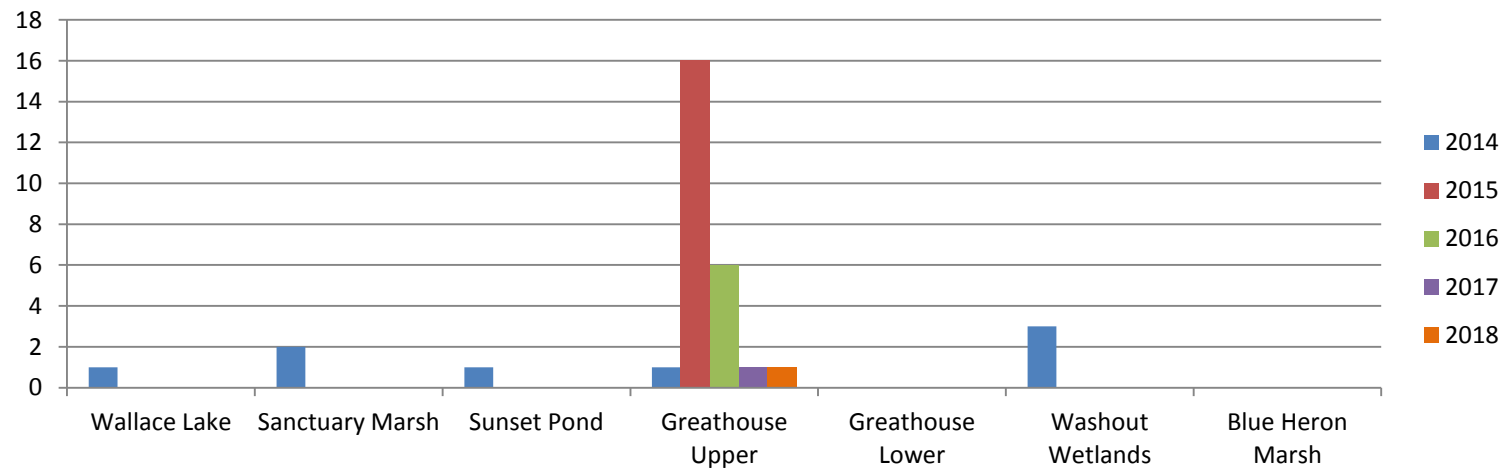
Sprouted + Unsprouted Hydrilla Tubers in Cleveland Metroparks

2017 & 2018 Summary of tuber sampling

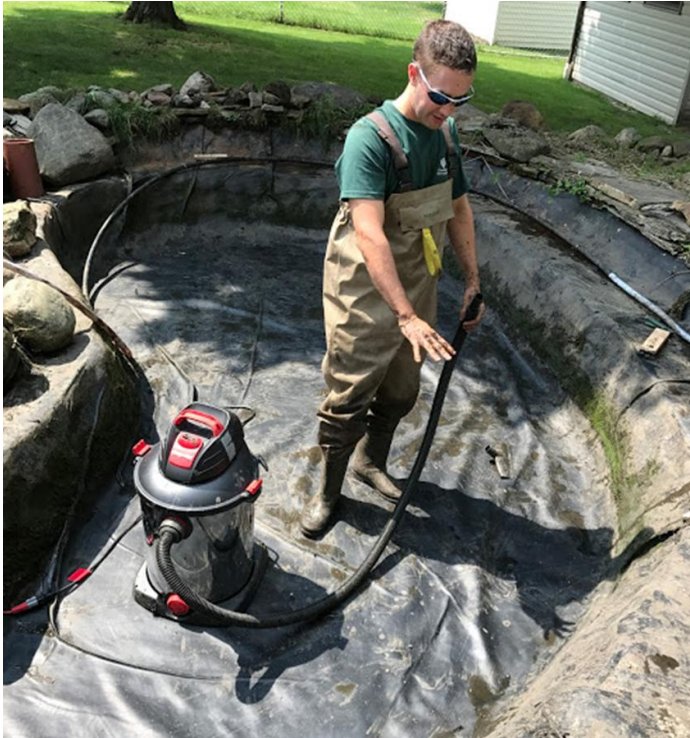
Removed all vegetation, vacuumed clean

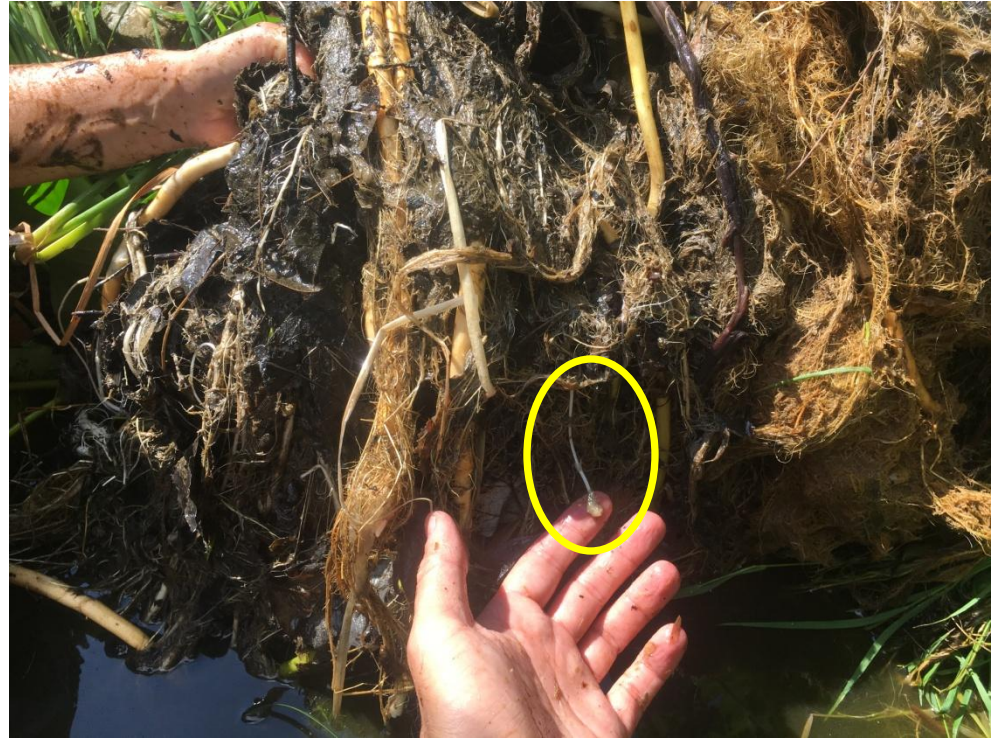
Hydrilla tuber in typha root wad

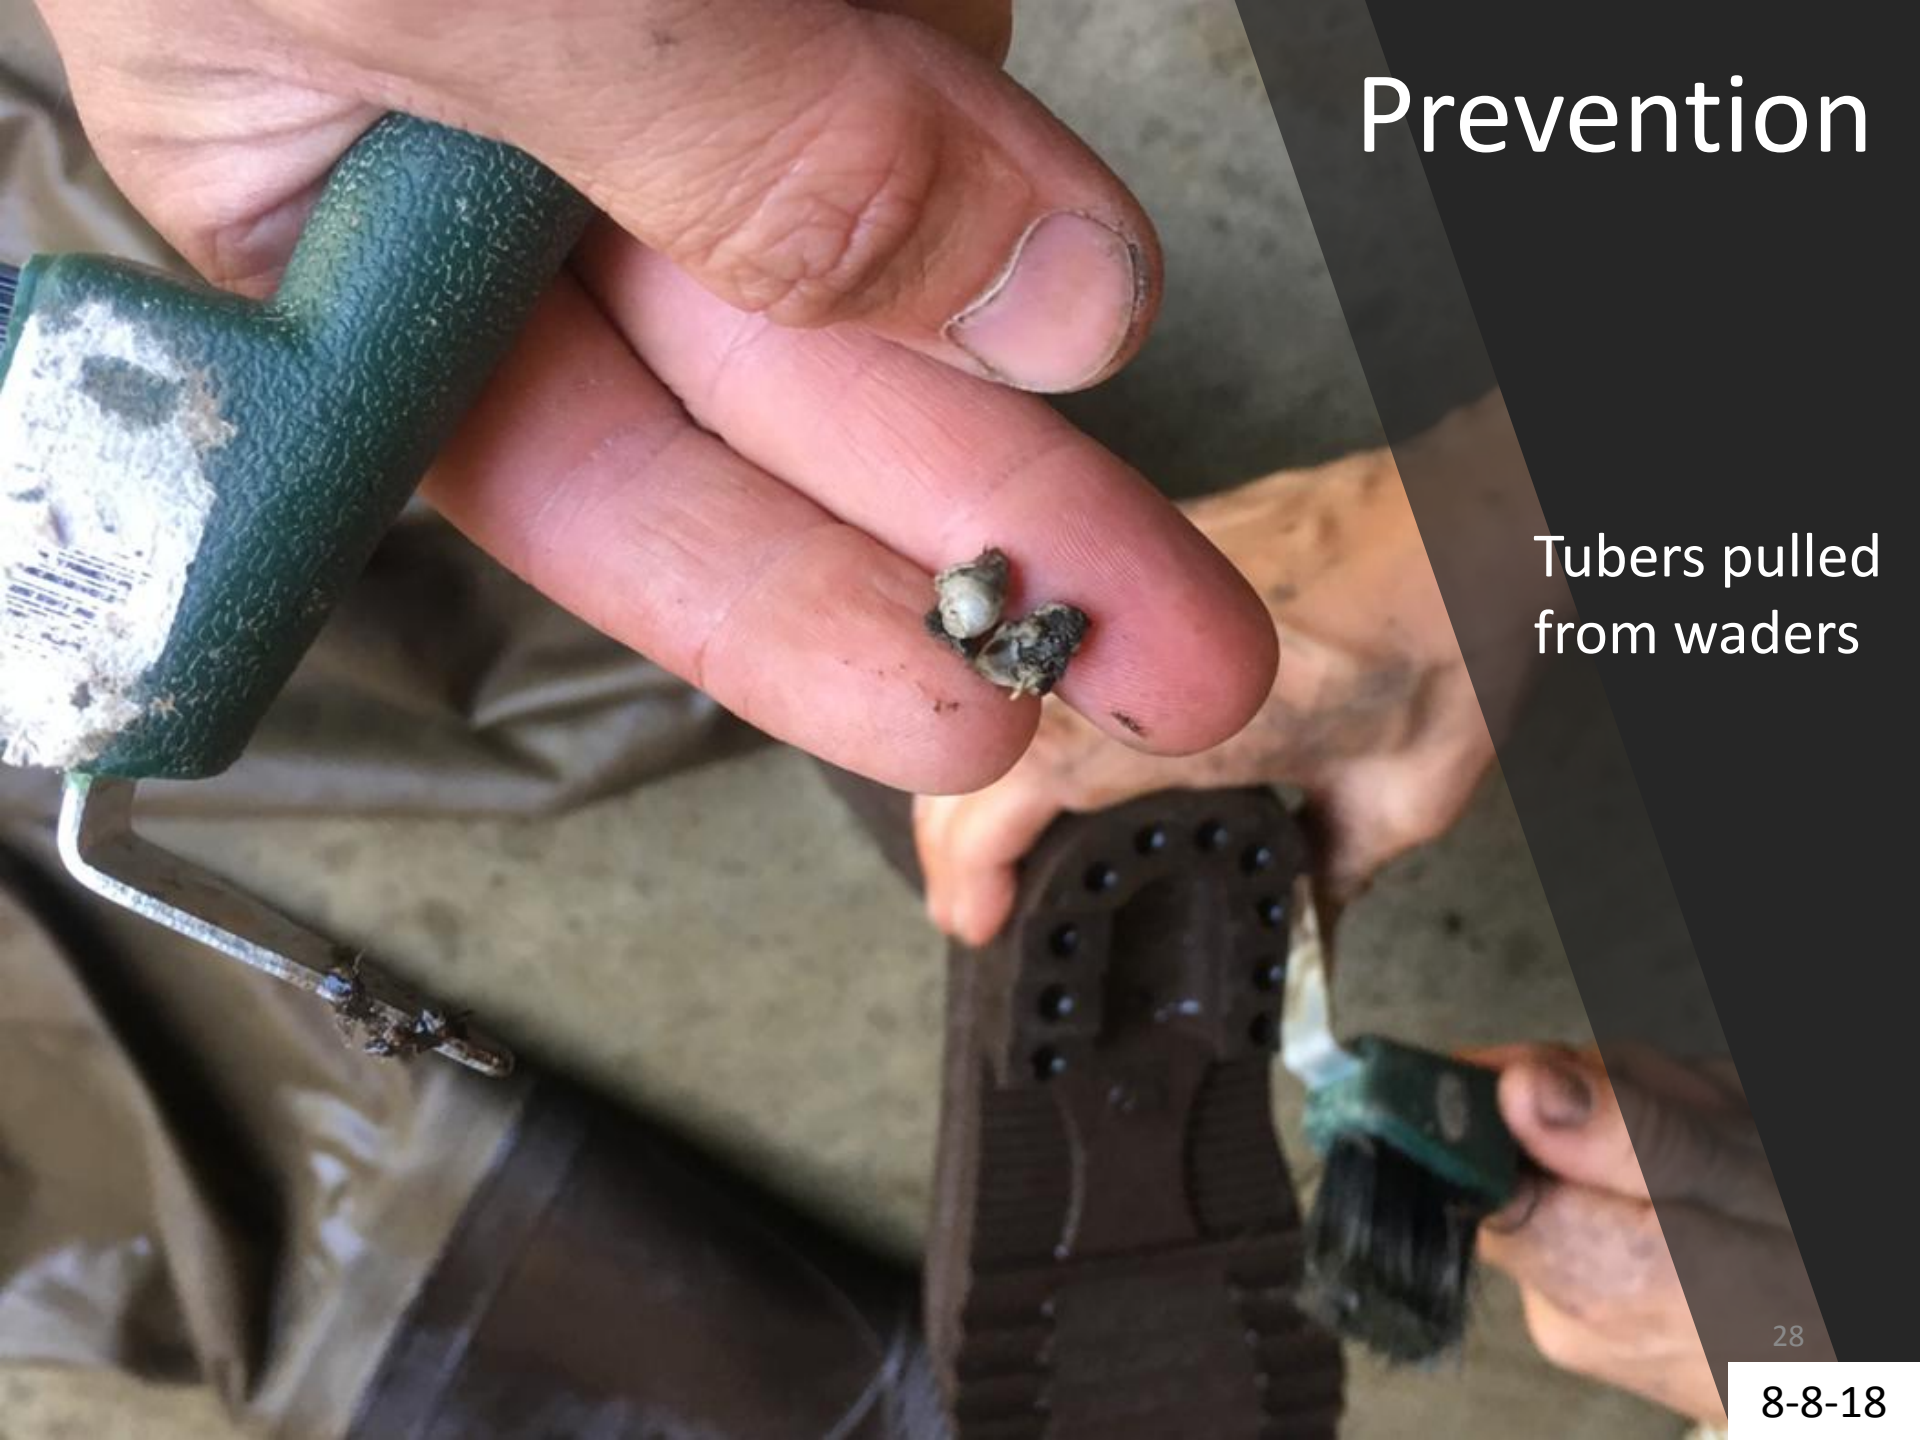
Tubers pulled
from waders
